A Derailment Investigation Leads to Broken Spikes

Brad Kerchof
Research & Tests

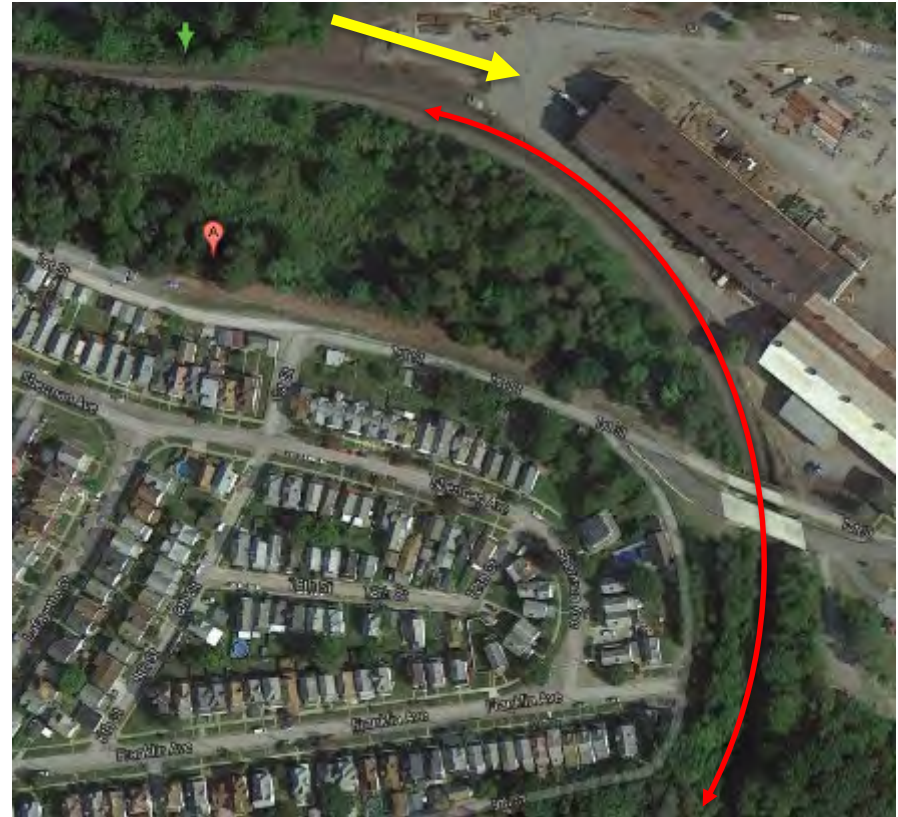
Google Earth image of the derailment site

- Vandergrift, PA, January 2014
- 8.3° curve, river grade (0.3% descending to 0%)
- Timetable speed 30 mph, direction of travel top to bottom on map
- former steel plant located on the outside of the curve
- length of track damage indicated by red line

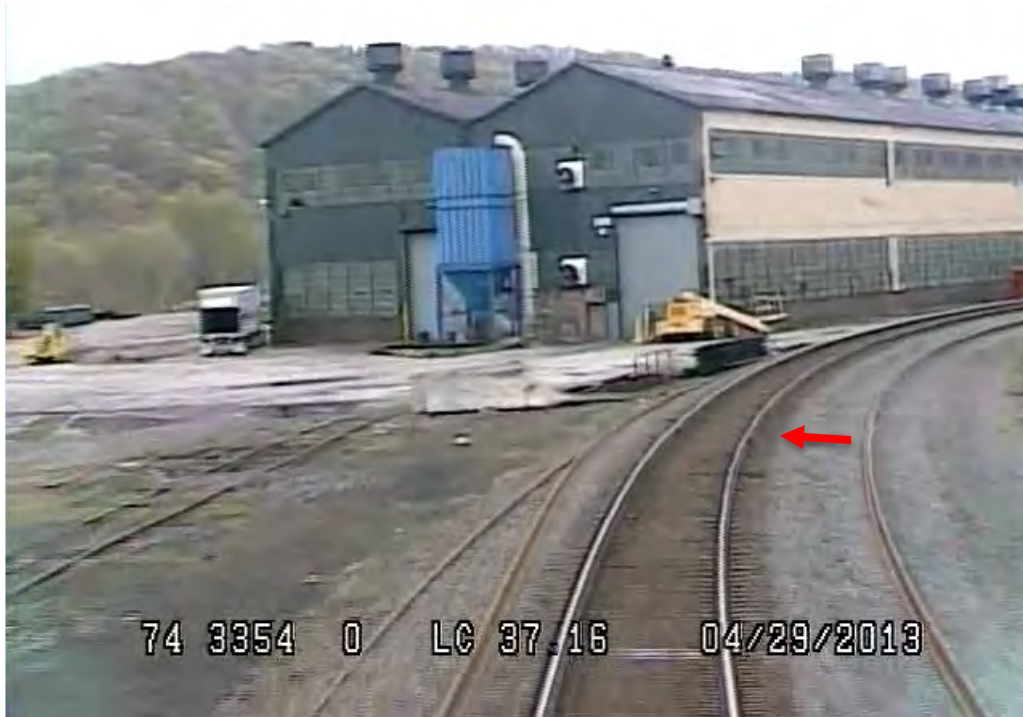
Looking in the direction of train travel

- looking east at the entrance spiral to the 8.3° curve and at the former steel plant
- signal cut section with insulated joints is at the point of spiral to curve (red arrow)
- track damage began at the insulated joints

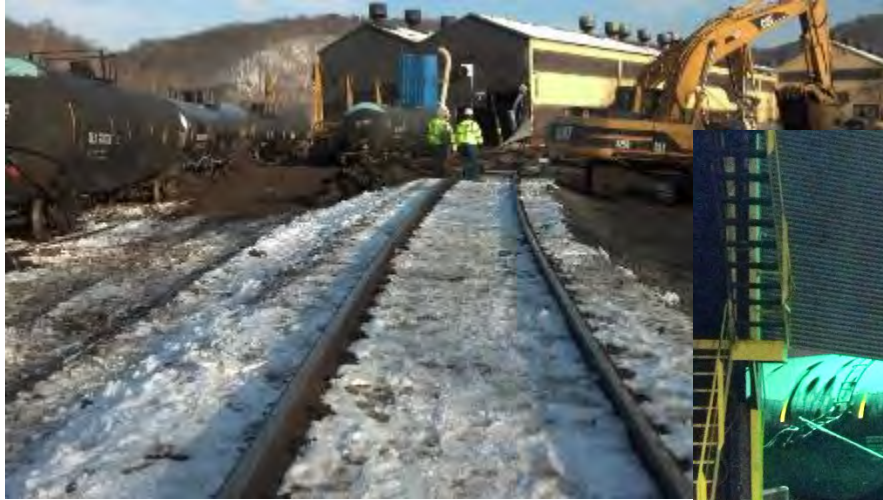
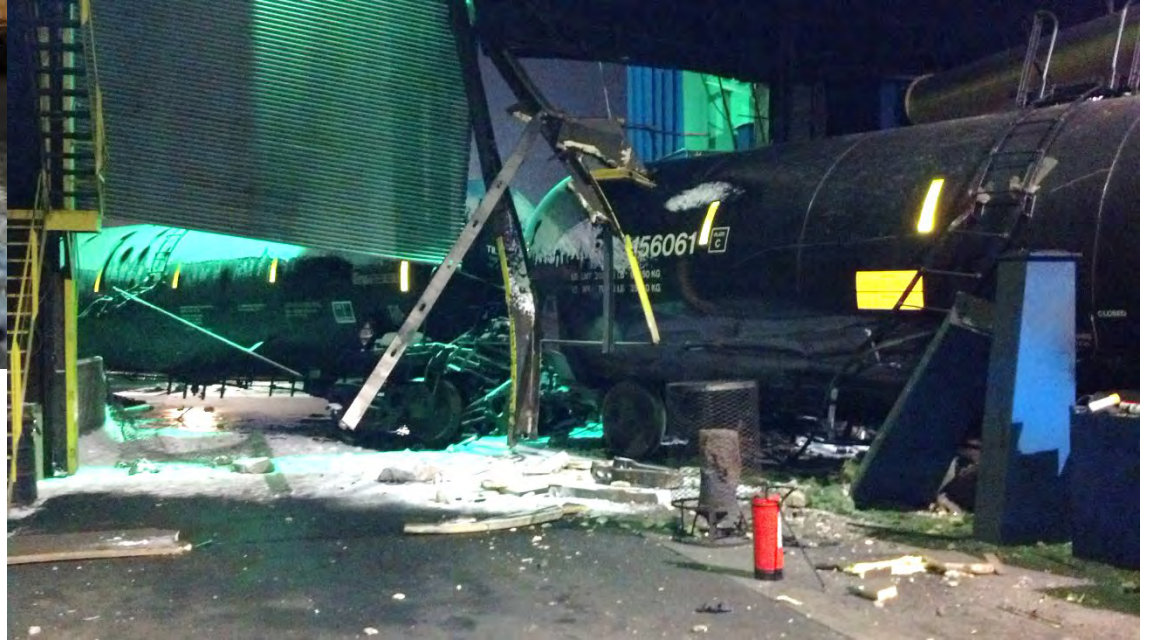
The 14th derailed car ended up inside the building

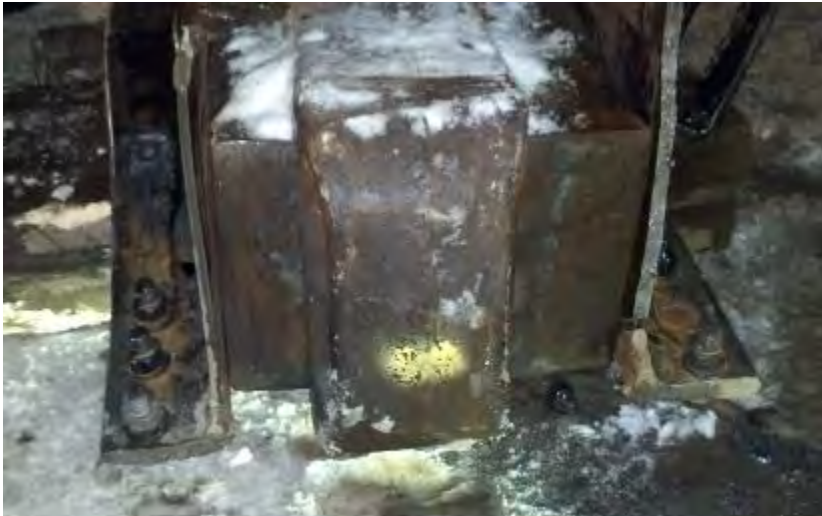
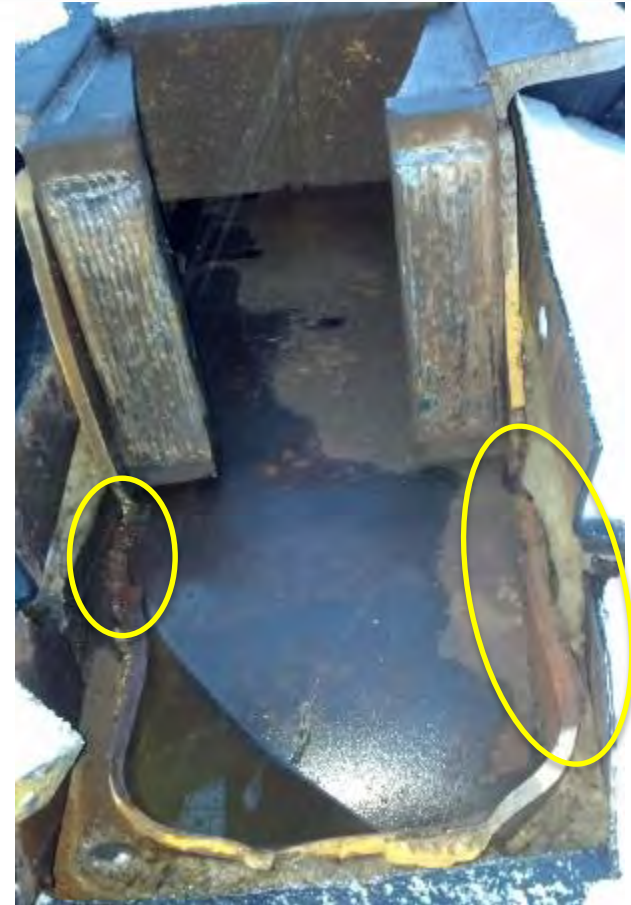
Proposed cause: broken stub sill on the 11th head derailed car

The fracture surfaces showed a number of old weld cracks, old fatigue cracks, and large areas of extremely poor weld penetration. However.....

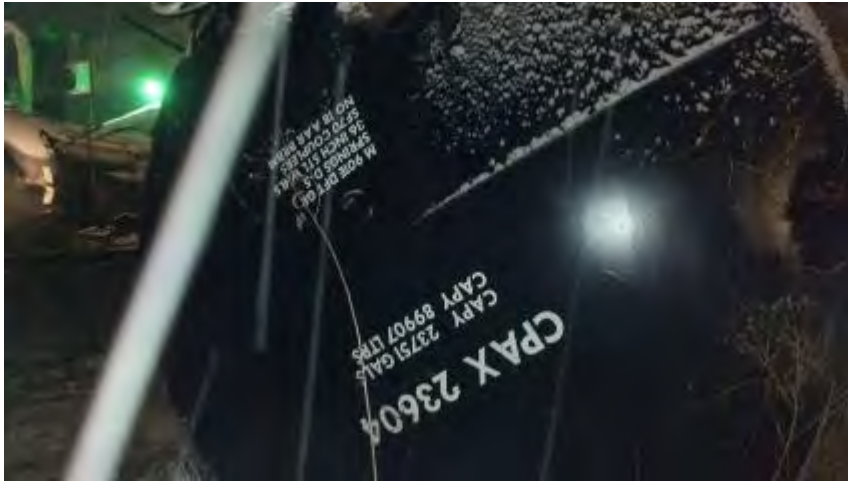
Based on the fracture pattern, we concluded that the stub draft sill failed due to a high rotational force consistent with coupled cars trying to roll over. Based on the orientation, CAPX 23604 was rolling toward the inside of the curve while the car behind was resisting.

This stub sill separated from the trailing end of the 11th derailed car. The coupler and stub sill were carried by the 12th car and had no marks to indicate that they had 1) struck the track structure or 2) impacted the car ahead.

Conclusion: The failure of the stub sill was a result of the derailment and not the cause.

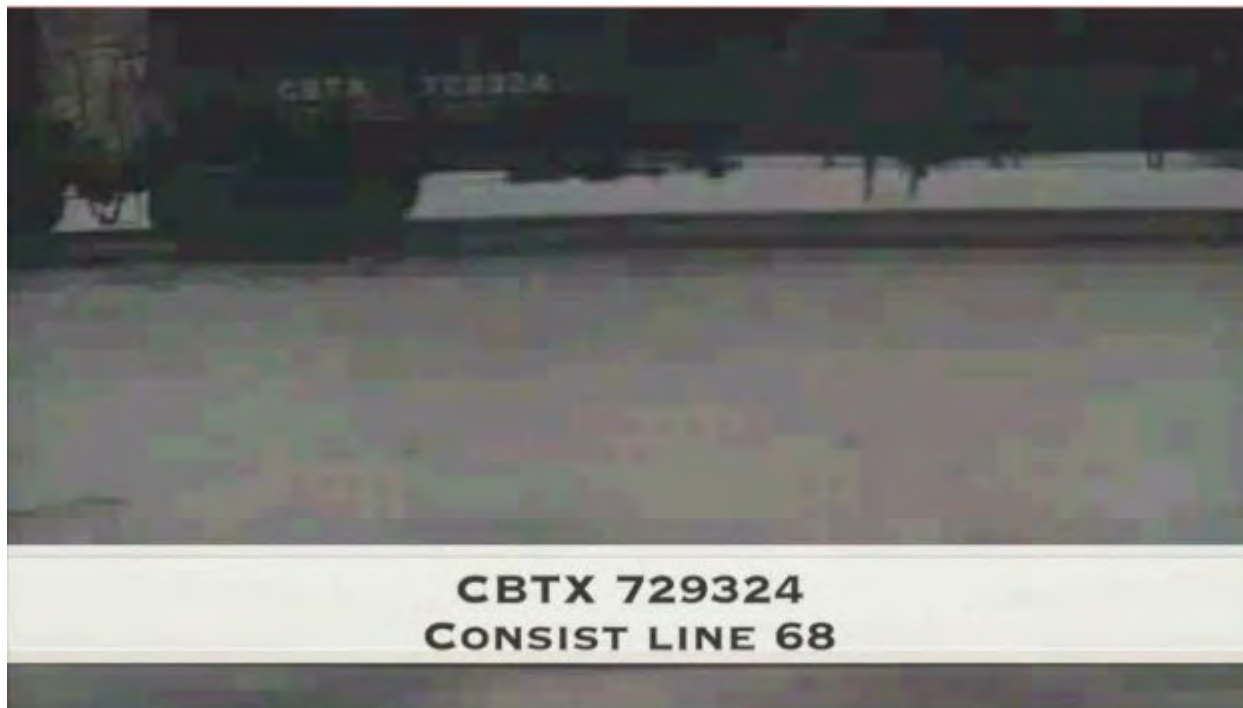
Another screen shot from the security camera video: We were able to read the reporting marks on the car that was two positions ahead of the first car to derail.

This car was consist line 68, or the 65th head car (the consist included 3 locomotives).

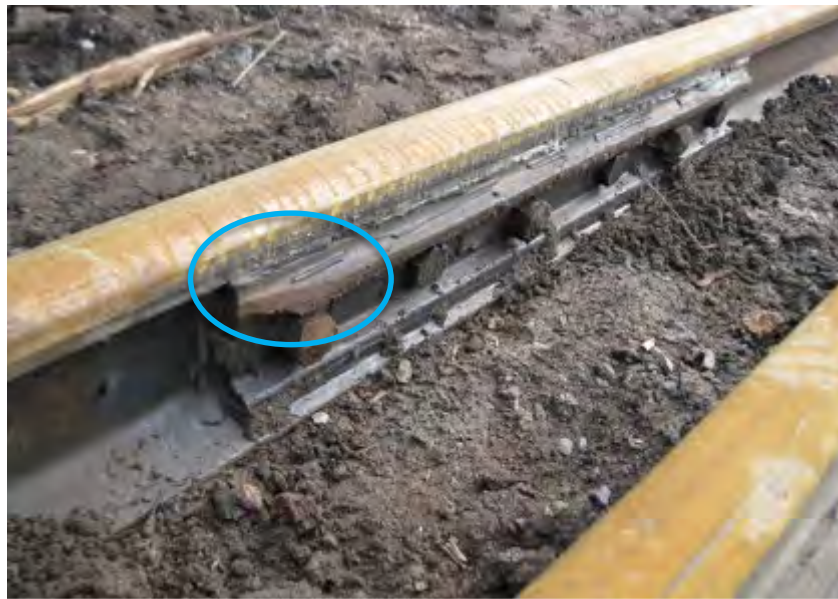
High-side IJ shows receiving end batter

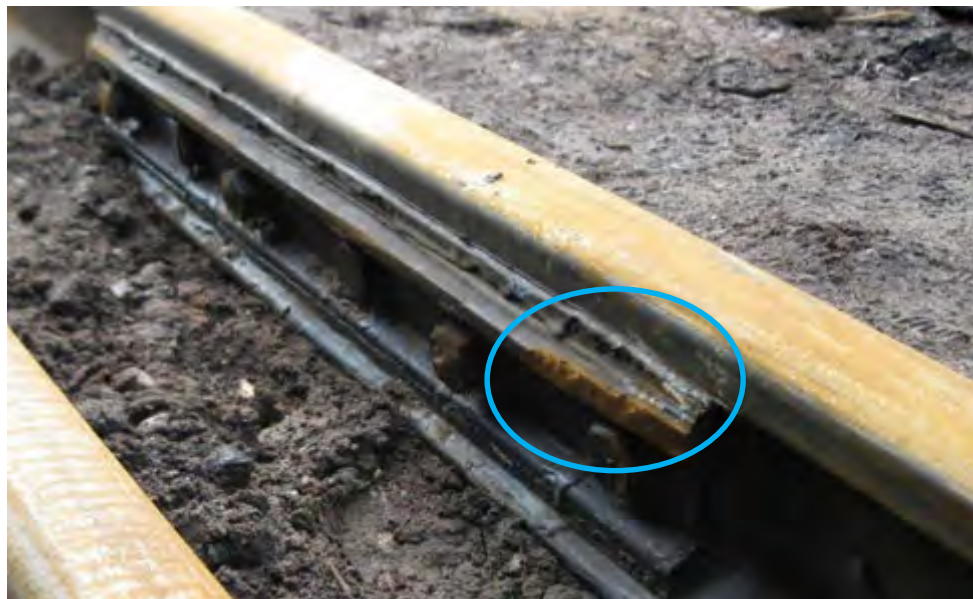
Low-side IJ also shows receiving end batter

Conclusion: Wheels dropped in before these joints (both rails).

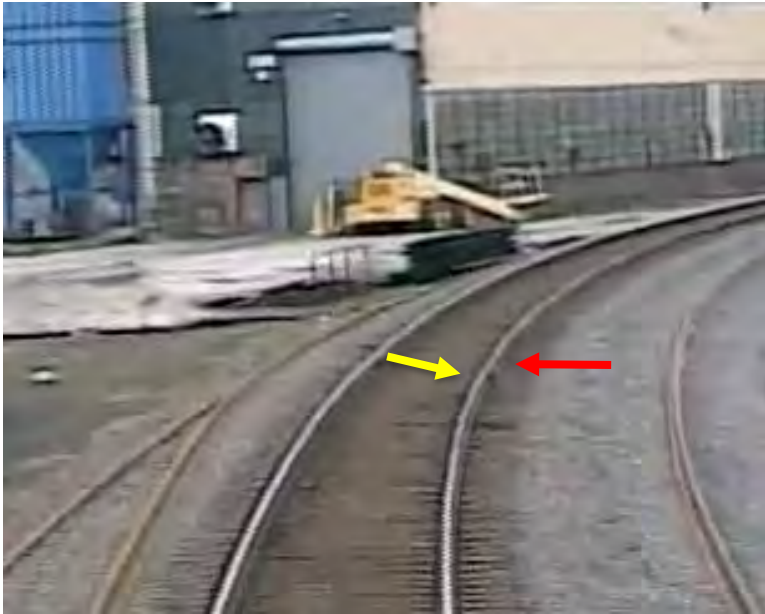
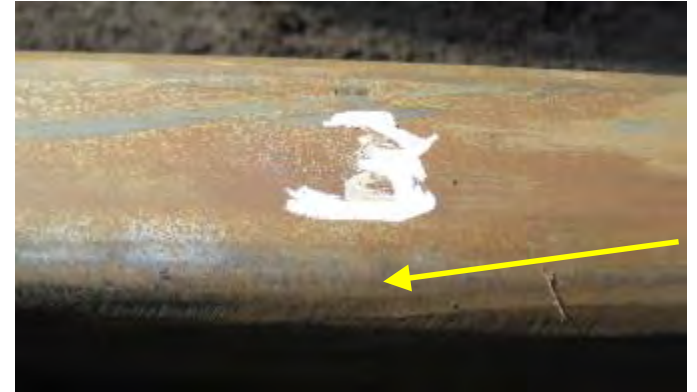
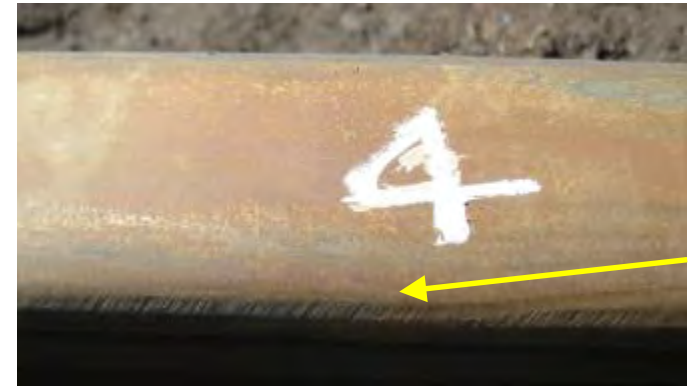
The low rail / gage corner showed four wheel rim drop-in marks, located 3 to 6 feet before the insulated joint.

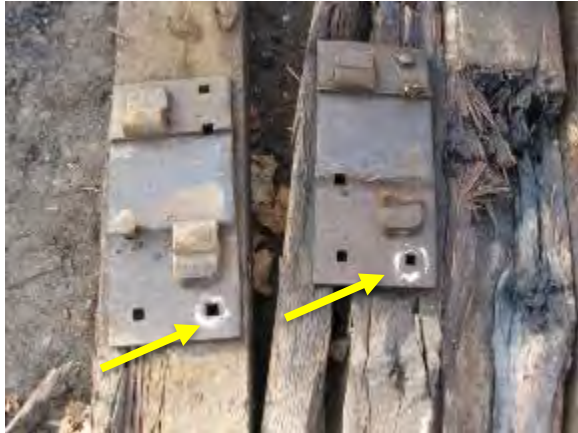
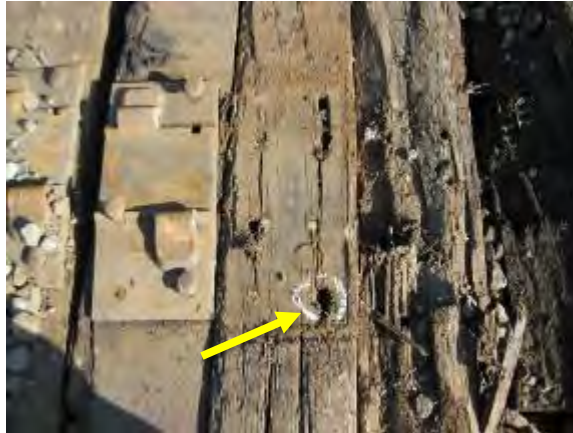
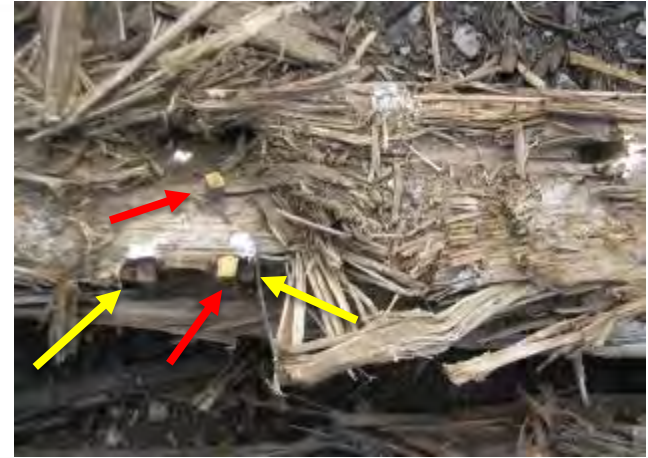
Liquid spike hole filler (red arrow)

- We did not see any plate movement (too much tie damage)
- But we did find broken spikes (yellow arrows)

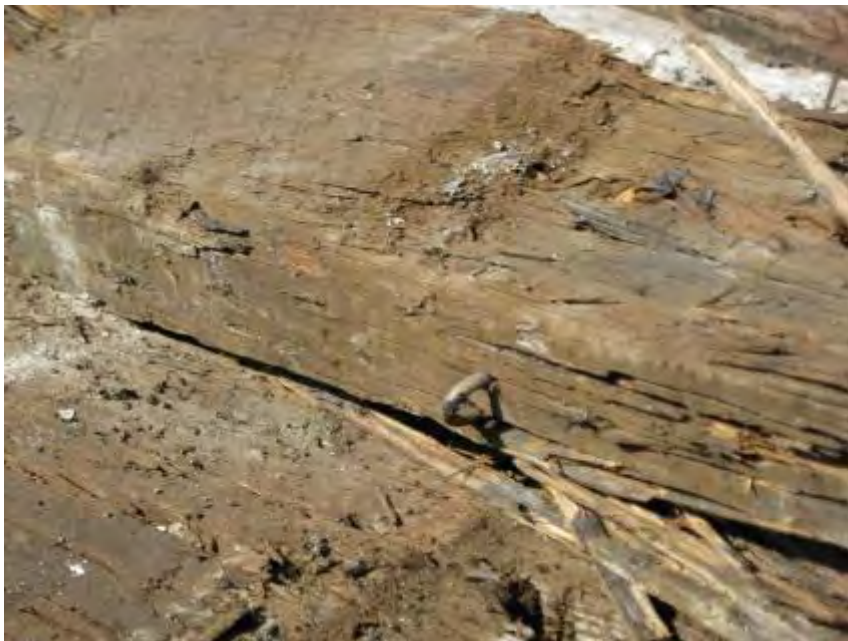
We looked for a staple that once held a track wire.

We found one.

This indicated we had the correct group of ties.

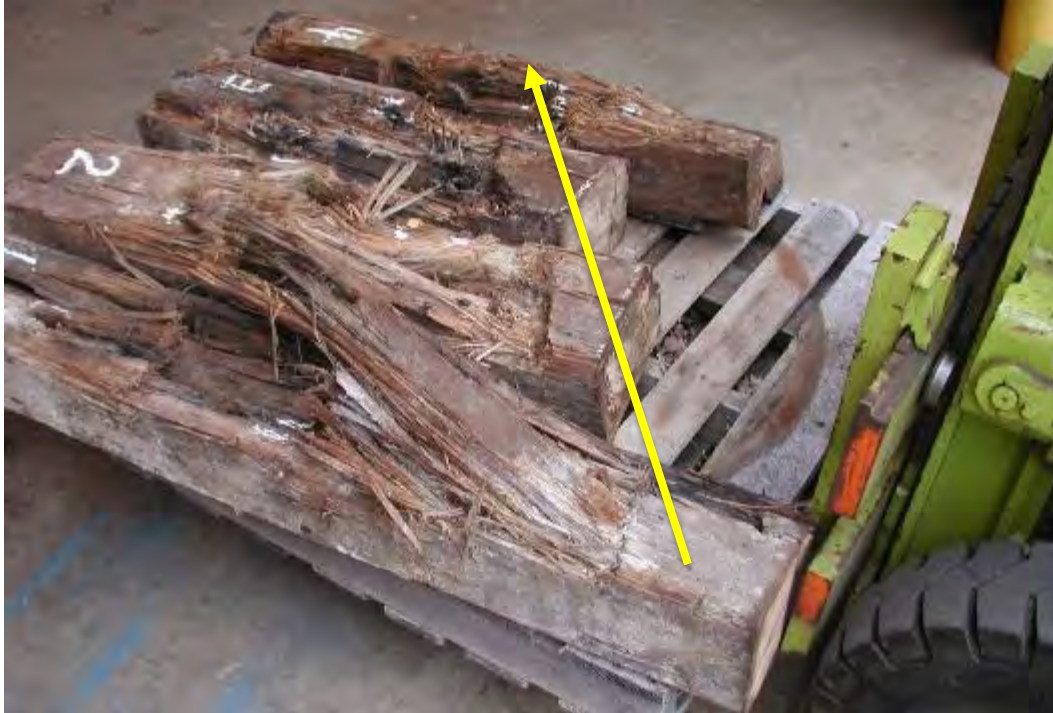
- These tie sections were all from the high side, based on condition of the tie plate seat.
- Wheel mark indicates that these were likely adjacent ties
- We believe that these ties were positioned under the high-side IJ, immediately east of the tie with the staple.

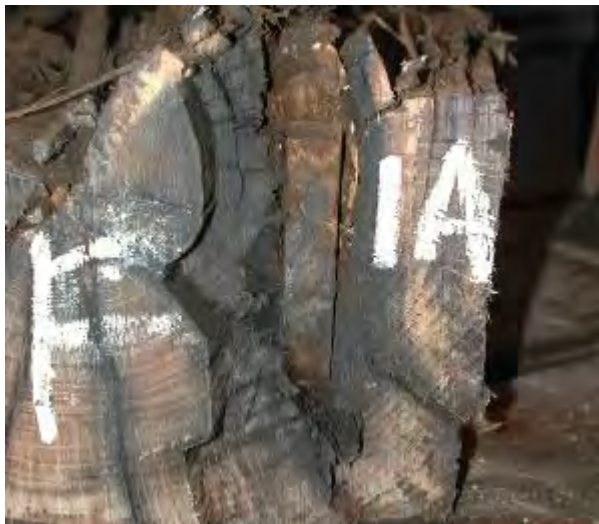
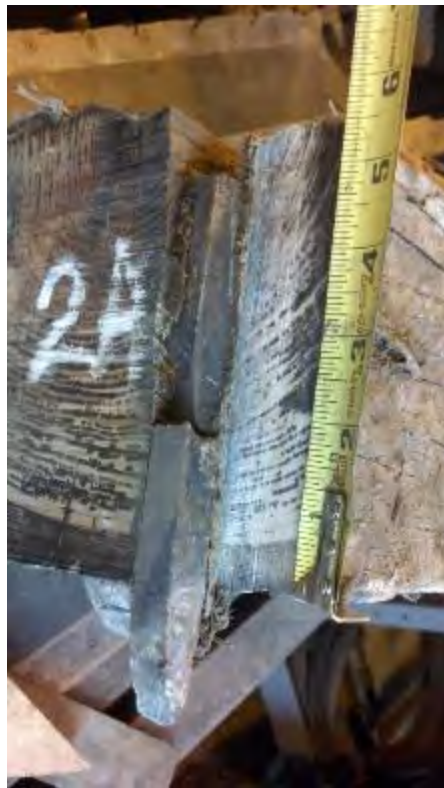
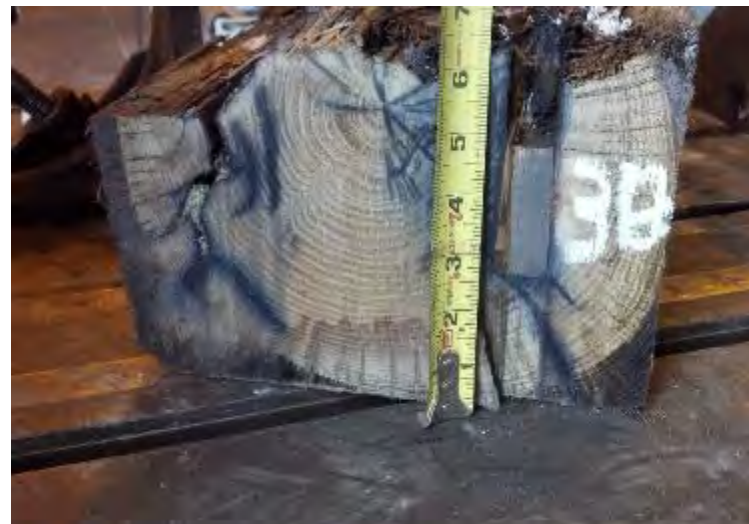
Cross-sectioning of ties revealed broken spikes

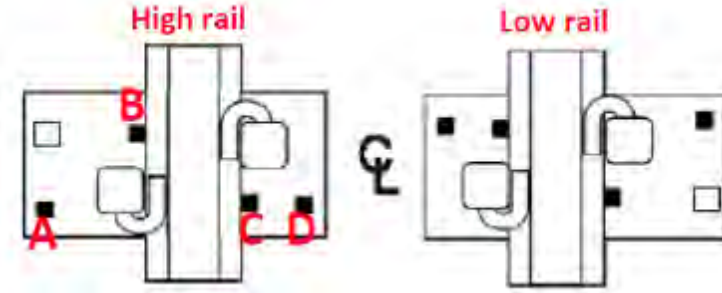
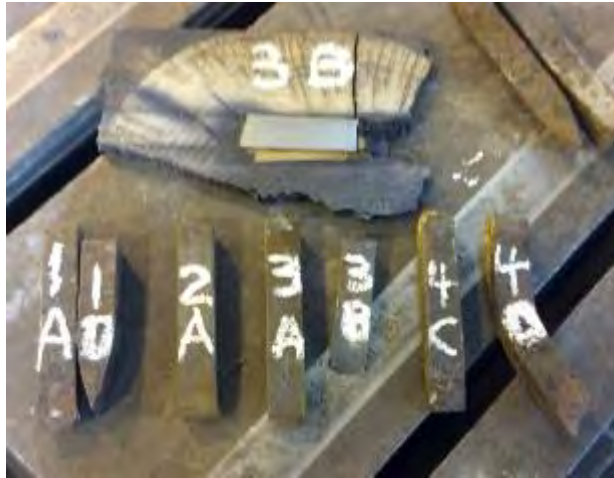
Broken spike inventory from the four tie ends

Tie	Location "A"	Location "B"	Location "C"	Location "D"
#1	Broken spike	Spike missing from hole	Spike missing from hole	Broken spike
#2	Broken spike on top of old broken spike	Spike missing from hole	Spike missing from hole	No spike or hole, old broken spike nearby
#3	Broken spike	Broken spike	Spike missing from hole	Spike missing from hole
#4	No hole or spike (old broken spike in alternate field hole)	No hole or spike	Broken spike	Broken spike

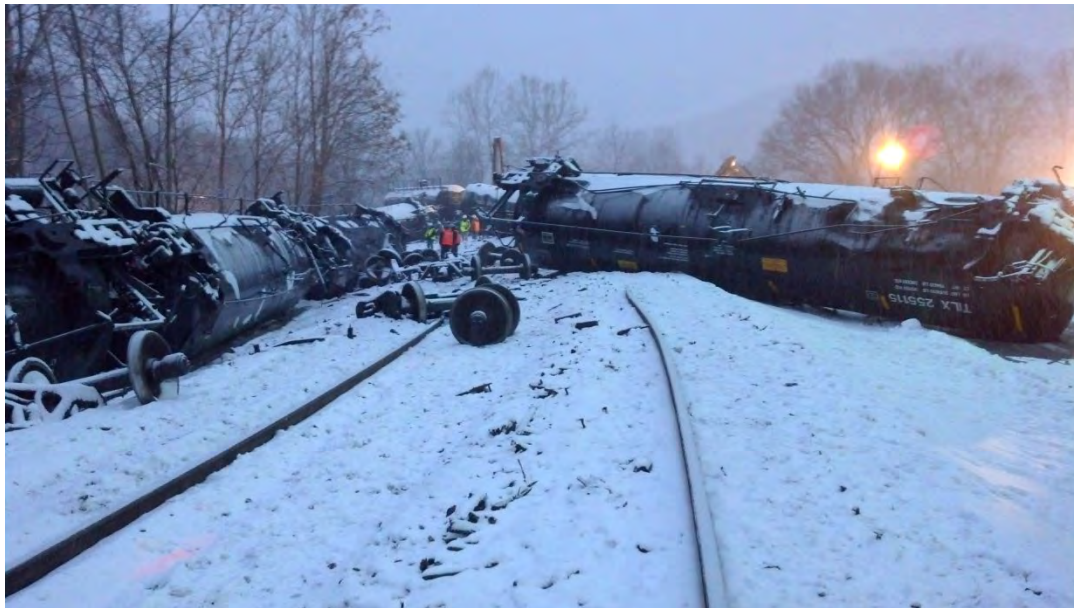
Cause determined

“High-side wheels of 67th head car, loaded tank CBTX 729715, ruptured gage by shoving the high rail out in a 8.3° RH curve account broken spikes under high rail JJ, and allowing low-side wheels to drop inside the low rail.”
