USDOT Tier 1  
University Transportation Center  
on Improving Rail Transportation Infrastructure  
Sustainability and Durability

Final Report 2

**ANALYSIS OF WHEEL WEAR AND FORECASTING OF WHEEL LIFE FOR  
TRANSIT RAIL OPERATIONS**

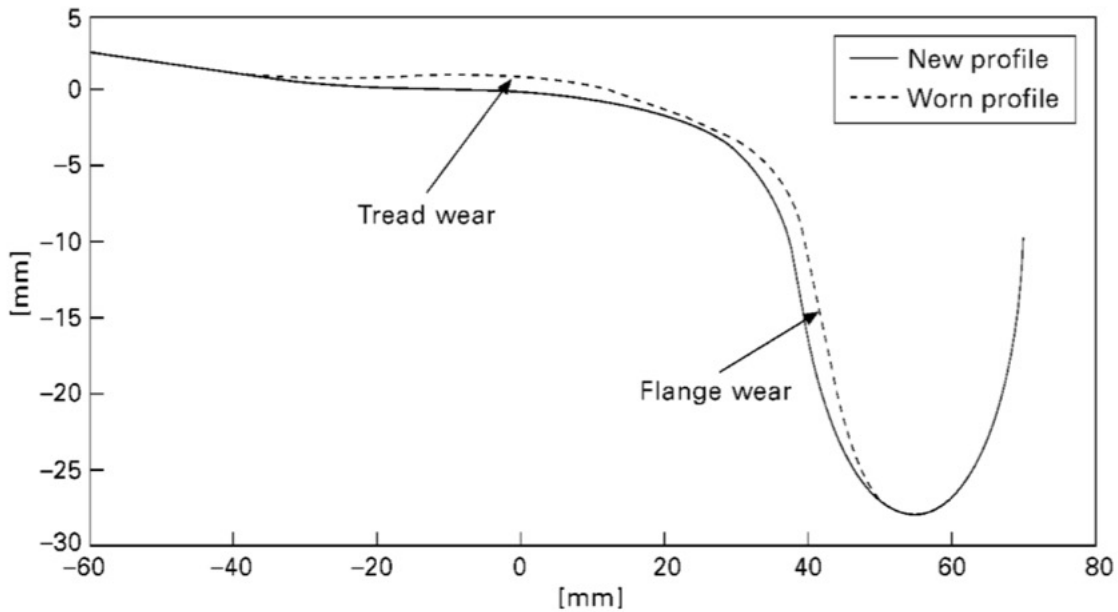
**Figure 2 New wheel profile vs worn wheel profile (Braghin, et al., 2009).**

One of the most fundamental issues facing the rail industry today is wheel wear. Wheels wear as a result of friction between the wheel and rail during operation. Moreover, wheels wear as a function of the contact forces and creep forces associated with the longitudinal and lateral motion of the wheelset. As a consequence, wheels tend to wear in two distinct locations: the flange and the tread. The rate of wear at these two locations depends on vehicle design, wheel service profile, track profile, the status of the contacting surfaces, and the inherent properties of the wheel and rail. (Braghin, et al., 2009). As wear increases over time, the wheel profile changes depending on the severity of the load environment. These changes in wheel profile greatly impact the dynamic characteristics of railway vehicles. For example, the stability of vehicles with worn wheels is greatly compromised as the wheel profile and rail head profile no longer conform with one another. This situation can lead to increased dynamic loads and excessive wear, which can result in accidents and derailments. In addition, in the passenger rail realm, increased vibration and noise levels can be attributed to worn wheels, which ultimately decrease passenger comfort (Braghin, et al., 2009). The difference between in a new wheel and a worn wheel is shown in Figure 2.

Nonetheless, when wheels wear, the flange becomes thinner and the tread becomes hollower. In particular, a worn or thin flange is extremely dangerous, as it can result in total flange fracture. A worn flange also results in an excessive flange angle, which promotes wheel climb. Figure 3 presents the breakdown of train accidents classified by wheel defect type. As can be seen, worn or thin flanges is the most frequent wheel defect that causes accidents (IHHA, 2001). Thus, it is crucial that the wearing behavior and patterns for wheel flanges are better analyzed and understood, in hopes of reducing the accidents associated with them.

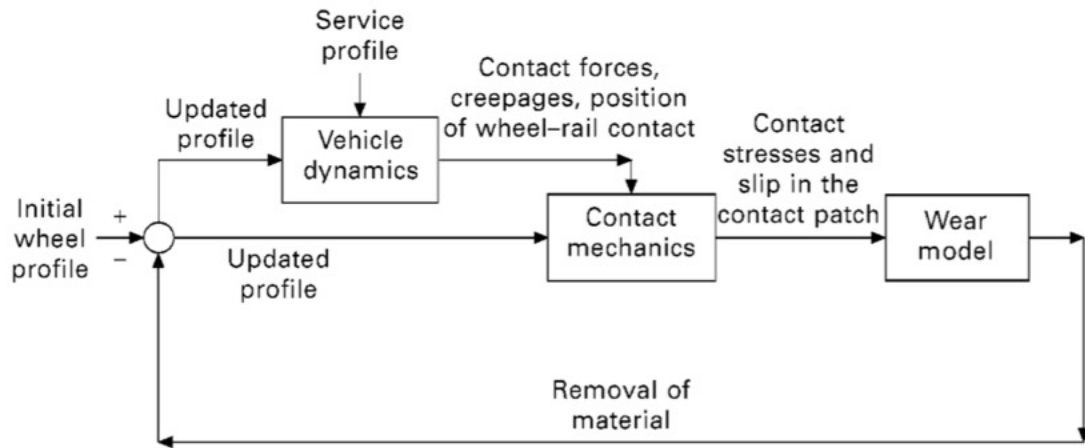
**Figure 4 Wheel Wear Flowchart (Braghin, et al., 2009).**

The flowchart presented in Figure 4 provides a general idea as to how wheels wear over time. It begins with an initial wheel profile, and considers how vehicle dynamics cause dynamic variations of wheel loads. Next, the effects of the various creepage and frictional forces, as well as the

migration and slipping of the contact patch, are considered. This information gives way to the determination of the shape, location, and size of the contact patch, as well as the distribution of the normal and tangential stresses within that patch. Finally, the normal and tangential stresses cause metal to be worn away in the tread and flange, and ultimately cause the aforementioned modification of wheel profile and causes maintenance process to form a natural loop. Unfortunately, the components that make up the loop are non-linear. This makes it difficult to predict how the process will evolve with time, and how the change of a single parameter, such as initial wheel profile, will impact the progression of wear (Braghin, et al., 2009).

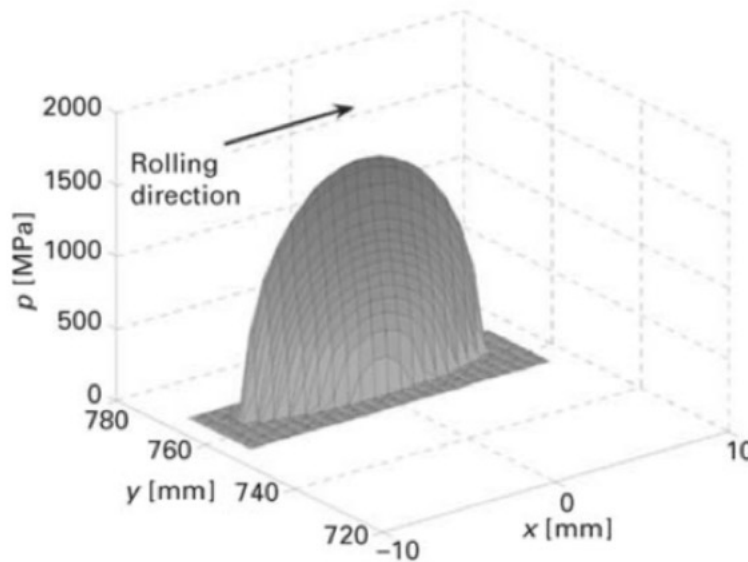
**Figure 7 Parabolic contact pressure distribution according to Hertzian contact theory (Braghin et al., 2009).**

The primary means as to which the normal problem of wheel/rail contact is defined is through Hertzian contact theory. In 1882, German physicist Heinrich Hertz was able to demonstrate the various pressures, stresses, and deformations that occur when two or more curved elastic bodies contact each other (Oldknow, 2017). Hertz assumed that when two elastic bodies are pressed together, there would be elastic behavior, a large curvature radius compared to the contact patch size, and constant curvatures inside the contact patch. If all of these assumptions held true, then it can be stated that when two elastic bodies are pressed together, the resulting contact patch will be a flat ellipse. Furthermore, the resulting contact pressures will be parabolic. The geometry of the contact patch and the maximum value of the contact pressure depend on the curvature of and the normal force reaction between the wheel and rail surfaces. Also, they are typically expressed by analytical formulas that are based on elliptic integrals. This is one of the main reasons why Hertzian contact theory is the most computationally efficient solution to the normal problem (Braghin et al., 2009). Hertzian contact theory in the general and railroad-specific cases can be seen in Figure 6 (Ayasse and Chollet, 2006). A visual representation of the parabolic distribution of contact pressures can be seen in Figure 7 (Braghin, et al., 2009).

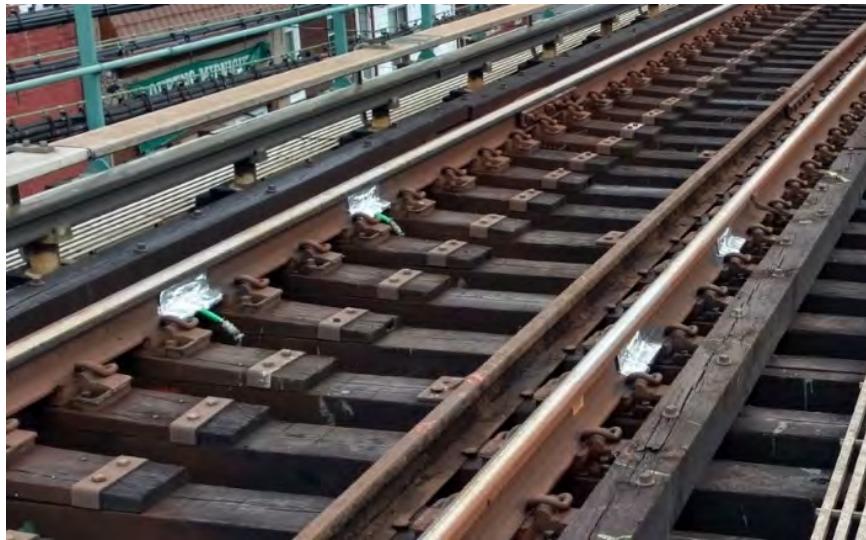
**Figure 10 ISI L/V measurement system located north of 103rd street station (NYCTA).**

lateral and vertical wheel/rail forces and calculated associated L/V ratios for every vehicle that passed over it, which included the entire 7 Line fleet. Excessively high L/V ratios are a cause for concern, as wheel climb derailments could occur. Thus, using the L/V system allows for better monitoring of wheel and rail performance, and identifies specific axles or bogies that may be at risk of derailment. In addition, the system allows for better monitoring of truck performance, and how it is affected by track maintenance activities like re-profiling, grinding, and lubrication. The ISI L/V Measurement System is shown in Figure 10.

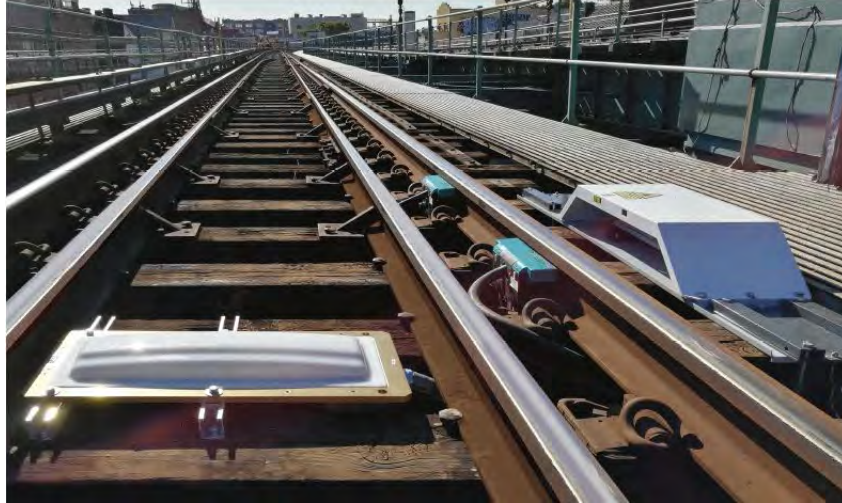
**Figure 11 WID TBOGI site located north of 103<sup>rd</sup> Street station (NYCTA).**

A companion wayside measurement system, also installed as part of this project was the TBOGI, as provided by WID, and located at the exit of a 3.2-degree curve just north of 103rd Street station. This wayside device was designed to measure key truck (bogie) characteristics and performance. Thus, for every truck that passes over the TBOGI, a set of key truck performance parameters are measured or calculated; most notably angle of attack and tracking position, but also inter-axle misalignment, rotation, shift, and tracking error. These parameters are used to help to identify bad acting trucks, to include any truck with curving performance issues, such as skewed axles, misaligned axles, or improper tracking. If left unattended, these issues can result in unsafe lateral load or L/V levels, as well as accelerated wheel and rail wear. In addition, these measurements can help characterize the wheel/rail interface, wheel and rail wear rates, and rolling resistance. The WID TBOGI is shown in Figure 11.

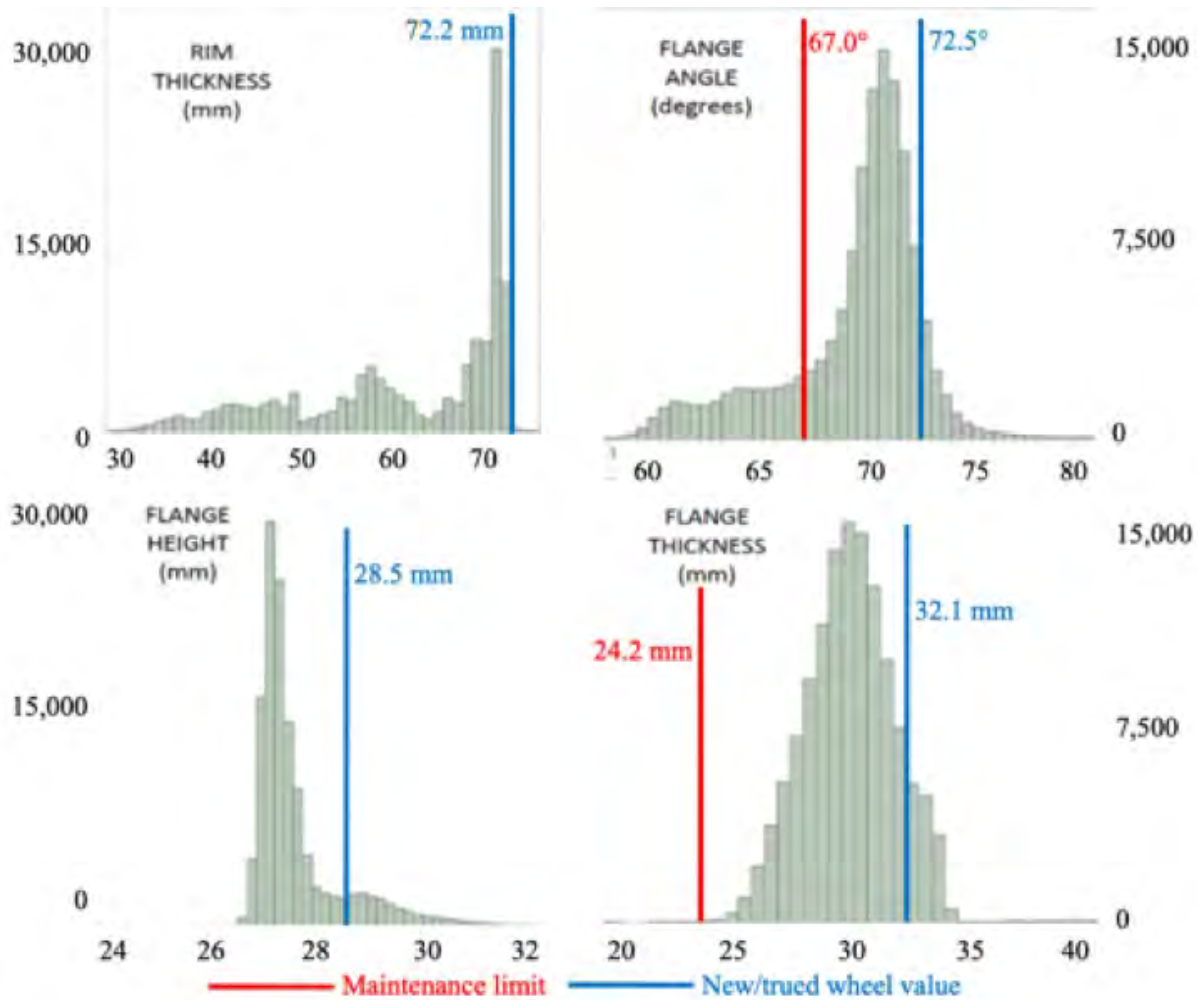
**Figure 13 Histograms of wheel profile measurements.**

The initial EDA included but was not limited to summaries of descriptive statistics, histograms, and box-and-whisker plots. Of particular interest were the histograms of flange thickness, flange height, flange angle, and rim thickness shown in Figure 13. The x-axis displays the measurement of each parameter; rim thickness, flange thickness, and flange height are measured in millimeters, while flange angle is measured in degrees. The y-axis displays the frequency of the observations. The blue lines on these plots represent the value of a new or recently trued wheel. Values beyond these lines can be attributed to measurement errors or errors in fabrication or maintenance. The red lines on these plots represent the maintenance limits set forth by the NYCTA. It is important to note that the rim thickness maintenance limit is 22.2 mm, but no wheel in the fleet has yet to reach a rim thickness that low. Wheels are typically replaced before this point is reached. Lastly, NYCTA has not reported a maintenance limit for flange height.

Various observations can be made from the distributions above. First of all, the distributions of flange angle, flange height, and flange thickness all appear to be generally normal. Flange angle and flange height are slightly skewed, but not drastically. These distributions allow for the conclusion to be made that wheels were regularly maintained. Had the distributions been more spread out, such a conclusion may not have been supported. More specifically, the histogram of rim thickness was particularly insightful, as shown in Figure 14, which shows three distinct distributions. At any point in time, a wheel can fall into one of three groups, based upon its rim thickness. This can be attributed to maintenance practices. Recall that every time a wheel is trued, its rim thickness is decreased in order to restore an acceptable profile. Thus, it appears that there is a large population of new wheels that have not yet been trued, along with two smaller populations of wheels which have been trued once or twice.

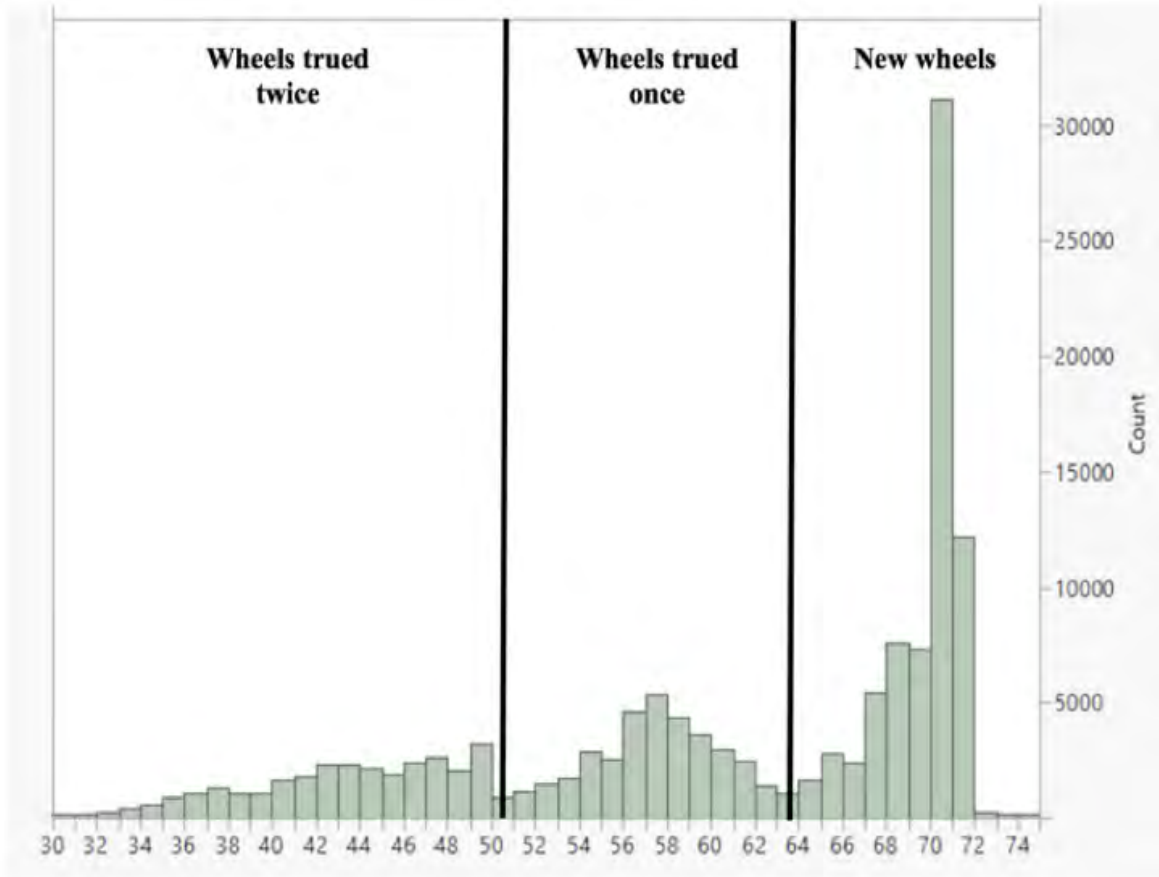
**Figure 14 Histogram of rim thickness (mm) depicting truing cycles.**

While the previous figure indicates that wheels are being trued at regular intervals, further investigation was conducted to verify this observation. In order to do this, plots of wheel measurements against time were generated, including flange thickness, rim thickness, and flange height. When truing occurs, a sudden drop in rim thickness is observed, accompanied by an increase in flange thickness. Moreover, the value of flange height stays relatively constant. Figure 15 is an example of one of these plots, for the left wheel on the first axle of car 7228.

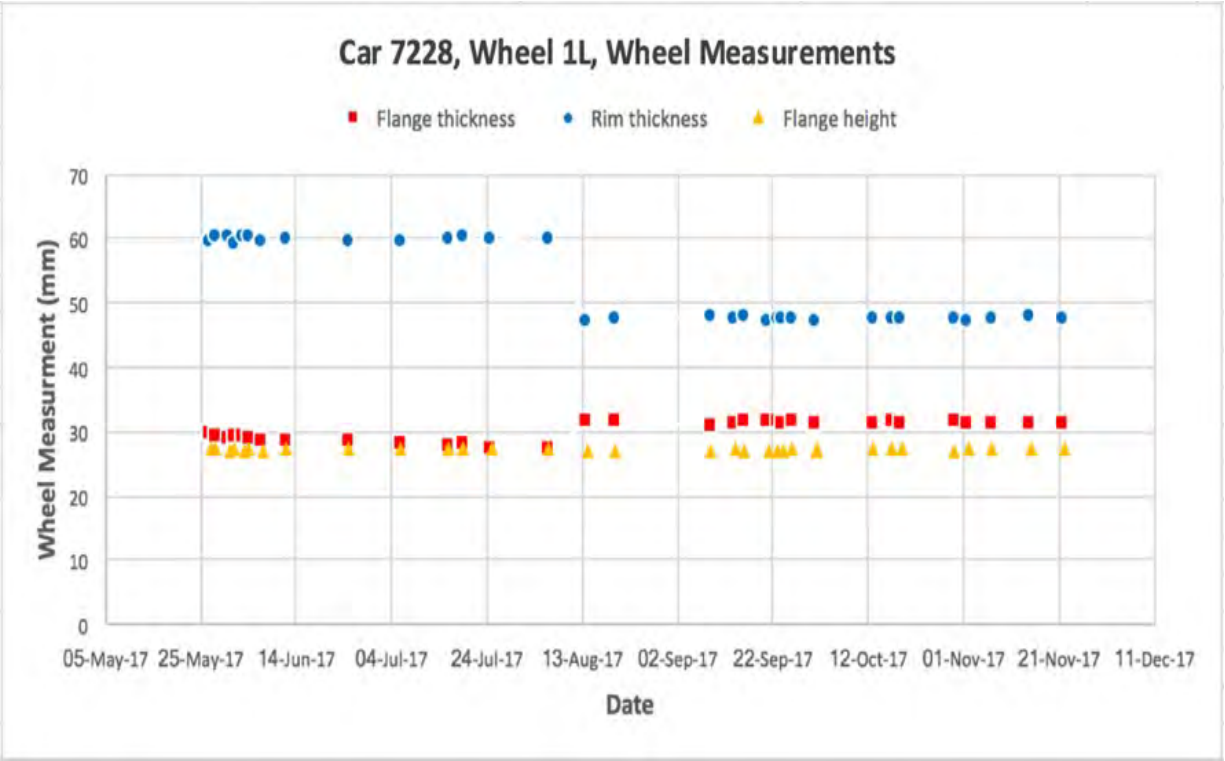
**Figure 15 Plot of wheel measurements for Car 7228, Axle 1, left wheel.**

Similar wheel wear plots were created for a number of the most frequently measured cars. The behavior shown in Figure 15 was consistently observed, indicating truing was regularly occurring. Since the truing process is primarily governed by the flange thickness measurement, the flange thickness wear rate is of great interest. If the flange thickness wear rate is known, then it can be used in order to predict when the next maintenance event will occur.

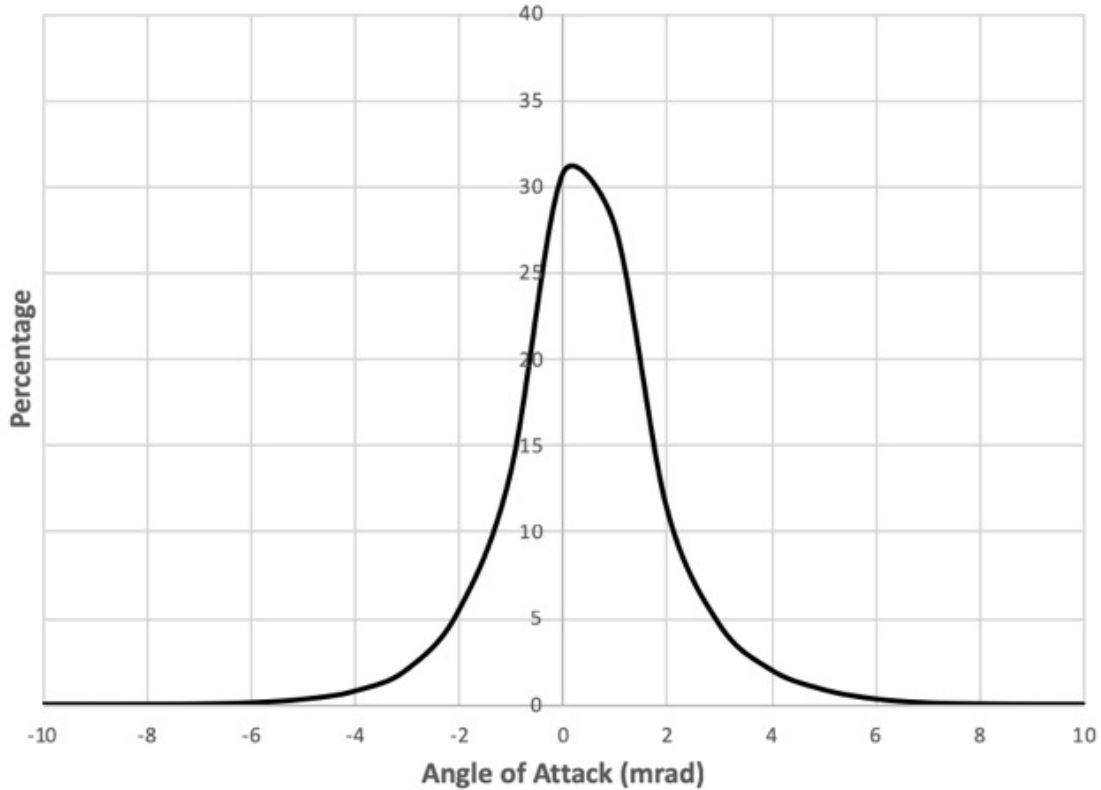
**Figure 20 Histogram of angle of attack (mrad).**

As shown, the angle of attack measurements is normally distributed and the mean is nearly zero. However, a large spread is seen in the data. Angle of attacks have been recorded anywhere between -10 mrad to 10 mrad. While these values are small in magnitude, the difference in behavior between an axle with a 0 mrad angle of attack and an axle with a 10 mrad angle of attack is significant. When the data is separated by axle, as in Figure 21, it can be seen that the lead axle angle of attack trend in the positive direction, while the trail axle angle of attack trends in the negative direction. Based on the fact that the TBOGI was placed in a left-hand curve, this type of behavior is anticipated. The same plots were created for tracking position, as shown in Figures 22 and 23, and the same statements can be made. Again, the mean is nearly zero, but there are some more extreme values that can lead to poor axle and truck behavior. However, when the data is separated by axle in Figure 23, the two distributions are nearly identical.

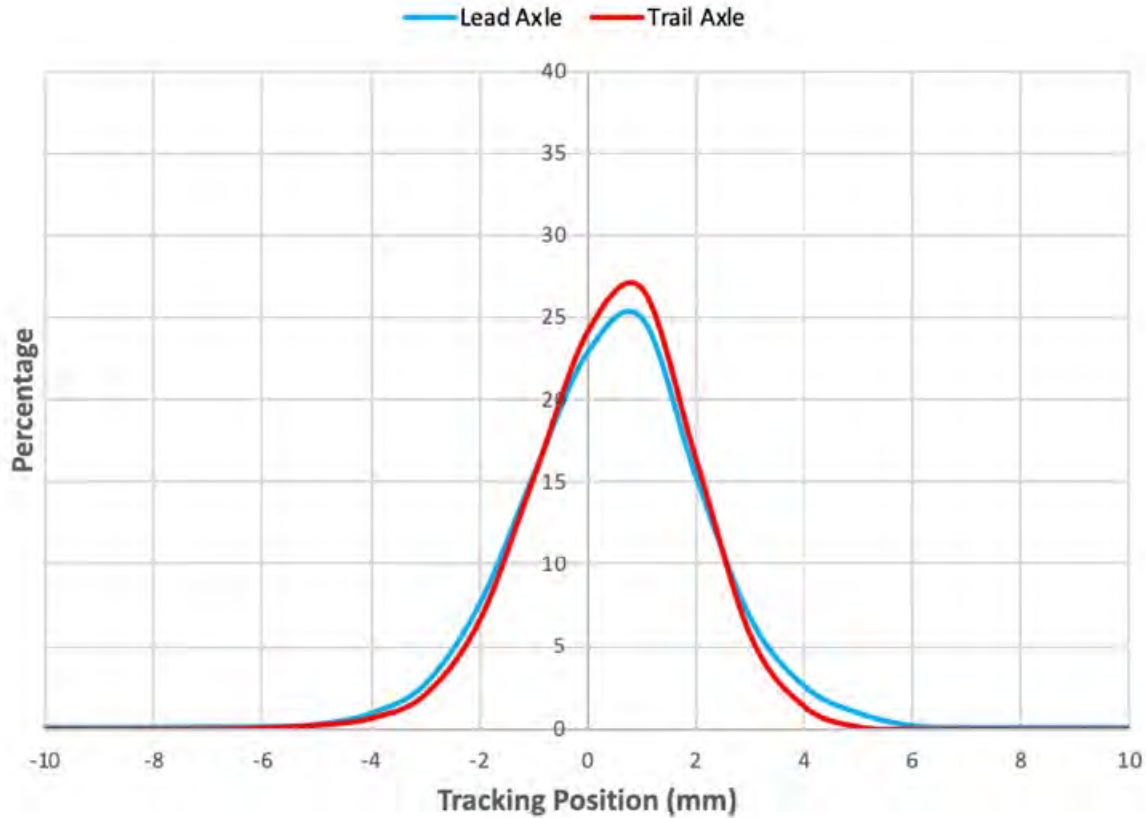
**Figure 23 Histogram of tracking position by axle position.**

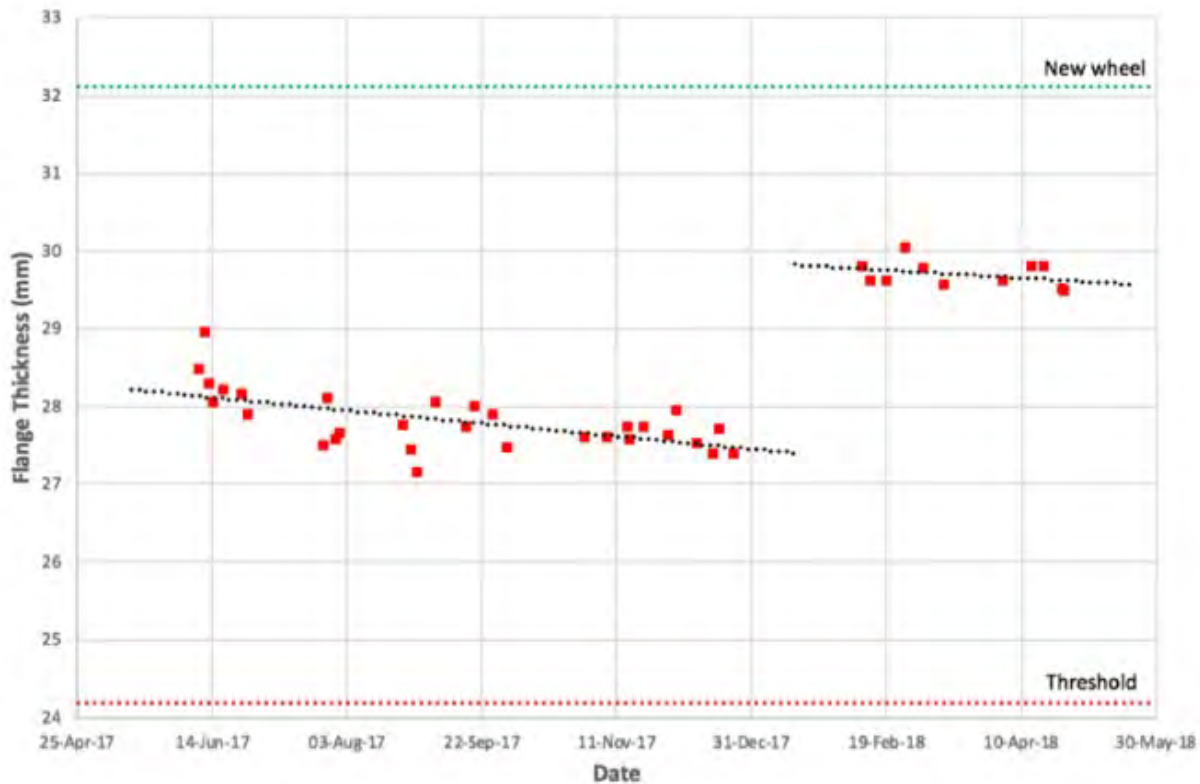
**Figure 30 Exponential regression of flange thickness for Car 7502, Axle 1, right wheel.**

Using Equation 2, the A and k parameters were calculated for each event of every wheel in the population. In addition, an  $R^2$  value was calculated to indicate how well the nonlinear regression fit the data. As an example, Figure 30 shows how the data in Figure 29 was fit to this function. At first glance it appears as if the fit is linear. This is deceiving, because the data range is so narrow. It is difficult to fully visualize an exponential curve when the data lies within a 2 mm range. In addition, any scatter that is observed in the data can be attributed to the measurement system having the capability of measuring flange thickness with a tolerance of +/- 0.5mm. This inherent field accuracy tolerance affects the overall fit of the exponential function.

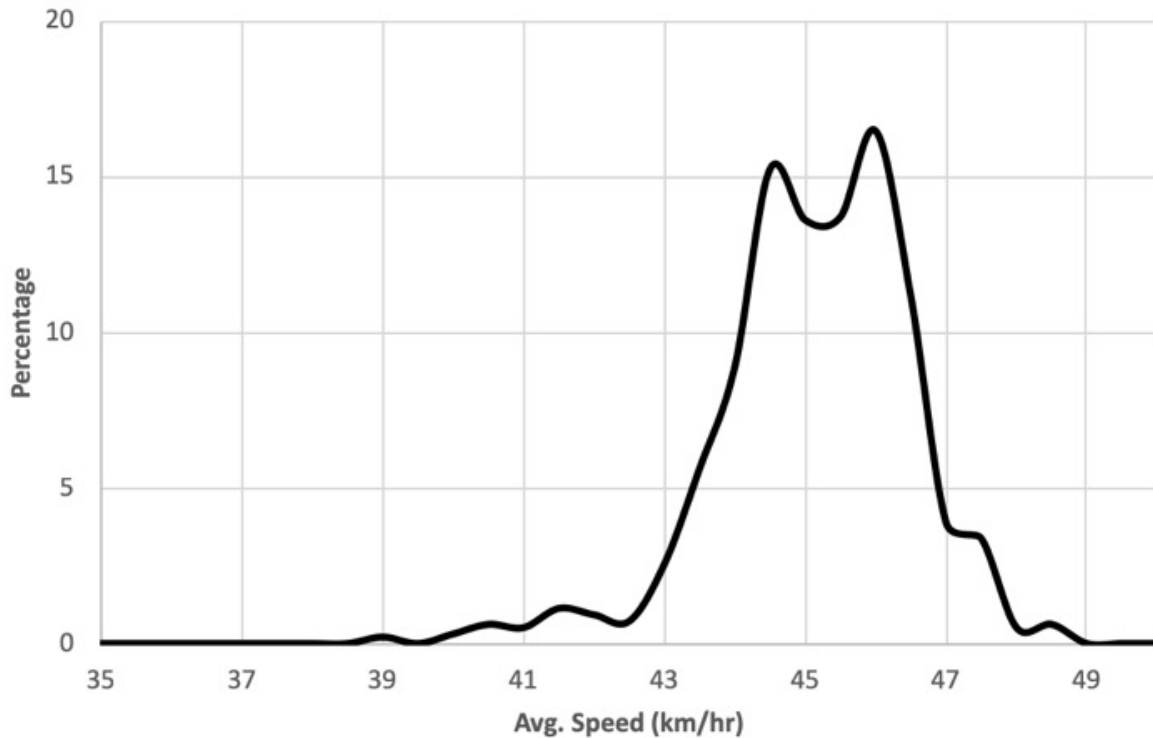
**Figure 37 Histogram of average speed.**

were obtained were also investigated. Figure 37 and Table 7 show the distribution and descriptive statistics for the average speed of each axle measured by the TBOGI.
