1. Report No. RailTEAM VT-9	2. Government Accession No.	3. Recipient's Catalog No.	
4. Title and Subtitle Design and Operational Assessment of a Mobile Robot for Undercarriage Inspection of Railcars		5. Report Date September 2024

Final Report VT-9

**DESIGN AND OPERATIONAL ASSESSMENT OF A MOBILE ROBOT FOR
UNDERCARRIAGE INSPECTION OF RAILCARS**

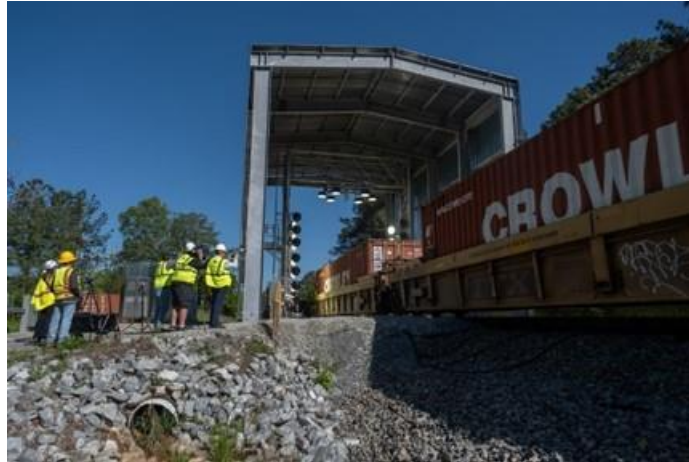
Figure 0-1: A train passes through an advanced inspection portal. Credit: Sofi Gratas/GPB News [6]

Figure 0-1. These systems capture images 360° around railcars at speeds up to 70 mph [5,9]. High-speed cameras and lighting systems are used to capture more than 1,000 clear images per rail car. These inspection portals use AI models to process the images for potential defects using the latest technology and report high detection rates of defects with low rates of false positives. Suspected defects are transferred to a team of subject matter experts. This team inspects the images to determine whether a defect exists and if immediate action must be taken in response. These systems help railroads gather advanced condition monitoring data from their rolling stock, and as the AI models inevitably improve, the data gathered by the portals will only become more valuable. However, these inspection portals are limited to in-motion inspections. By definition, a train must be cleared in a stationary inspection before it can pass through and be inspected by one of these systems. Additionally, these portals are out of reach for all but the Class I railroads, with unit costs reportedly nearing \$3 million [6]. Other commercial visual inspection WTMSs are designed solely to inspect the railcar undercarriages. One of these systems is designed to compare undercarriage images of railcars to template images in order to detect foreign objects [25]. This system is primarily designed for usage within the security industry, where detecting and identifying foreign objects is of great safety concern. Other systems, however, gather similar data to the above-described inspection portals using systems that solely inspect the railcar undercarriage [26,27]. The system developed by TrackVue is equipped with an array of sensors to detect defects in the undercarriages of in-motion rolling stock. This system includes line-scan cameras as well as laser, acoustic, and thermal sensors. LED lighting is integrated into the system to aid in imaging. Using the gathered data, the system can identify a wide range of defects, including structural defects, missing or broken components, low-hanging components, wheel profile defects, and worn brake pads, among others. The system timestamps the analytics from the system and uses details about the passing train to determine a defect's location. This system shows the capabilities of a dedicated undercarriage inspection device. Although data from a few of its sensors are only feasible on in-motion trains, the imaging data is especially useful for providing railroads with a historical record

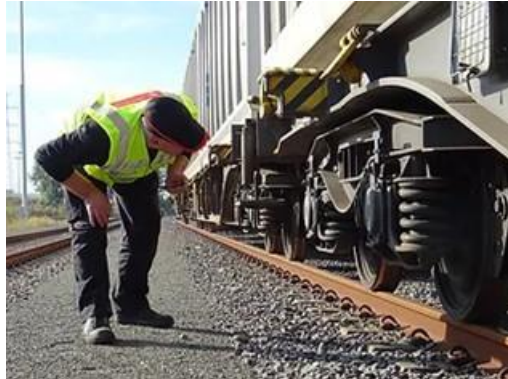
Figure 0-2: Carman straining to inspect beneath a railcar. Image reproduced under fair use [28]

Regarding inspections conducted on stationary trains, not much research has been conducted. The pre-departure inspection of railcars remains a manual process, and viewing the undercarriage is difficult and time-consuming.

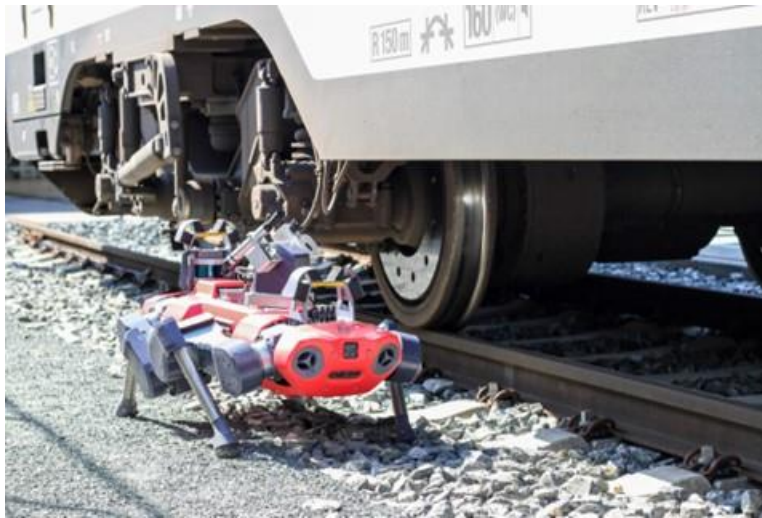
Figure 0-5: The ANYmal conducting an inspection on the side of a railcar. Image reproduced under fair use [40]

Figure 0-5 [40]. The ANYmal platform was not designed for this explicit purpose; however, it is a versatile platform that can be used in a wide variety of operating conditions. The ANYmal can traverse beside the train, gathering data from the side of the car and wheelsets. It can also inspect the undercarriage of the train using a recessed inspection pit or inspect the inside of the cabin using its unique mobility capabilities; however, this system does not currently appear to be able to traverse beneath rolling stock in revenue service conditions due to a lack of clearance.

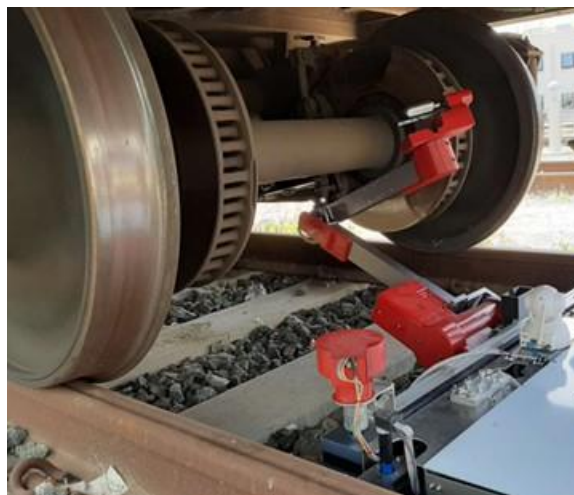
Figure 0-6: The robot developed by Chiaradia et al. [44] inspecting an undercarriage on revenue service tracks. Image reproduced under fair use

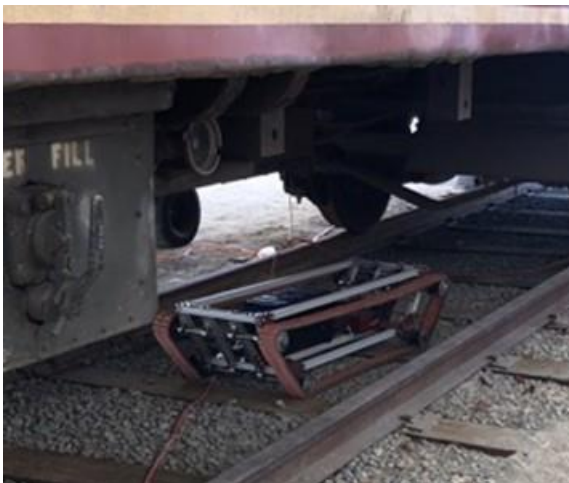
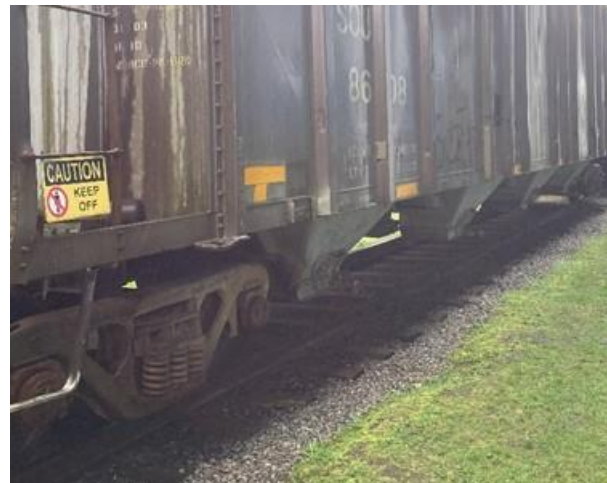
Figure 0-1: (a) The TCR operating on the track bed beneath a railcar; (b) A hopper railcar illustrating the low height of the gates above the track bed.

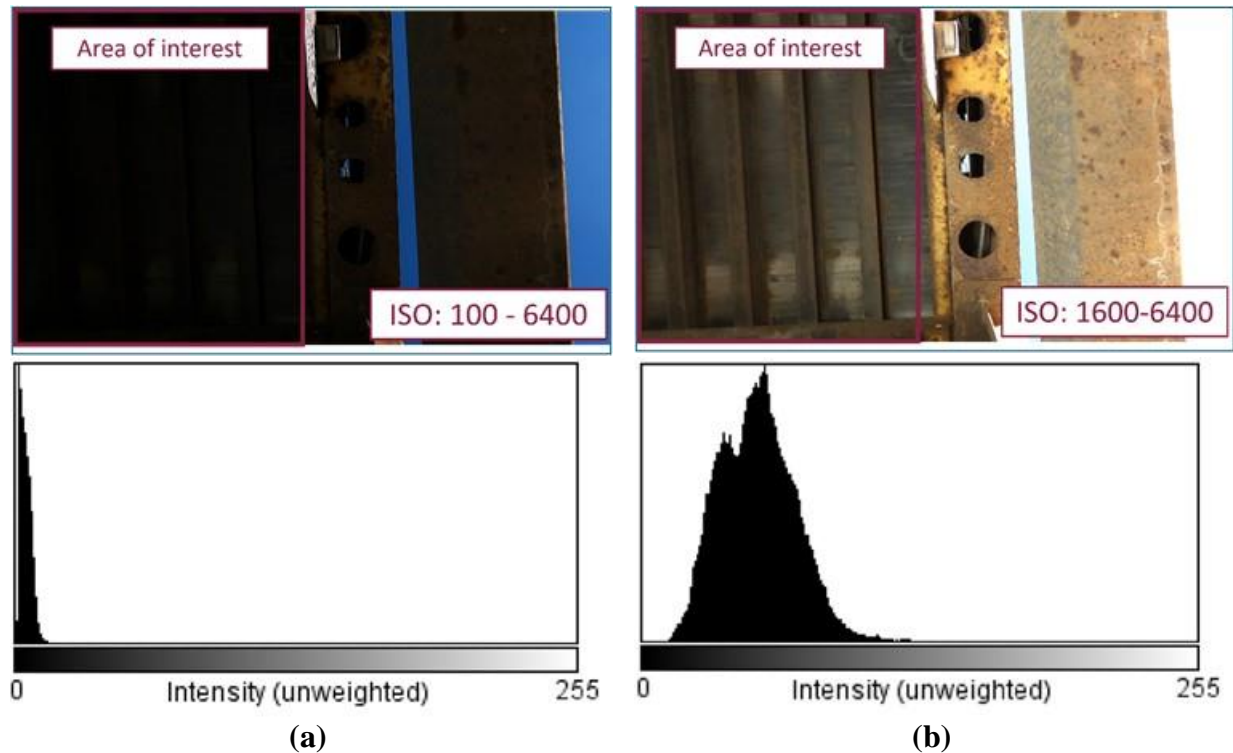
Figure 0-5: Comparison of transient images where undercarriage and sky are both visible: (a) Full ISO range test with pixel intensity histogram; (b) 1600 – 6400 ISO test with pixel intensity histogram

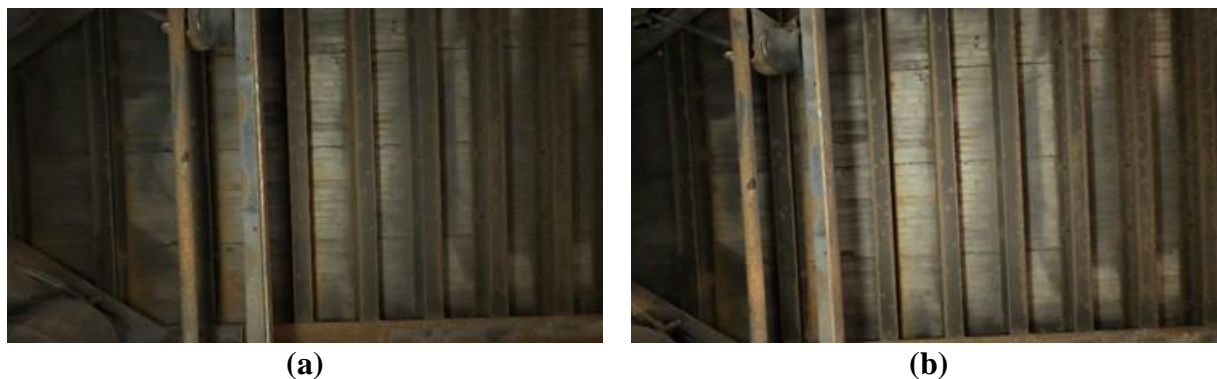
Figure 0-6: Steady state comparison between (a) 100 – 6400 ISO range and (b) 1600 – 6400 ISO range

Figure 0-6 shows that the change in ISO range does not drastically affect the steady-state imaging of the camera. In fact, the reduced ISO range image appears a bit brighter. This is most likely due to the sensitivity being held to a higher ISO value as it is limited to being above 1600. However, digitally raising the brightness using the ISO can result in increased noise within the image, which is detrimental to defect detection efforts and should be monitored. Lastly, this method requires determining the minimum ISO value to be chosen. This value should be chosen by incrementally increasing the minimum ISO value until the area of importance becomes overexposed. After reaching this point, reduce the minimum ISO value to the next lowest value. This method ensures that the minimum ISO value will not cause overexposure in the areas of interest and will filter out light sources brighter than this threshold. This ISO value may be different depending on different variables, such as ambient lighting, but can quickly be determined. Based upon these results, determining and setting the minimum ISO was included into the standard operational procedure of the TCR before inspections.

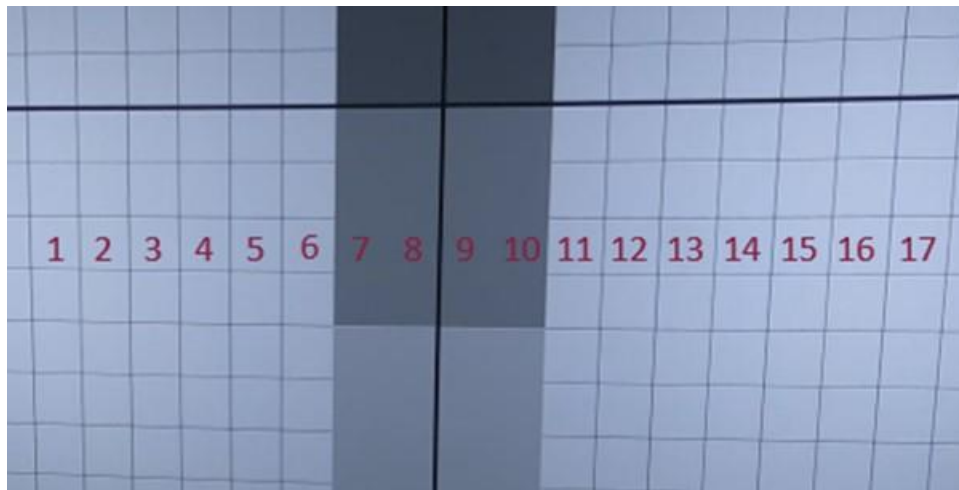
Figure 0-1: This field of view (FOV) evaluation image shows an ability to image only 17 in. wide at a minimum height of 15 in.

Figure 0-1 demonstrates that just over 17 in. could be imaged at the minimum height. Therefore, the system was only capable of imaging 30% of the 56.5 in. wide railcar undercarriage at the minimum height.

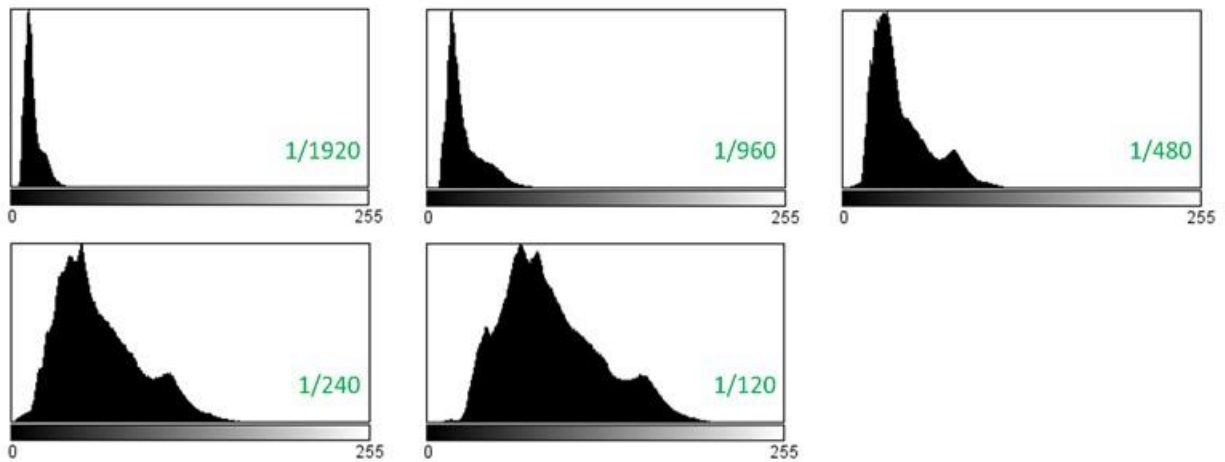
Figure 0-2: Exposure vs. shutter speed pixel intensity histograms with shutter speeds shown (sec.)

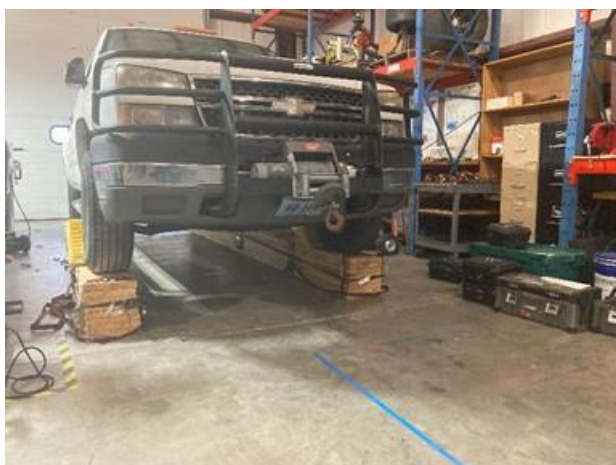
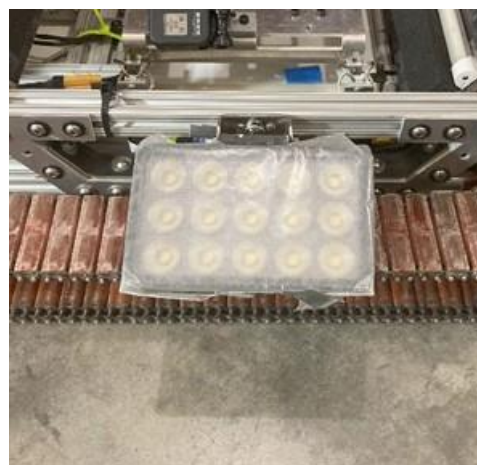
Figure 0-6: Under-truck testing setup: (a) Pickup truck placed on 15 in. high blocks; (b) A sample diffusive covering, two layers of wax paper.

To complete this test, a pickup truck undercarriage was used to approximate the railcar undercarriage. Imaging the poster was useful for discovering the spotlight behavior of the added light sources; however, an imaging target more closely related to railcar undercarriages is desirable for evaluating the lighting system's performance. The pickup truck was driven onto 1 ft. blocks over an indoor concrete floor to simulate the approximate height and width of typical rolling stock undercarriage components, Figure 0-6a.

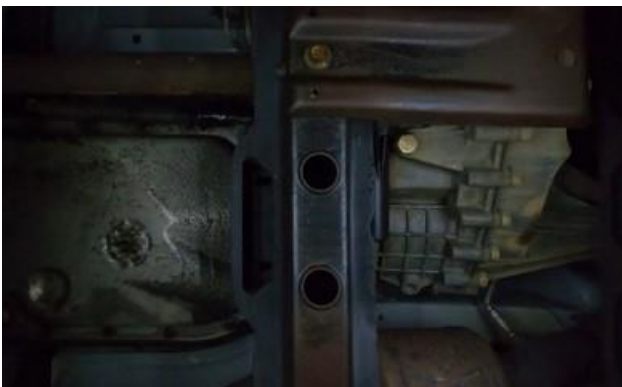
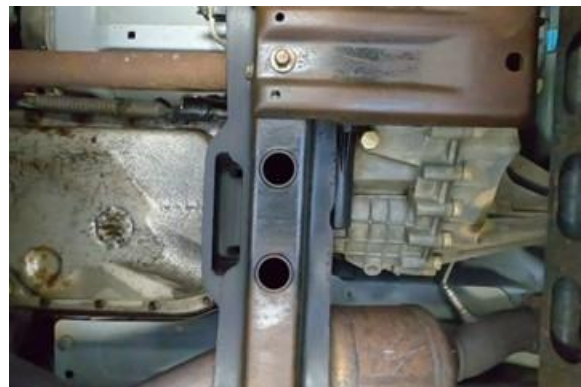
Figure 0-9: Vertical image of the pickup truck undercarriage comparing (a) the original lighting systems and (b) the improved lighting system with diffusive coverings

The images of the pickup truck's undercarriage using the chosen set of diffusive coverings indicate the ability to light and image a wide FOV at close range. The width between the tires is similar to the rail gauge, and the wheels are mounted at a height of 1 ft., lower than the required 15 in. height. Therefore, these results show the ability to illuminate a greater FOV than required. Lastly, Figure 0-9 demonstrates the improvement from the original lighting system, Figure 0-9a, to the improved lighting system, Figure 0-9b, when capturing images of the overhead undercarriage. The original lighting system focuses most of its light on the directly overhead region of the undercarriage; however, even this region is inadequately lit during the pickup truck test. Figure 0-9b, however, demonstrates an ability to excellently illuminate the overhead undercarriage using the improved lighting system. The close-up metal bar is adequately lit without oversaturation, and the components in the background remain well-lit.

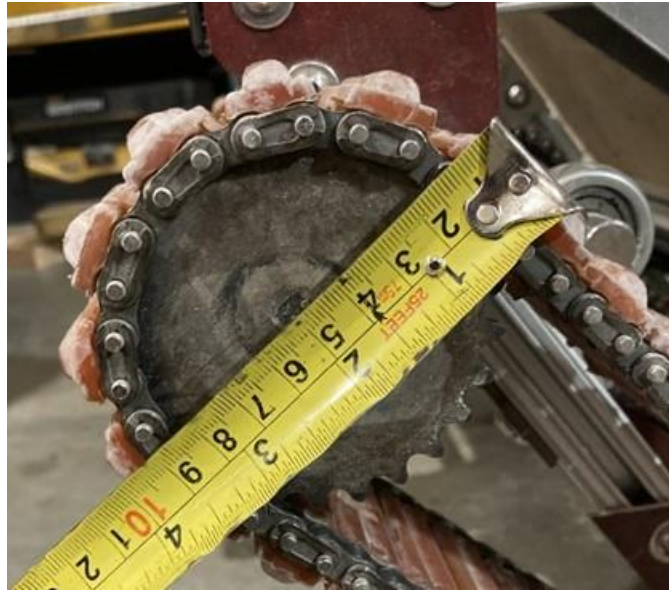
Figure 0-2: Measurement used to input the initial wheel diameter

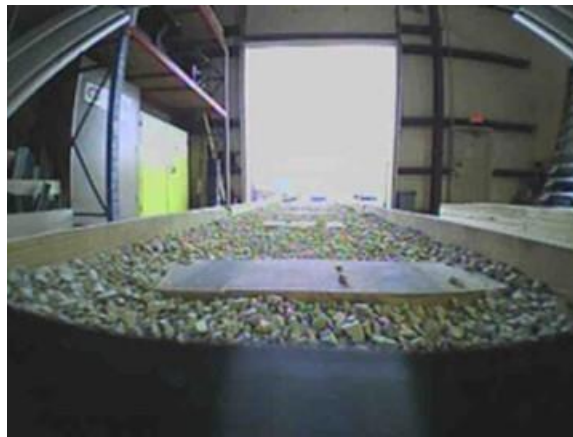
Figure 0-9: Frame from the FPV camera footage during the 3 mph Test Bed evaluation

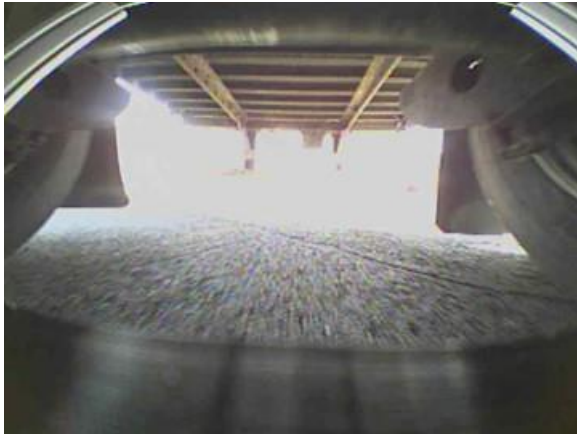
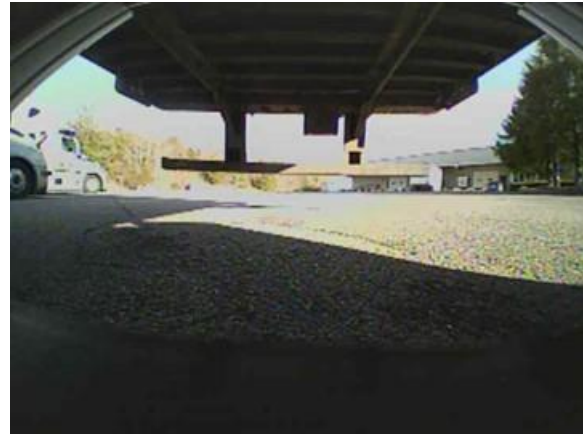
Figure 0-10: Images from the 6 mph under-trailer test: (a) Image taken as the TCR passes under the rearmost axle of the trailer, (b) Image taken 0.24 s later when the camera has readjusted to the scene

Tests conducted at 6 mph beneath the trailer indicate the FPV system's ability to operate in similar lighting conditions as seen beneath the railcars. The FPV camera effectively altered its sensitivity to provide a clear image both beneath the trailer and the sky, although, as expected, periods of saturation or dimness occurred when transitioning from dim to bright and vice versa, respectively. Figure 0-10 shows one such transition as the TCR travels into a brightly lit area from beneath the rearmost axle of the trailer. Figure 0-10a shows an image while the TCR passes beneath this axle. The scene directly ahead is almost completely saturated, making effective navigation difficult. The underride guard located directly in the TCR's path is almost invisible. If this component were an obstacle in the TCR's path, the operator would most likely not have identified it at this point. Figure 0-10b is taken at the first moment when the FPV camera has effectively adjusted to the new lighting conditions. This frame occurs 0.24 s. later in the video. A quarter of a second can be a significant length of time; however, at the operating speed of the TCR, the transition period does not appear to pose a critical risk to controllability. Additionally, these tests demonstrated that the system was able to be controlled at more than twice the track bed operating speed without detrimental effects due to latency. The FPV had now been tested in similar vibratory and lighting environments as will be seen beneath railcars, and the system was deemed fit. A later section will cover the final validation of the system in the real-world inspection environment.

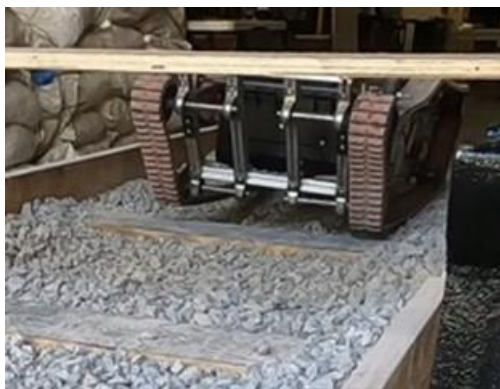
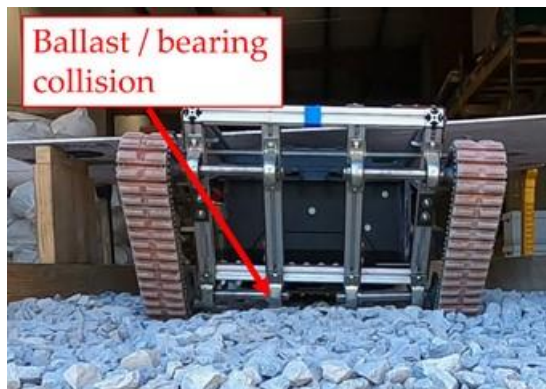
Figure 0-1: Test Bed evaluation results: (a) Sharp collision during 4.25 mph test causing the front end of the TCR to become airborne; (b) Impact between the ballast and bearing housing

The first evaluations of mobility and reliability were constant speed tests across the Test Bed. The TCR was placed a short distance from the ramp of the Test Bed to allow it to reach testing speed before traversing. The TCR's performance was evaluated using video images. At speeds below 3 mph, the TCR was observed colliding with the edges of the ties, but the collisions did not appear significant, with a few causing the front end of the TCR to become slightly airborne. However, at 4.25 mph, the TCR was violently jolted by collisions with ties, and the front end became airborne to a more significant degree, Figure 0-1a. As noted, the TCR has no suspension. Collisions such as this impart large shock loads into the idler sprocket assemblies. It was determined that speeds above 3 mph would not be attainable with the current configuration but determining the maximum controllable and reliable speed would require further investigation. During these tests, it was suspected that the undercarriage bearings and housing were being contacted by the ballast. To investigate this, a camera was placed at the end of the Test Bed to film the interaction between the ballast and undercarriage components throughout the test. Video from this camera clearly showed the bearing housings being impacted by ballast, Figure 0-1b. Further inspection of these components revealed that they all showed signs of impact, and a few of the bearing housings had become deformed to the point of no longer securing the bearings and axles in place. From this evaluation, it was determined that the current idler sprocket assemblies would need to be redesigned such that the bearings and housings would no longer be vulnerable to consistent impacts.

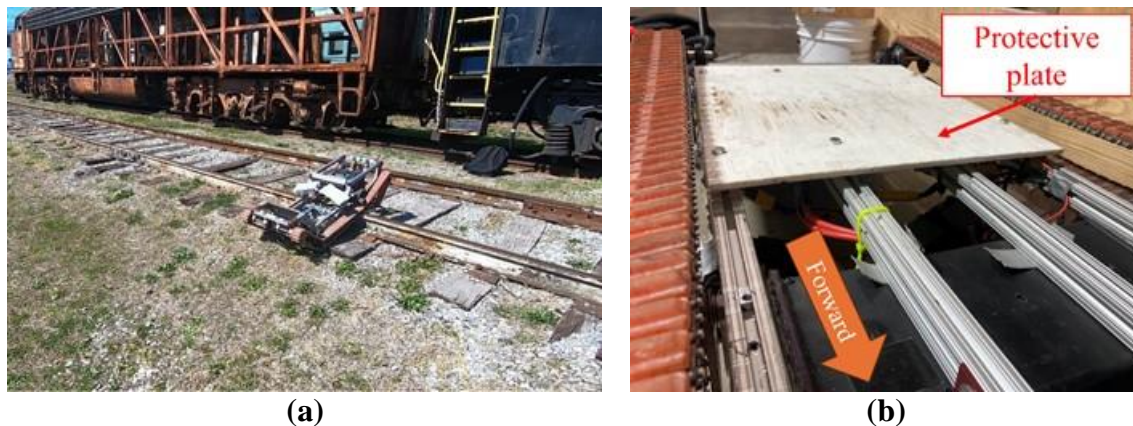
Figure 0-2: (a) TCR shown stuck rail climbing as the edge of the protective plate impacts the rail; (b) the protective plate mounted to the TCR's undercarriage

During the rail climbing portion of the test, the TCR was unable to consistently climb over the rail, stopping many times at the location shown in Figure 0-2a. The system possessed enough torque and traction to begin pulling itself onto the rail; however, the leading edge of an undercarriage plate intended to guard electrical components, Figure 0-2b, would ram into the edge of the rail, stopping rail climbing. This collision was due to the level of tension within the tracks. With most of the TCR's weight supported by a small section of the tracks, that portion would sag below the level of the protective plate, allowing collision to occur. At times, it was possible to clear this edge; however, the rail would then rest against this plate. The traction at the tracks decreased as the plate supported a portion of the TCR's weight. This led to track slippage, which further hindered rail climbing. Despite these issues, the system eventually climbed into the track bed during this test. When attempting to climb out, the same issues occurred; however, they were compounded by the fact that the tracks were causing the ballast to slip. Rail climbing is a high-torque maneuver, and the ballast was breaking away under the forces causing a further loss of traction. These conditions led to the TCR being unable to climb out of the track bed during the initial tests.

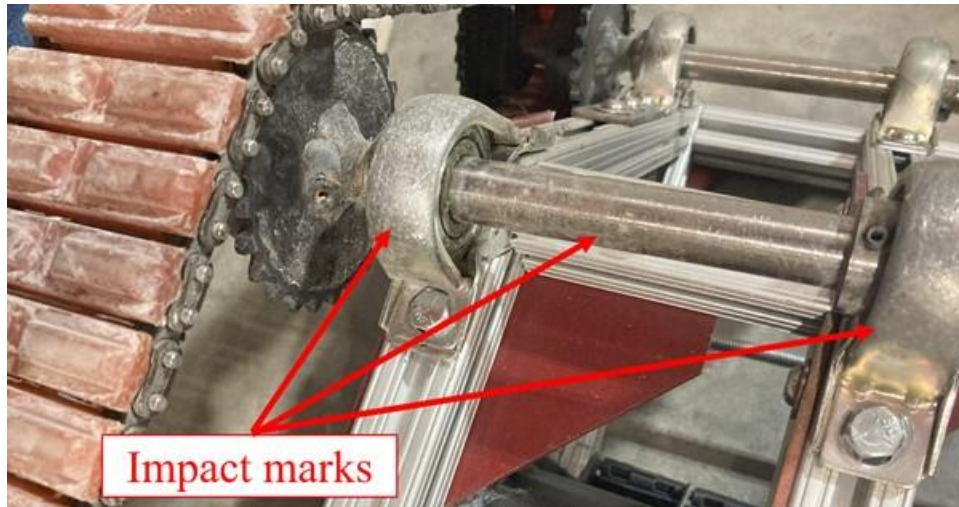
Figure 0-4: Original idler sprocket assembly showing evidence of impacts

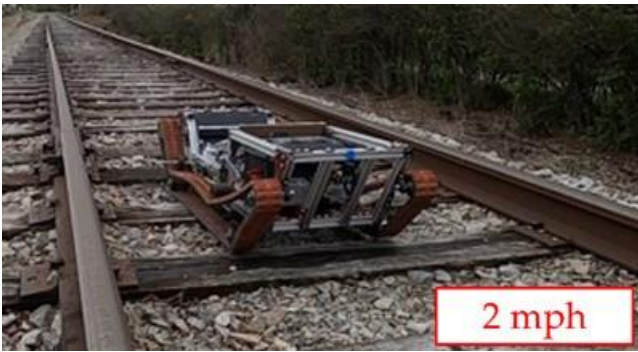
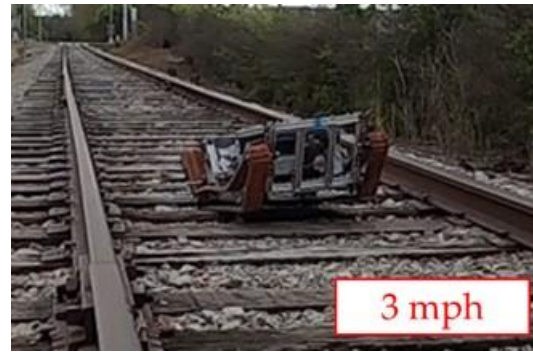
Figure 0-10: Images of the TCR colliding with the edge of a tie within the track bed at (a) 2 mph and (b) 3 mph

In addition to the modifications to the idler sprocket mounting assemblies, modifications were made to the operating conditions of the TCR. It was determined that operating at speeds above 2 mph within the track bed may be detrimental to the TCR in its current condition. Collisions with ties and ballast impart large shock loads into the system without any form of suspension. It appears from testing that this loading moves into unacceptable ranges between 2 and 3 mph. At 2 mph within the track bed, collisions with ties may cause the front of the TCR to become slightly airborne, Figure 0-10a; however, the motion is not incredibly violent, and control may be maintained throughout. At 3 mph, the front of the TCR is jolted upwards violently,

Figure 0-10b. This behavior was observed on the Test Bed; however, 3 mph operation was acceptable during these tests, while large collisions were occurring at 4.25 mph. It appears that the actual track bed is slightly rougher than the Test Bed, causing large collisions to occur at lower speeds. It was, therefore, concluded that the TCR's operation should be limited to 2 mph within the track bed until further modifications or testing demonstrate its ability to operate above this threshold reliably and controllably.

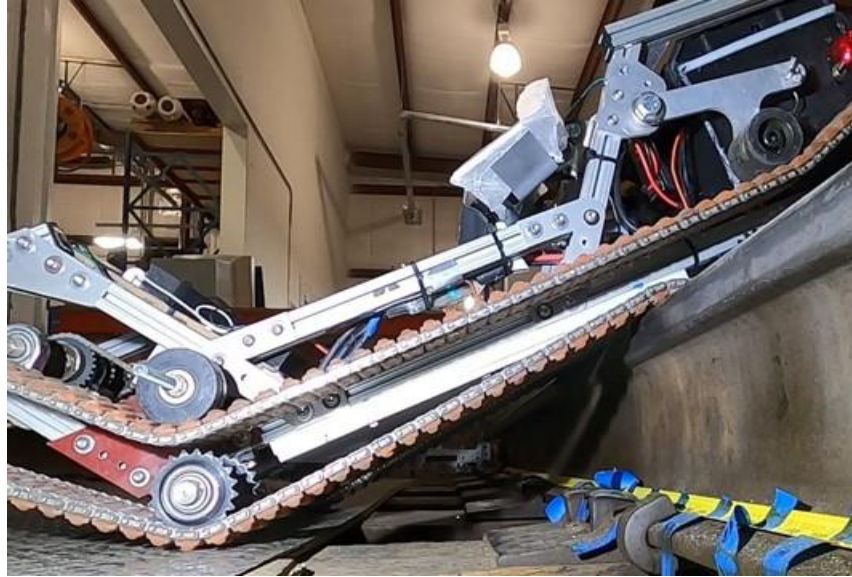
Figure 0-11: Indoor rail climbing test illustrating how the undercarriage plate removes traction from the tracks

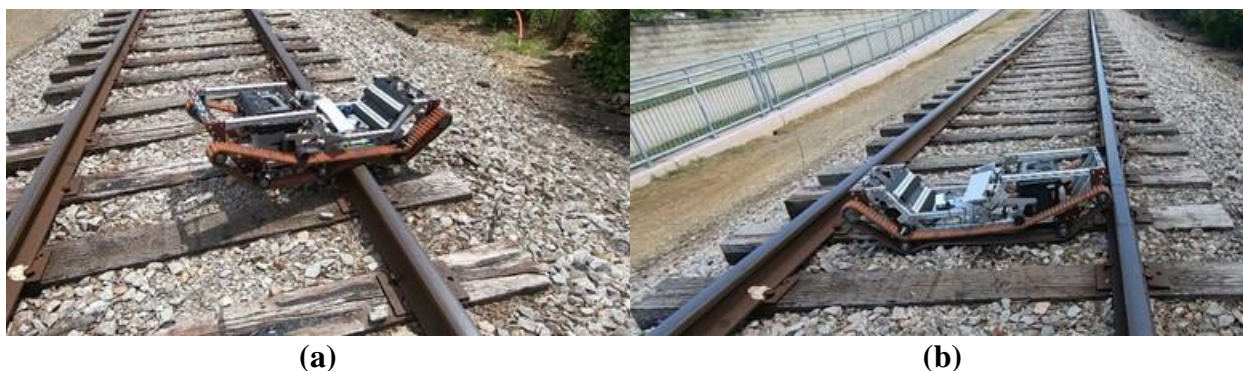
Figure 0-14: Images from the rail climbing test of the improved system: (a) TCR tipping into the track bed while climbing in, (b) TCR becomes stuck on a tie while attempting to climb out

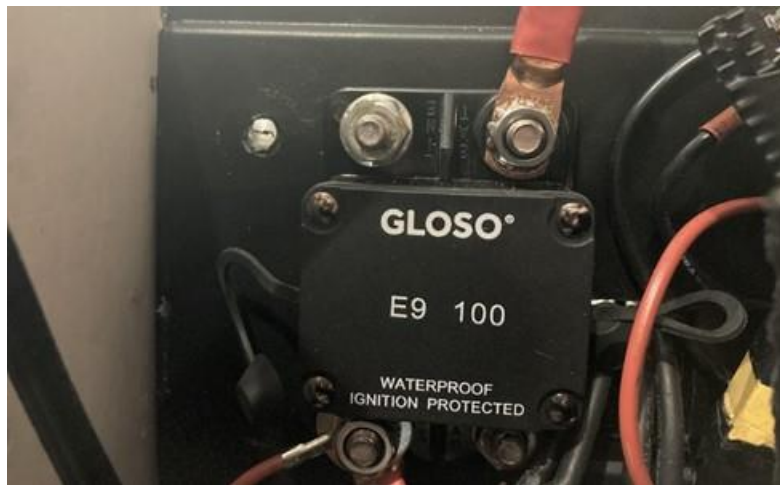
Figure 0-3: Installation of the auto-reset circuit breaker

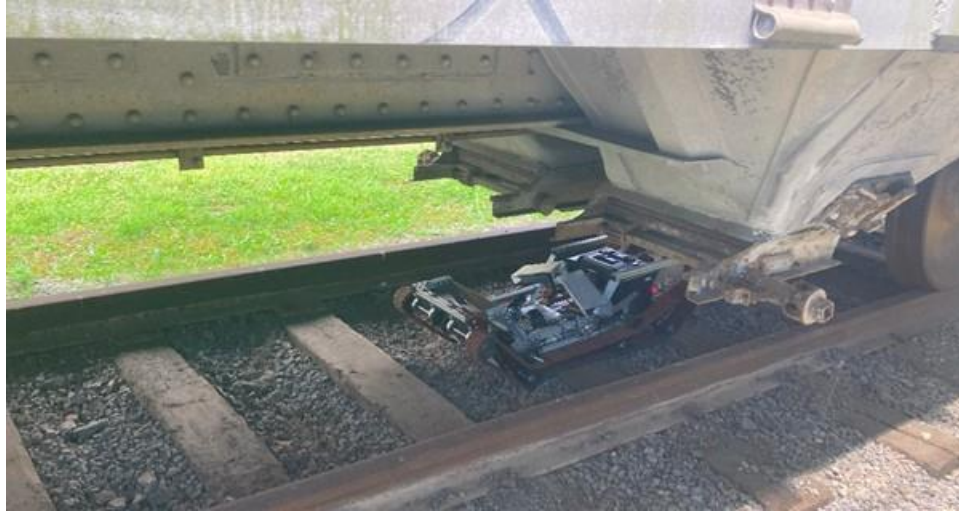
Figure 0-1: The TCR at the testing site, shown beneath the hopper railcar

The tests were then carried out, traversing beneath a boxcar and a hopper car, Figure 0-1. The images from each test were then analyzed for adequate clarity and contrast.

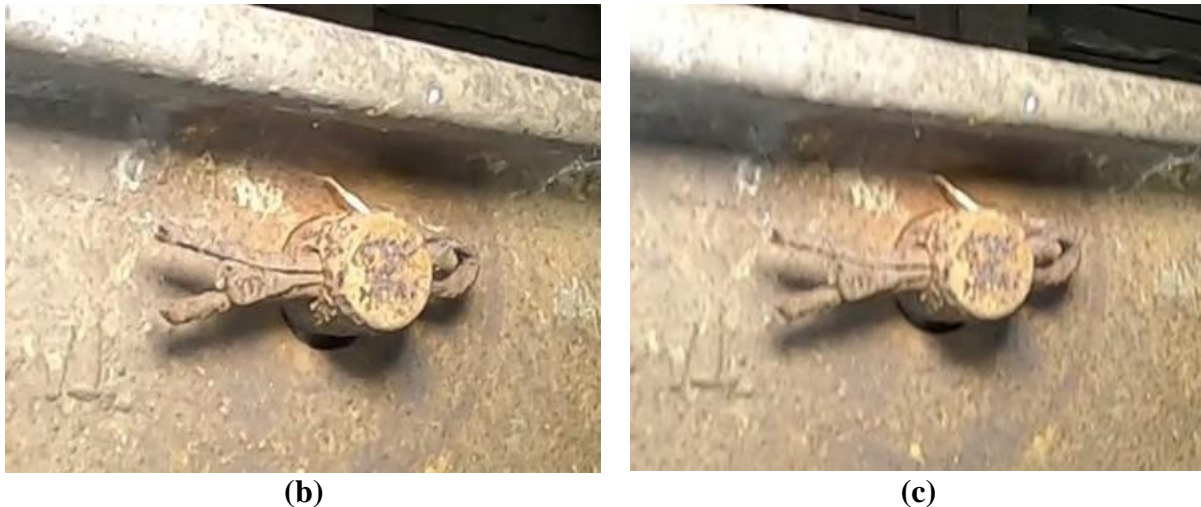
Figure 0-2: Retaining clip on a railcar undercarriage captured at 2 mph using a shutter speed of (a) 1/1920 s., (b) 1/960 s., and (c) 1/480 s.

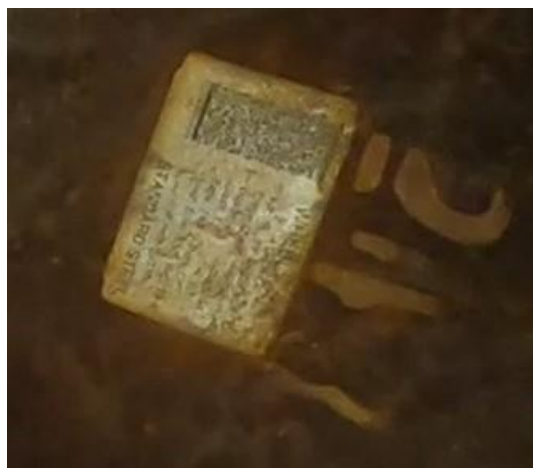
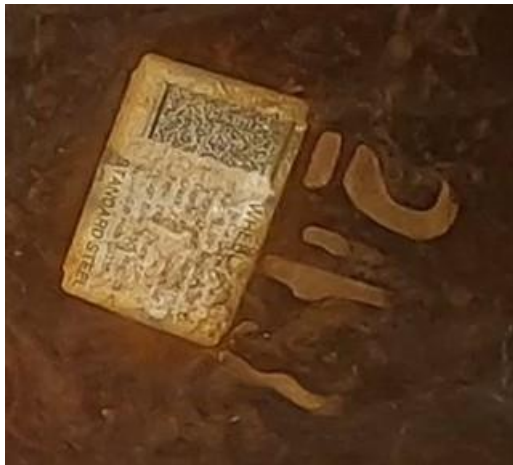
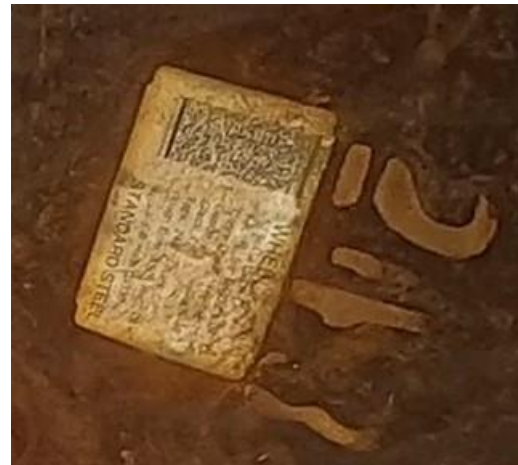
Figure 0-5: Zoomed-in photo from the label of the rail wheel captured at shutter speeds of (a) 1/1920 s., (b) 1/960 s., and (c) 1/480 s.

Figure 0-4 presents the pixel intensity histogram from each rail axle and wheel image. A close inspection shows that the intensity distribution for each image is very similar. The mean values of each histogram indicate that the images do, in fact, grow brighter as the shutter speed decreases, but the effect is not drastic, ranging from 77-88. Additionally, the 1/1920 s. case (Figure 0-4a) appears to lack detail in the plateau located near the center of the sensor's range. The 1/960 s. (Figure 0-4b) and 1/480 s. (Figure 0-4c) cases share similar peaks and valleys in this region, whereas the 1/1920 s. case appears to not capture this intensity range with as fine of resolution. Interestingly, the contrast (represented by standard deviation) remains nearly constant across the set of images, between 50-55. This statistic suggests that each image contains a roughly equal amount of information. This statistic was unexpected. The 1/480 s. case gathers 4 times the light of the 1/1920 s. case. It would be expected that this increase in exposure would allow for greater information to be gathered. Investigating the images closely reveals the reason.

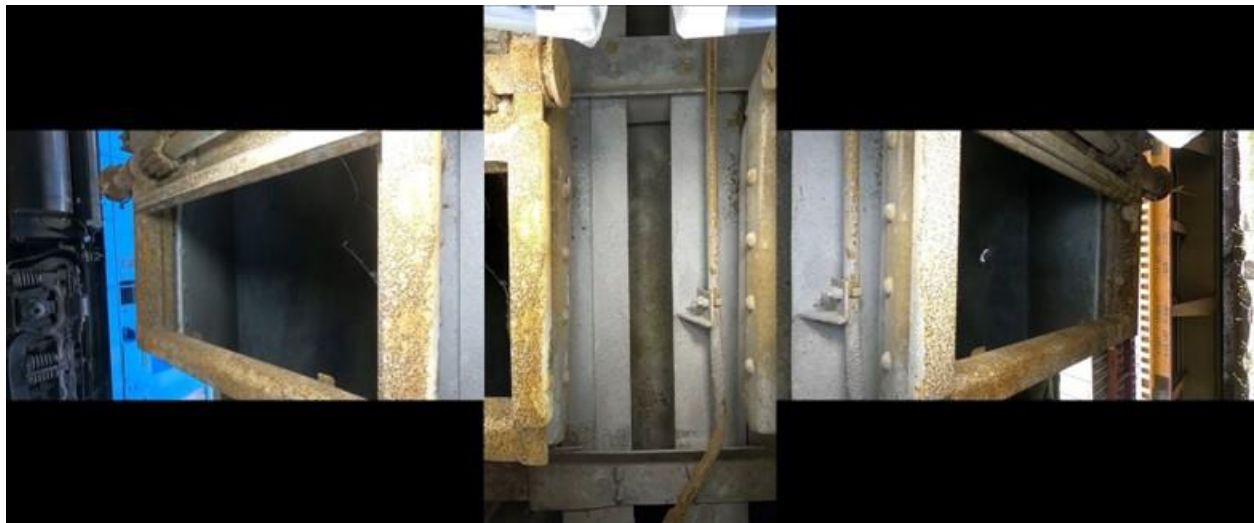
Figure 0-7: Images from the left, vertical, and right-view cameras of a lateral member within the railcar bogie

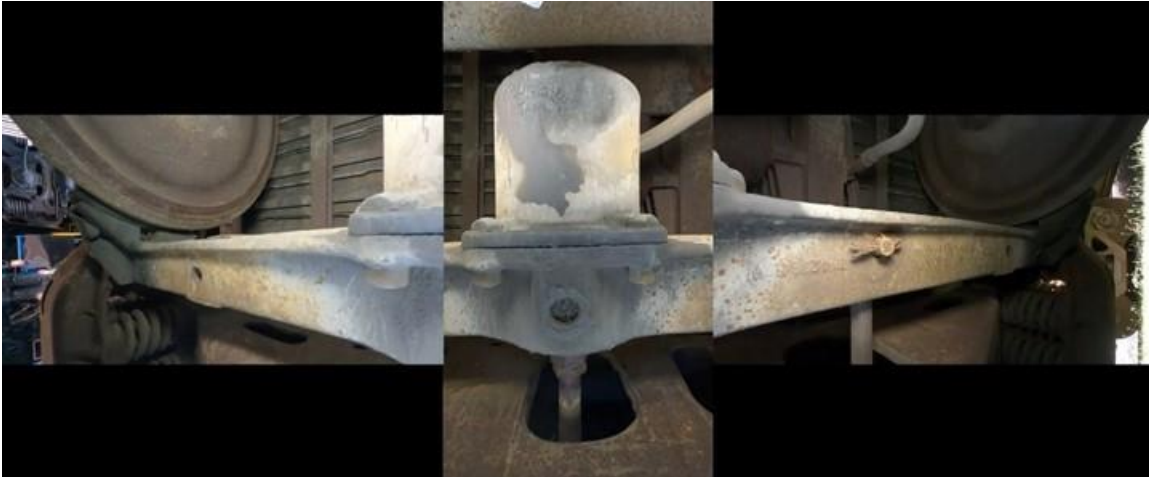
Figure 0-1: Aligned images of a railcar undercarriage taken from each camera
