1. Report No. RailTEAM UNLV-3	2. Government Accession No.	3. Recipient's Catalog No.	
4. Title and Subtitle Non-Contact Acoustic Emission Approach for Rail Health Monitoring		5. Report Date July 2024

Final Report UNLV-3

## **NON-CONTACT ACOUSTIC EMISSION APPROACH FOR RAIL HEALTH MONITORING**

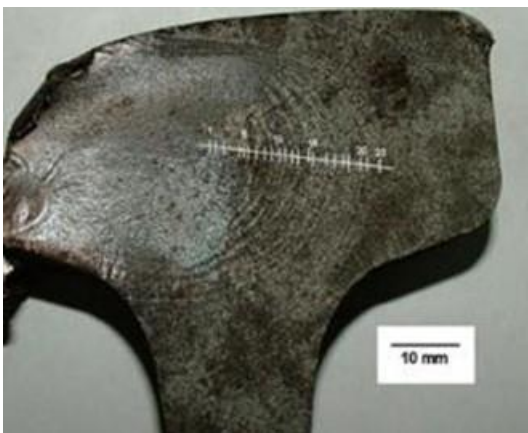
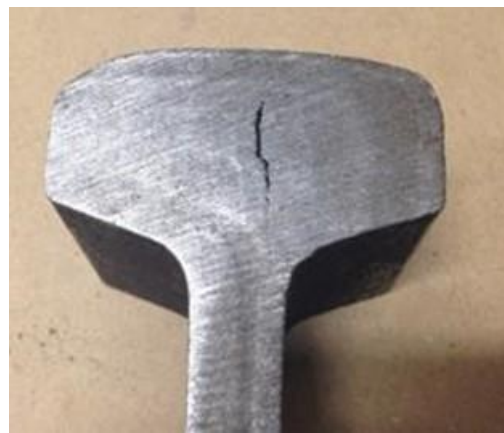
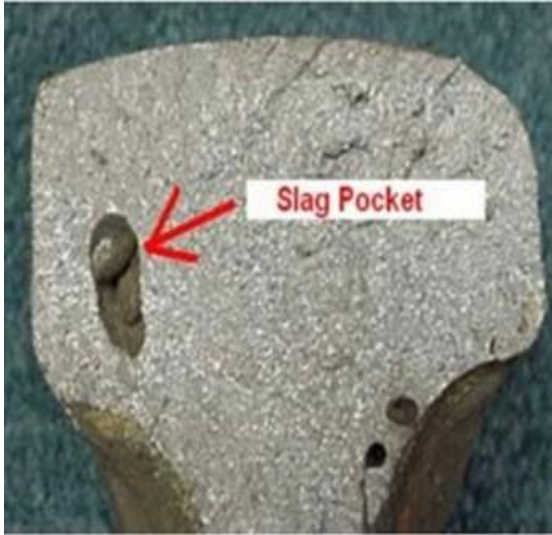
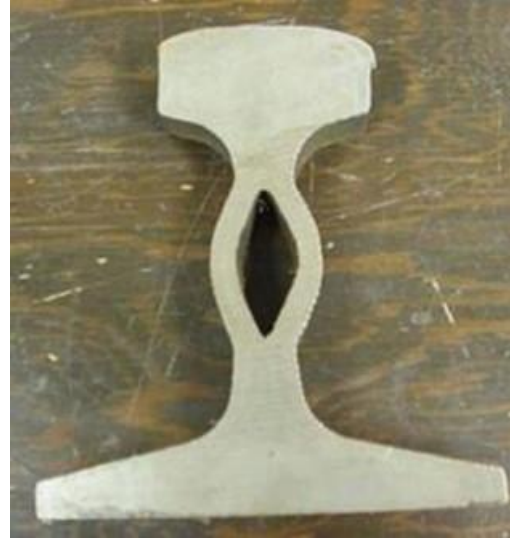
**Figure 3 Rail Internal Defects (Office of Railroad Safety, 2015)**

Transverse fissure

Vertical split head

Defective weld with slag entrapment

Piped Rail

presents external defects such as head checks at the higher side, side shell corrosion, flaking caused by centralized loading, and thermal cracks on burned stock railheads. Internal defects include transverse fissure, vertical split head, defective weld with slag entrapment, and piped rail as shown in

Figure 3. Internal defects are invisible from the exterior.

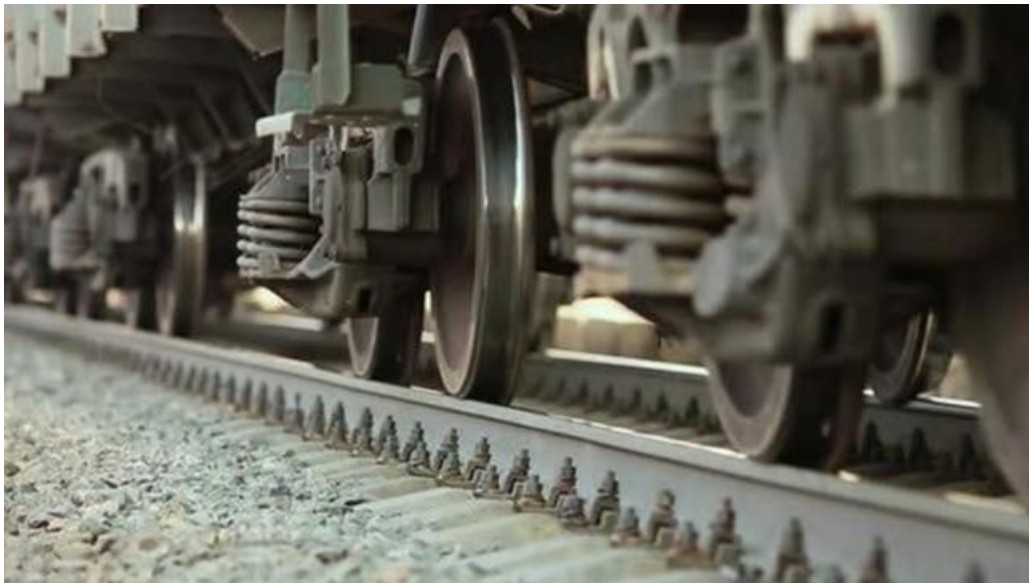
**Figure 1 Rail Wheel Interaction (Elements, 2019)**

In railroad transportation, the rail and wheels directly interact while trains move forward (Figure 1). The railroads would experience wear and tear during daily operations, leading to defects both internally and on its surface.

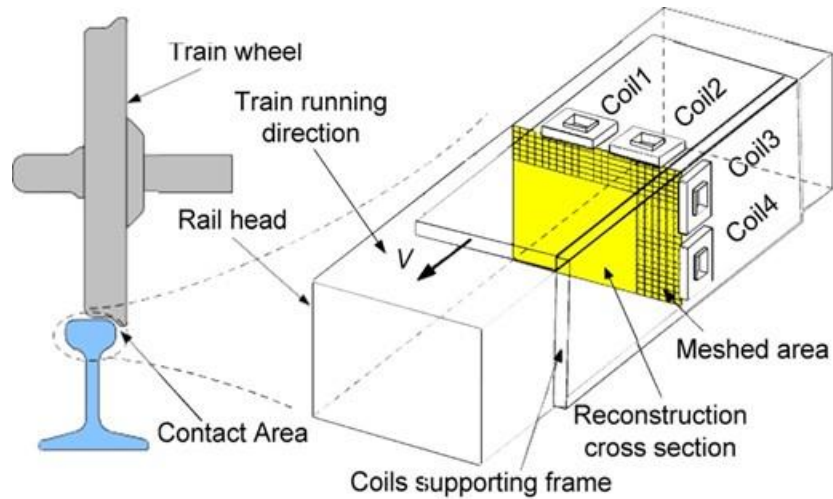
Magnetic-related techniques, such as electromagnetic tomography technology (EMT), are less commonly utilized rail defect detection methods (Liu et al., 2015). This EMT uses a tomographic approach to measure the alternating magnetic signal modulated by cracks in the rail and then reconstructs the distribution of cracks. One of the EMT's advantages is its ability to detect and reconstruct internal cracks within the rail, offering a non-contact, continuous inspection method that can operate at higher speeds compared to traditional inspection techniques.

**Figure 4 Sensor structure of the EMT rail defect inspection (Liu et al., 2015)**

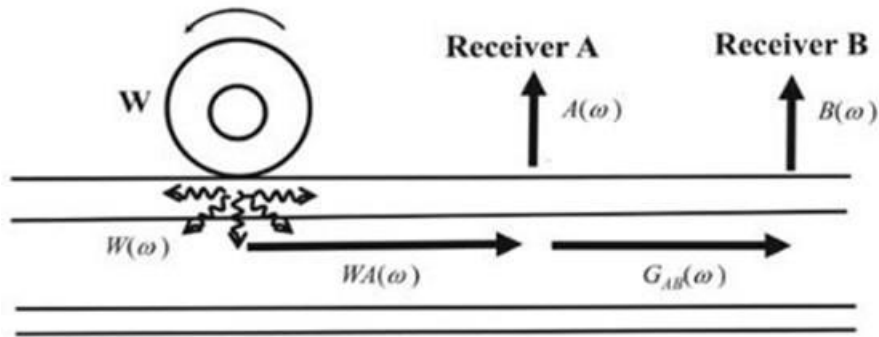
A passive extraction method has been used to isolate defect signals based on non-contact ultrasonic monitoring (Lanza di Scalea et al., 2018). Three options were listed to present the differences in isolating the defect signal: cross-correlation, normalized cross-correlation, and deconvolution. According to previous research, ultrasonic energy and properties will change due to the rails' discontinuities (Coccia, Bartoli, et al., 2011; Coccia, Phillips, et al., 2011). A defect inspection prototype was developed in the experiment, placing two arrays of air-coupled receivers to collect ultrasonic waves (Figure 5). Normalized cross-correlation and deconvolution operations were used to extract the defect properties during the data analysis. In their discussion, rail lubrication is an uncertain factor that may affect the wheel-rail contact behavior. Meanwhile, many improvements need to be made to increase detection accuracy and faster data analysis.

**Figure 5 Theoretical consideration of passive extraction of defect information (Lanza di Scalea et al., 2018)**

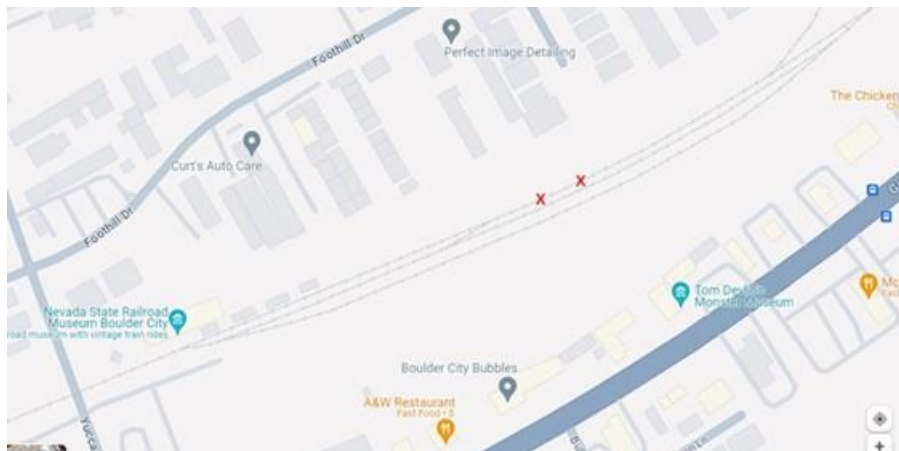
To assess the feasibility of installing the AE sensors on the train to detect rail defects, on-vehicle field tests were conducted in the Nevada Railroad Museum. One rail section with two pre-damaged internal defects (Figure 9) was selected for the tests. Two internal defects were prepared by replacing about 100 ft of track with pre-damaged defects for the field test. In this stage, the sensors were installed on the vehicle to collect the AE signals when the train ran over the defect locations. The rail track used in the field tests was an AREMA 130-lb rail, and the defects were internal defective welds characterized by the crack types and locations. As illustrated in Figure 10, the size of the first defect was 0.2 inches by 0.3 inches, located 0.7 inches below the rail surface, and the second defect was 0.2 inches by 0.2 inches, located 1 inch below the rail surface. An Olympus Epoch 1000i ultrasonic inspector was used to evaluate the defect information, which indicated that both defects were in the early stages of development based on size. The rail track was supported by wood sleepers and ballast. The rail gauge was 4 feet 8.5 inches, and the distance between the sleepers was about 19 inches.

**Figure 9 Internal defect location (red x-marked)**

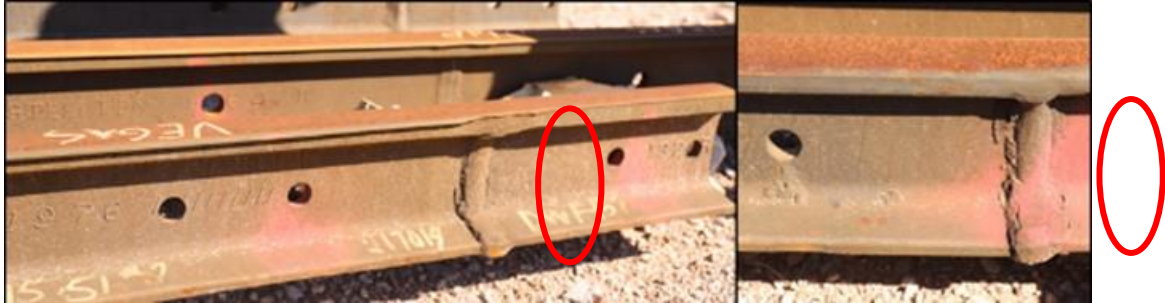
**Figure 10 Two welding defects**

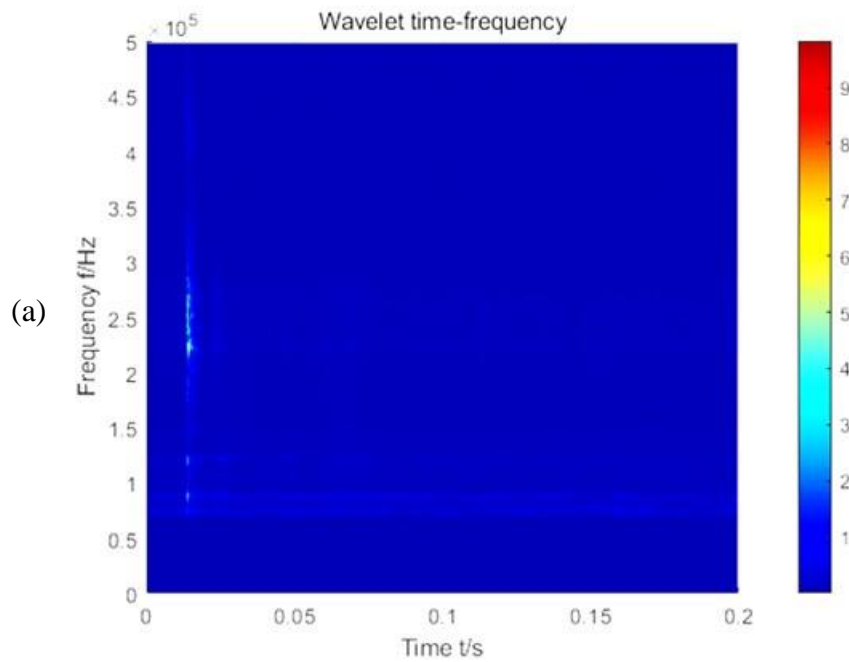
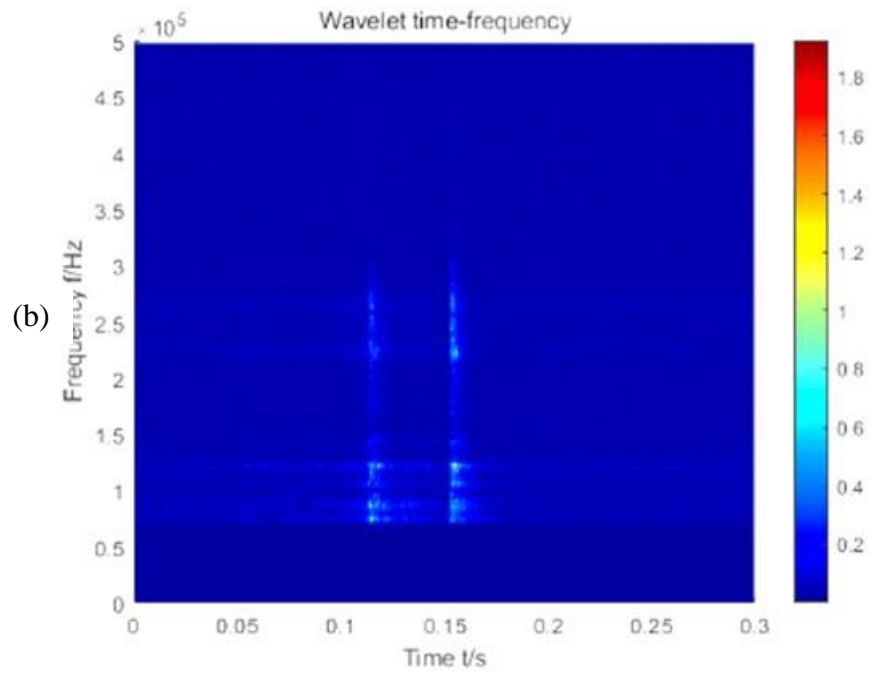
To effectively present the AE features, a high-pass filter with 60 kHz was employed to reduce the effects of low-frequency noises. Figure 14 indicated that the wave energy was primarily concentrated in the 60-120 kHz and a notable amount of energy is in the 200-300 kHz range. In contrast, Figure 15 presented the CWT of two typical ambient noises, where the energy was mainly concentrated below 150 kHz. This is significantly different from the defect-induced AE signals. Therefore, filtering out the lower frequency components of the AE signal can significantly reduce the impact of noise. Additionally, such visible differences made identifying and canceling ambient noise possible in the future.

**Figure 14 Defect-induced AE signals (a) single impulse (b) dual impulses**

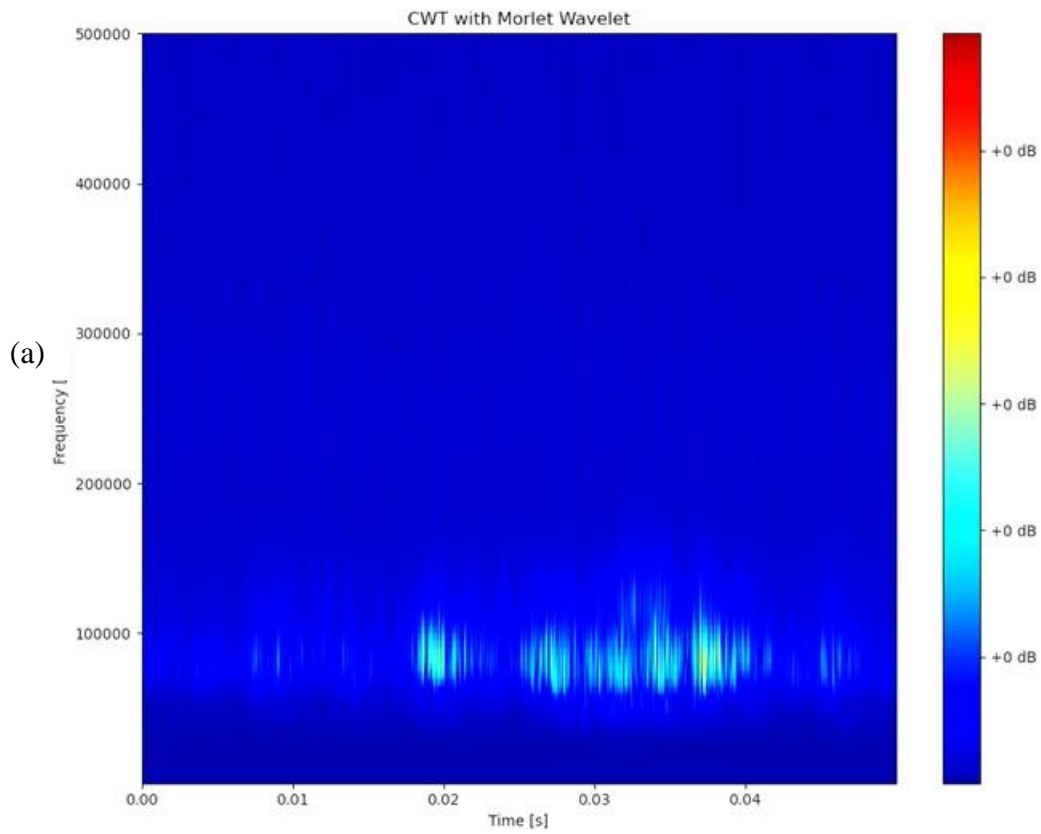
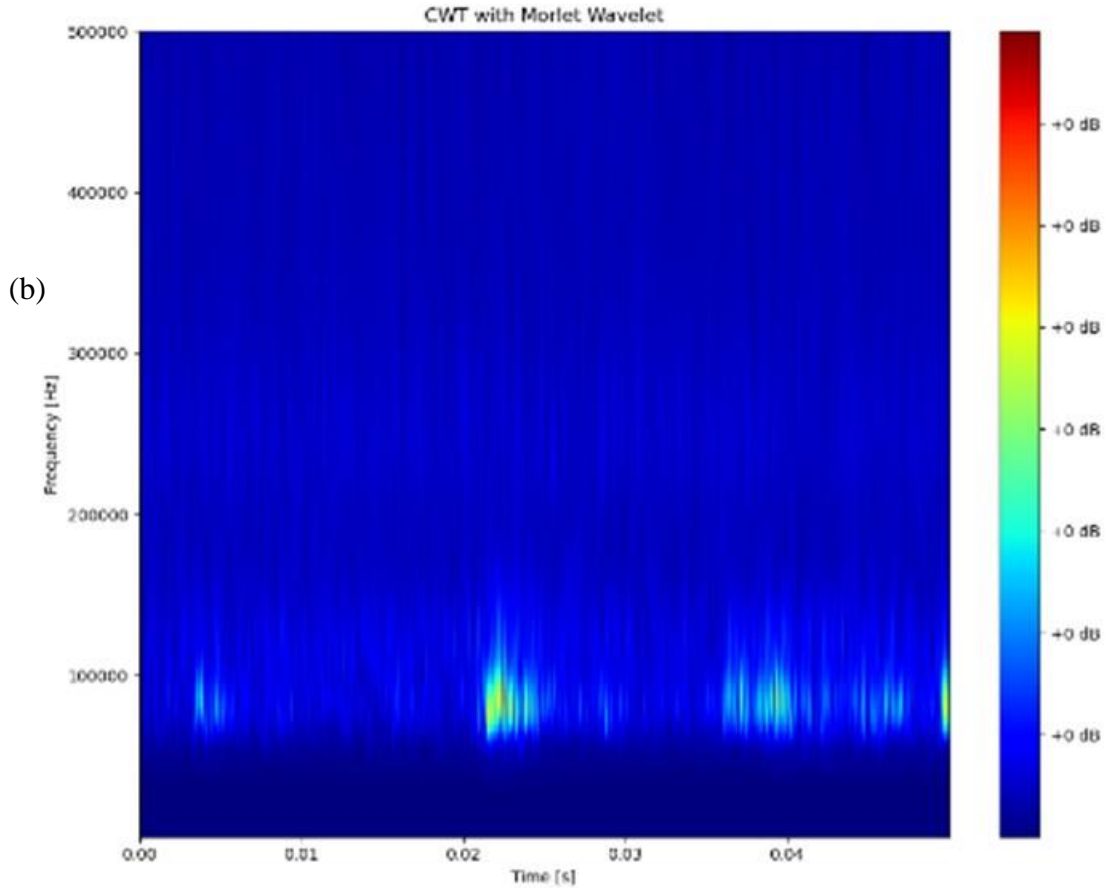
**Figure 15 Ambient noise-induced signals (a) braking noise (b) mechanical vibration**

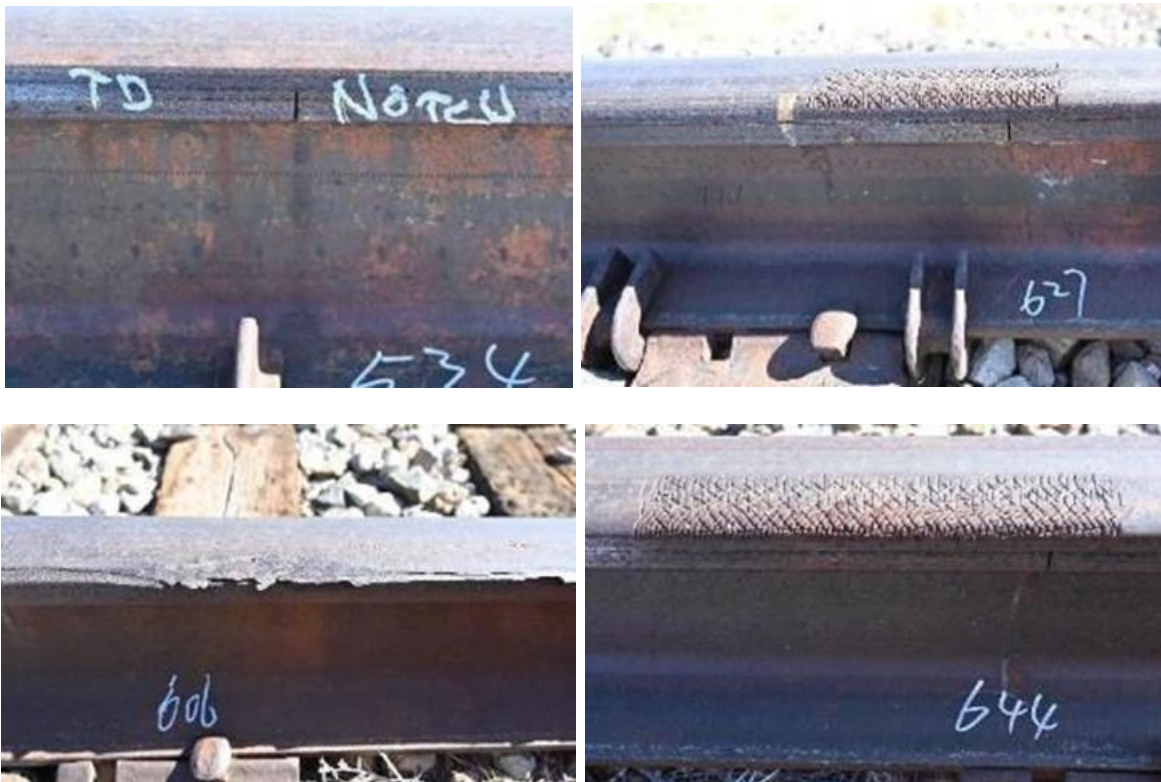
Acoustic signals were collected as the Hi-rail vehicle traversed the defects. A hammer hit was used at the beginning of each test to synchronize the cameras with the DAQ equipment. The Hi-rail vehicle, weighing approximately 5 tons, had an axial load significantly lower than that of a commercial hopper. Field tests were conducted at four different speeds—5 mph, 10 mph, 15 mph, and 20 mph. The 20-mph setup included 10 runs (each run consisting of a back-and-forth motion), while the other setups had 5 runs each. This ensured sufficient rail-wheel impacts to generate AE events. The primary goal was to collect AE signals at various speeds, enabling a comprehensive evaluation of AE features based on different defect types and vehicle speeds.

**Figure 19 Defects in RDTF loop**

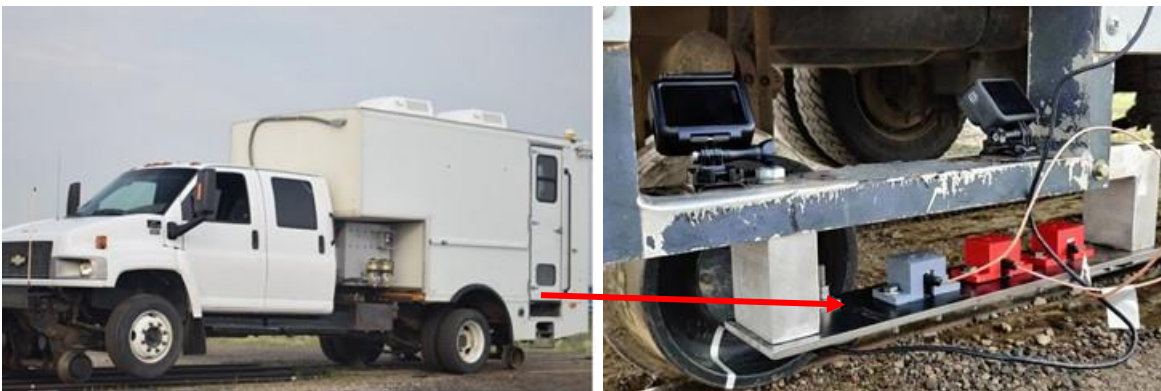
**Figure 20 Configuration of sensors and cameras on Hi-Rail vehicle**

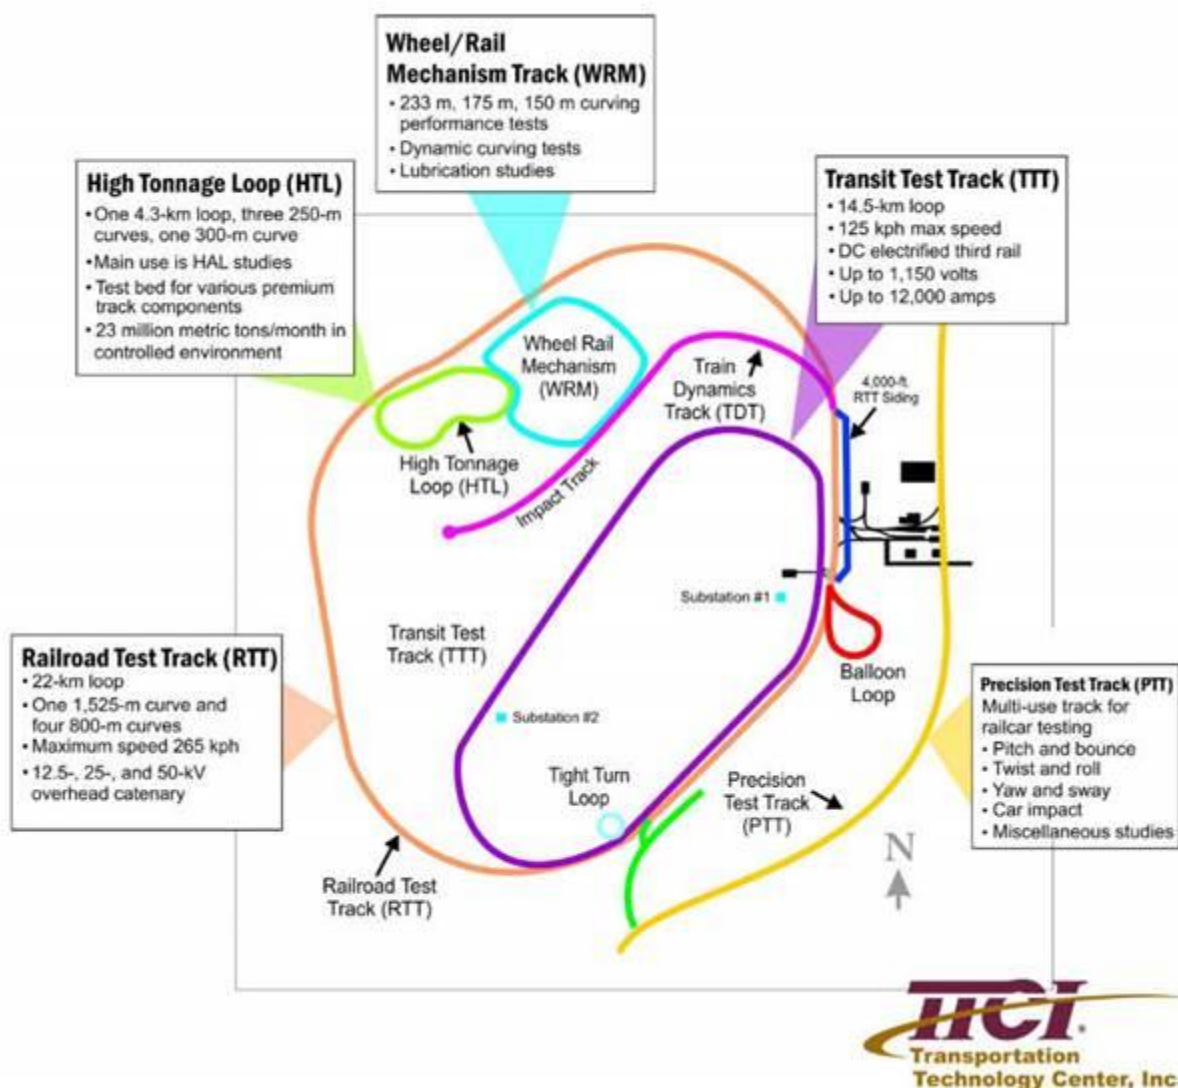
The entire length of the RTT loop was 13.5 miles, with a maximum allowable speed of 165 mph (Figure 26). The testing system was installed similarly as installed in the Nevada field test, as presented in Figure 27. However, due to safety concerns regarding the sensors and cameras, the maximum speed during this test was limited to 105 mph. Five tests were conducted: two at 40 mph and three at 105 mph. The purpose of the 40 mph tests was to evaluate and compare the effects of ambient noise with those observed during the HTL tests.

Figure 26 RTT loop (orange line)

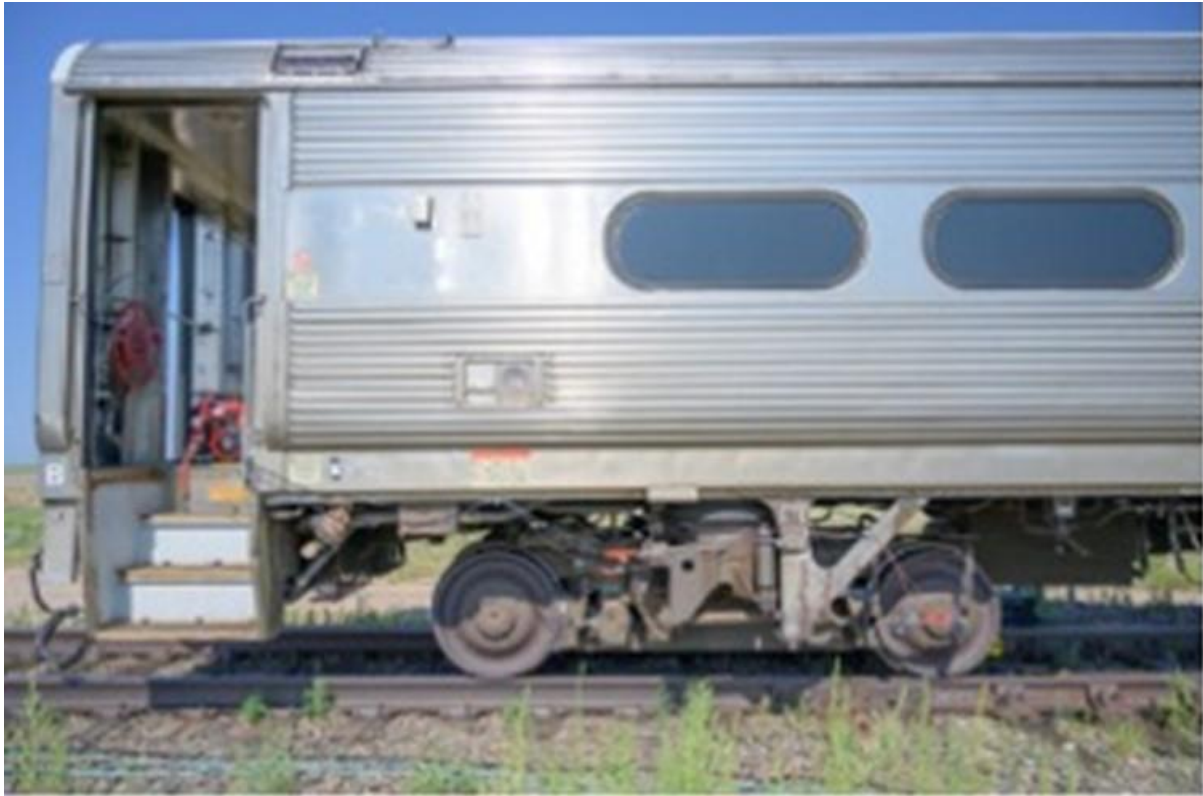
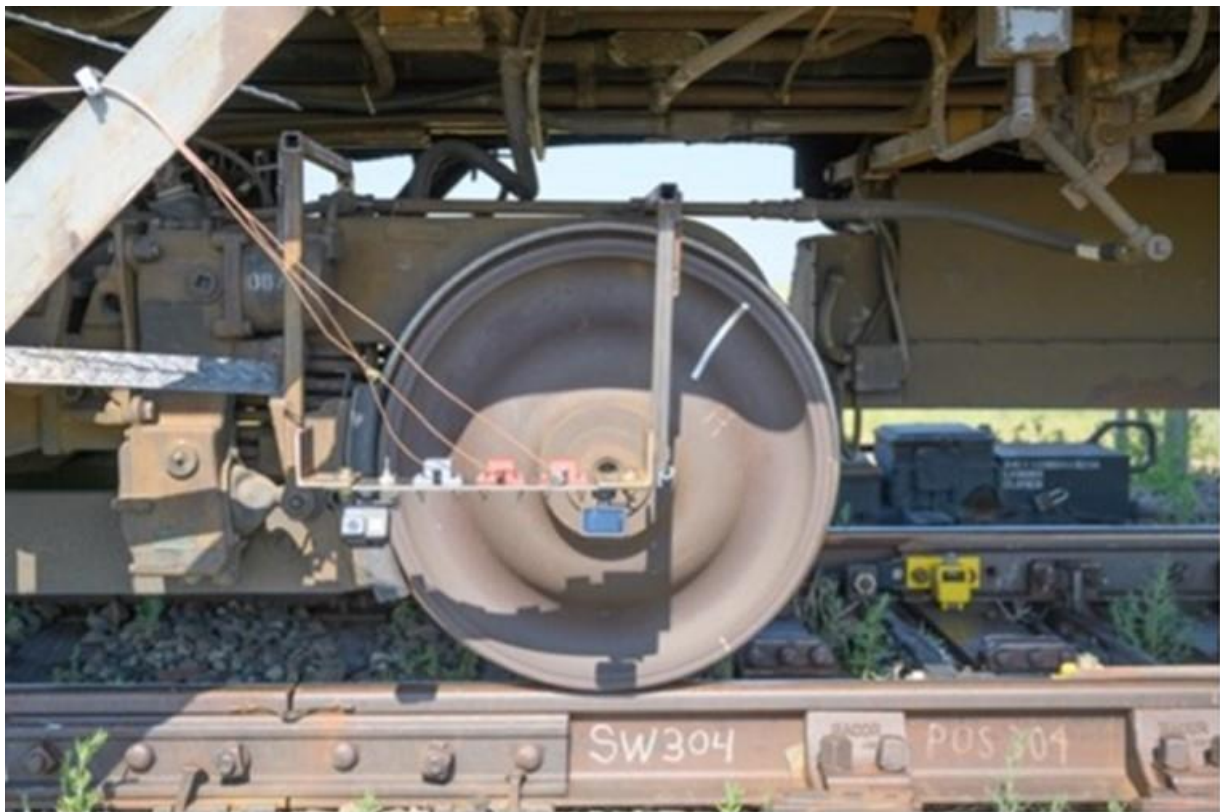
**Figure 27 Sensor location and testing car**

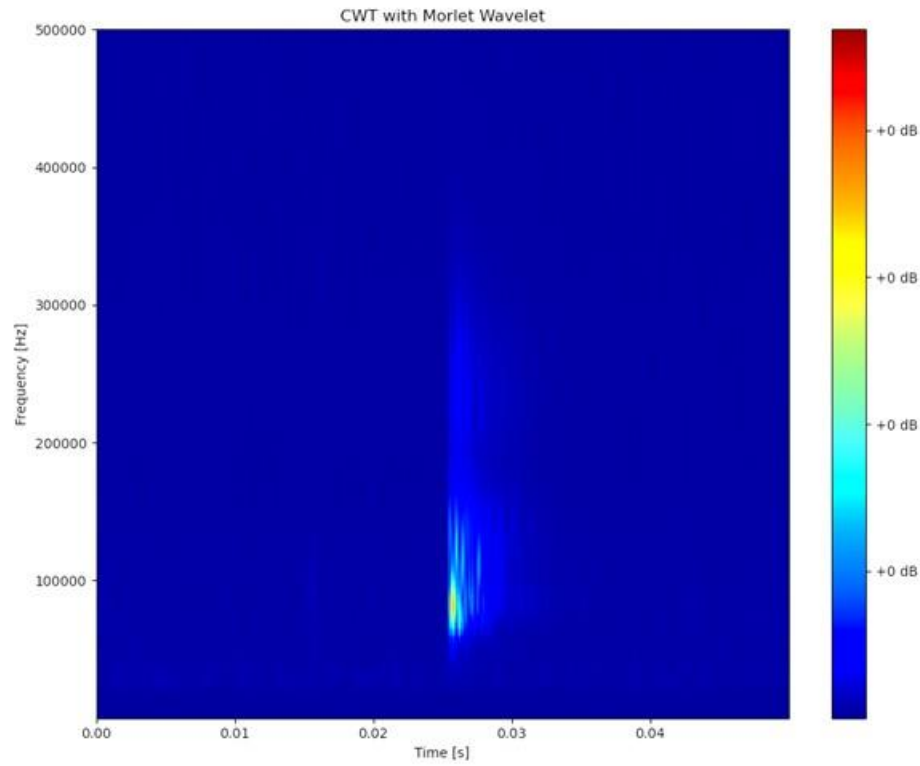
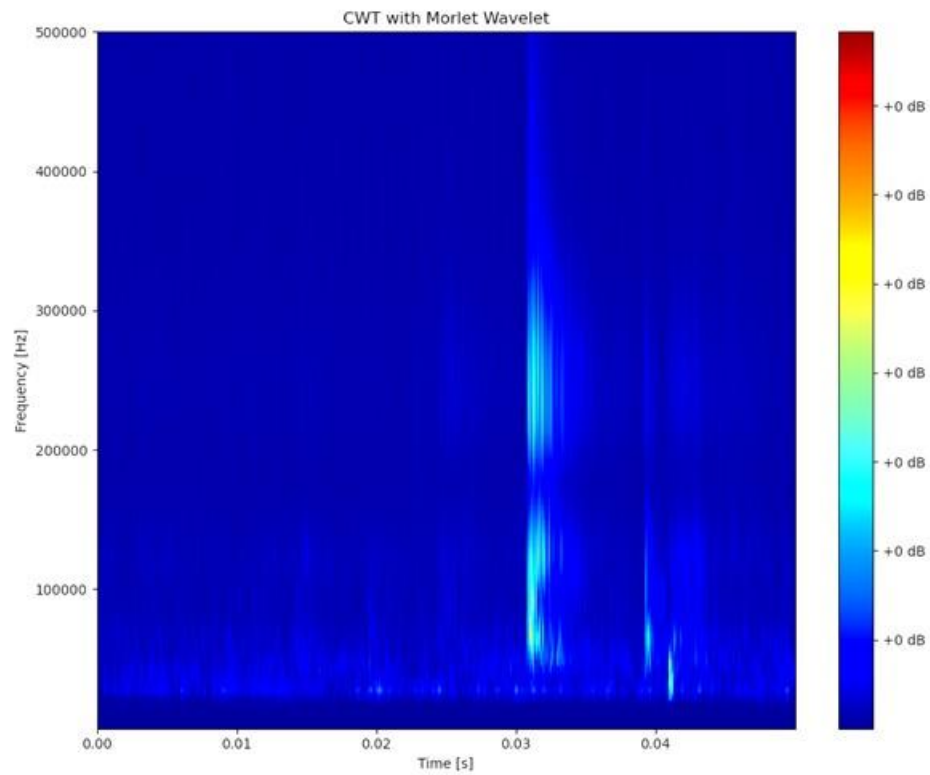
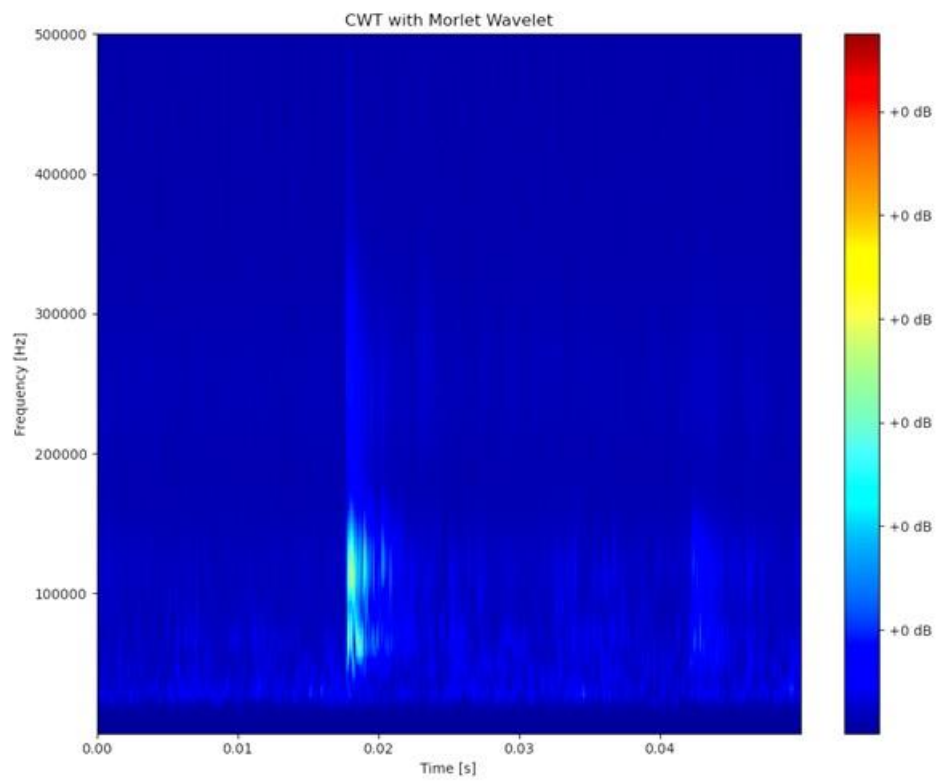
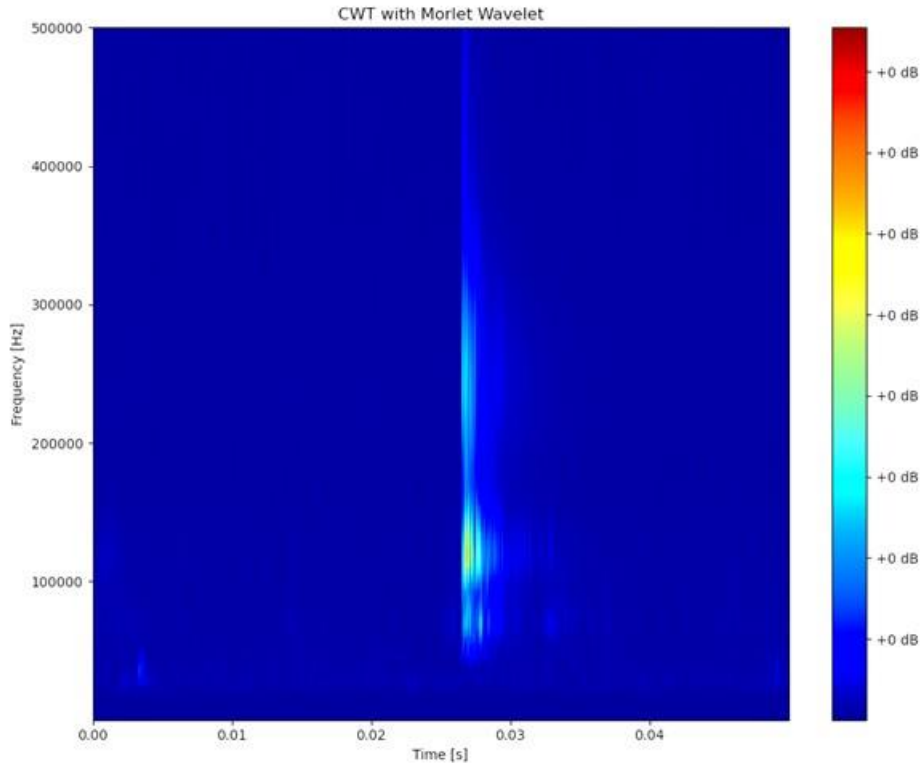
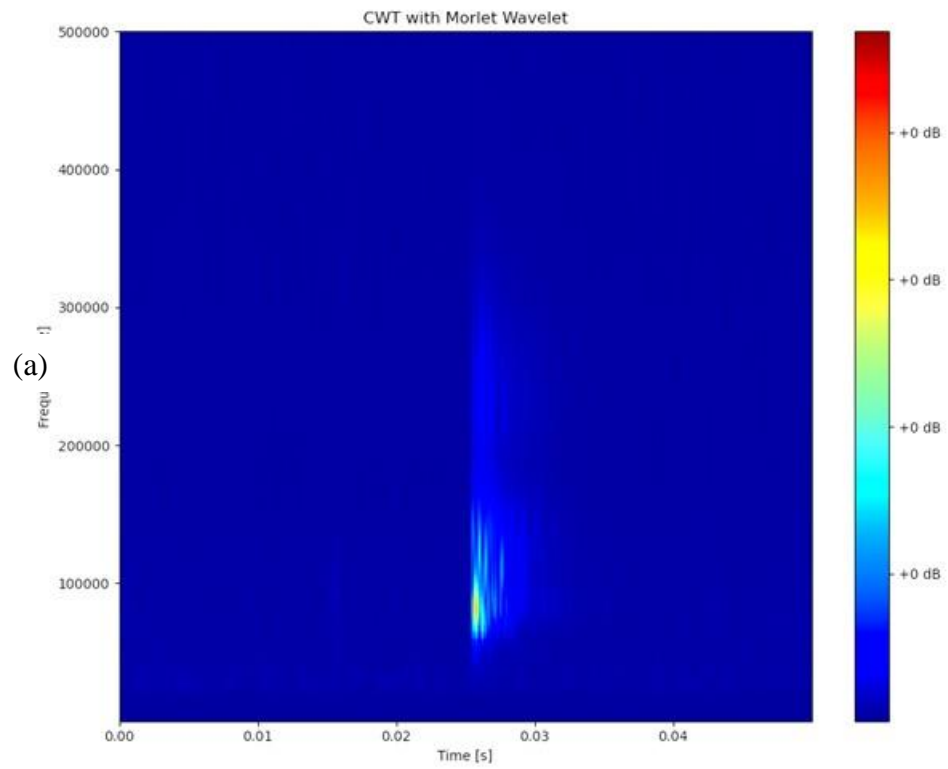
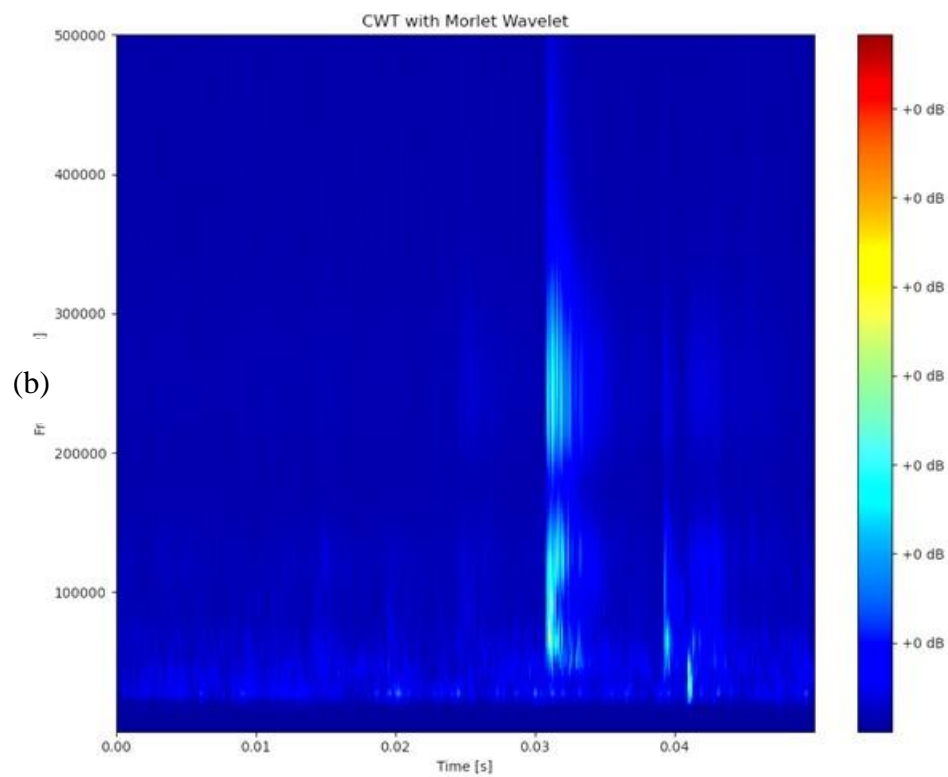
Figure 28 presents the CWT of typical impulse signals from different testing speeds involving complicated frequency distributions. While these signals generally lasted very short, the frequency range was typically distributed from 60 to 500 kHz. Meanwhile, the wave energy was primarily concentrated in the 60-150 kHz range, and a notable amount of energy was observed in the 200-300 kHz range. Similar to the conclusions of the first stage field test in Nevada, such features were observed in all the testing speeds.

**Figure 28 AE signals in RDTF tests (a) 5 mph (b) 10 mph (c) 15 mph (d) 20 mph**

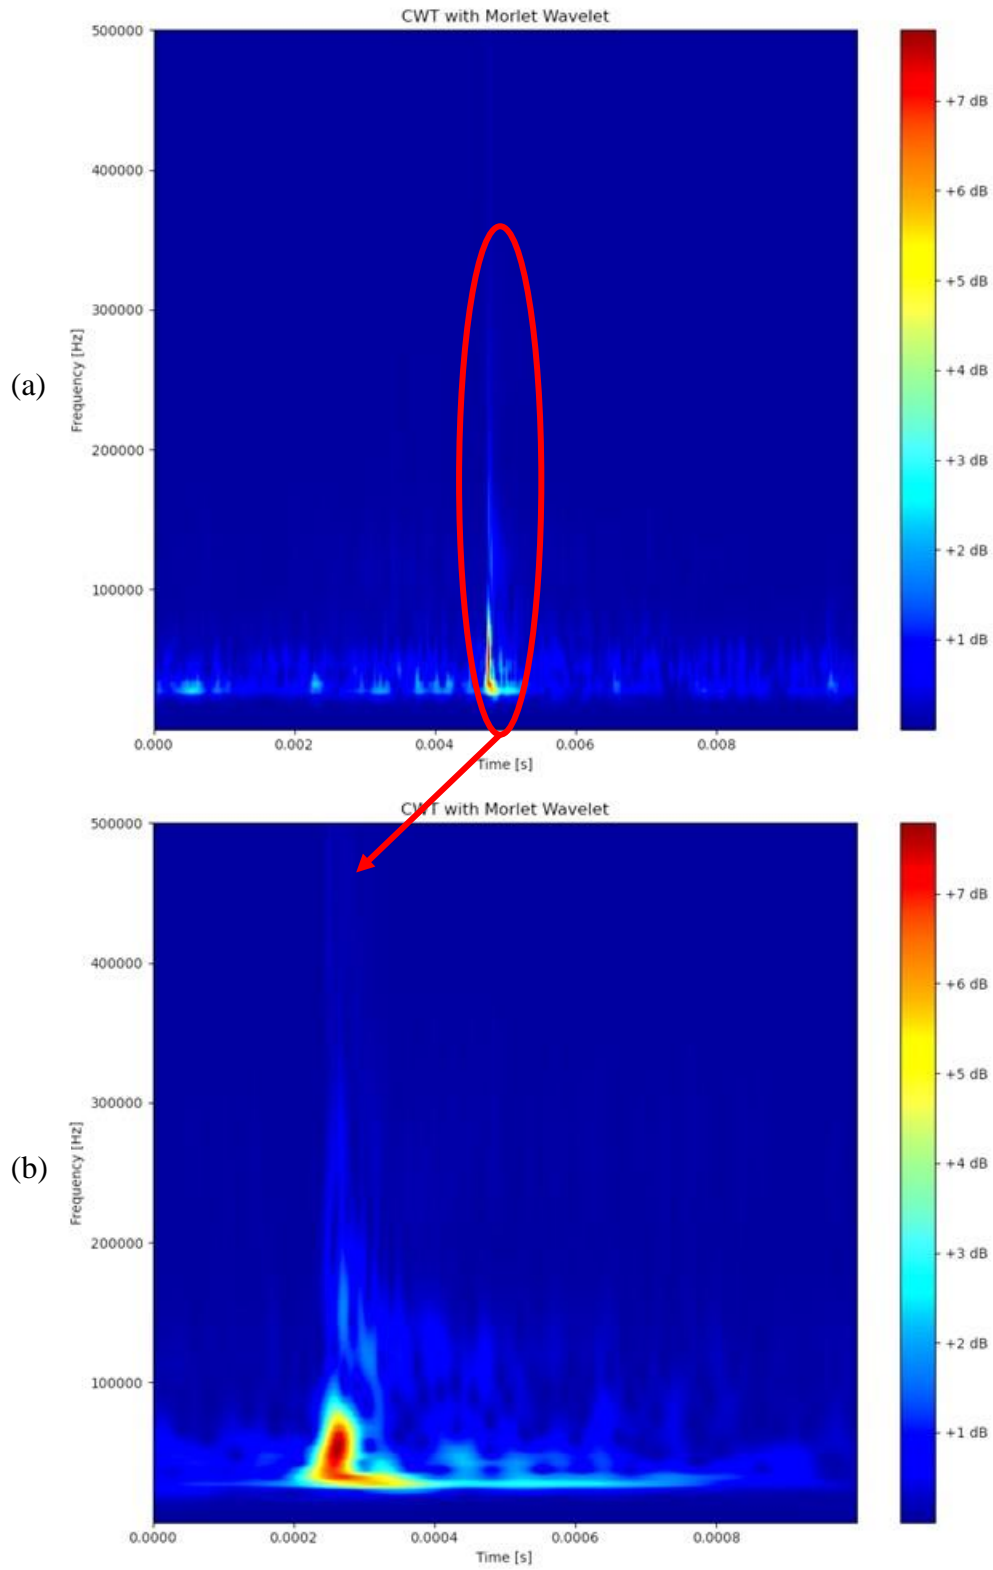
**Figure 31 Visible AE signal detected in HTL loop**

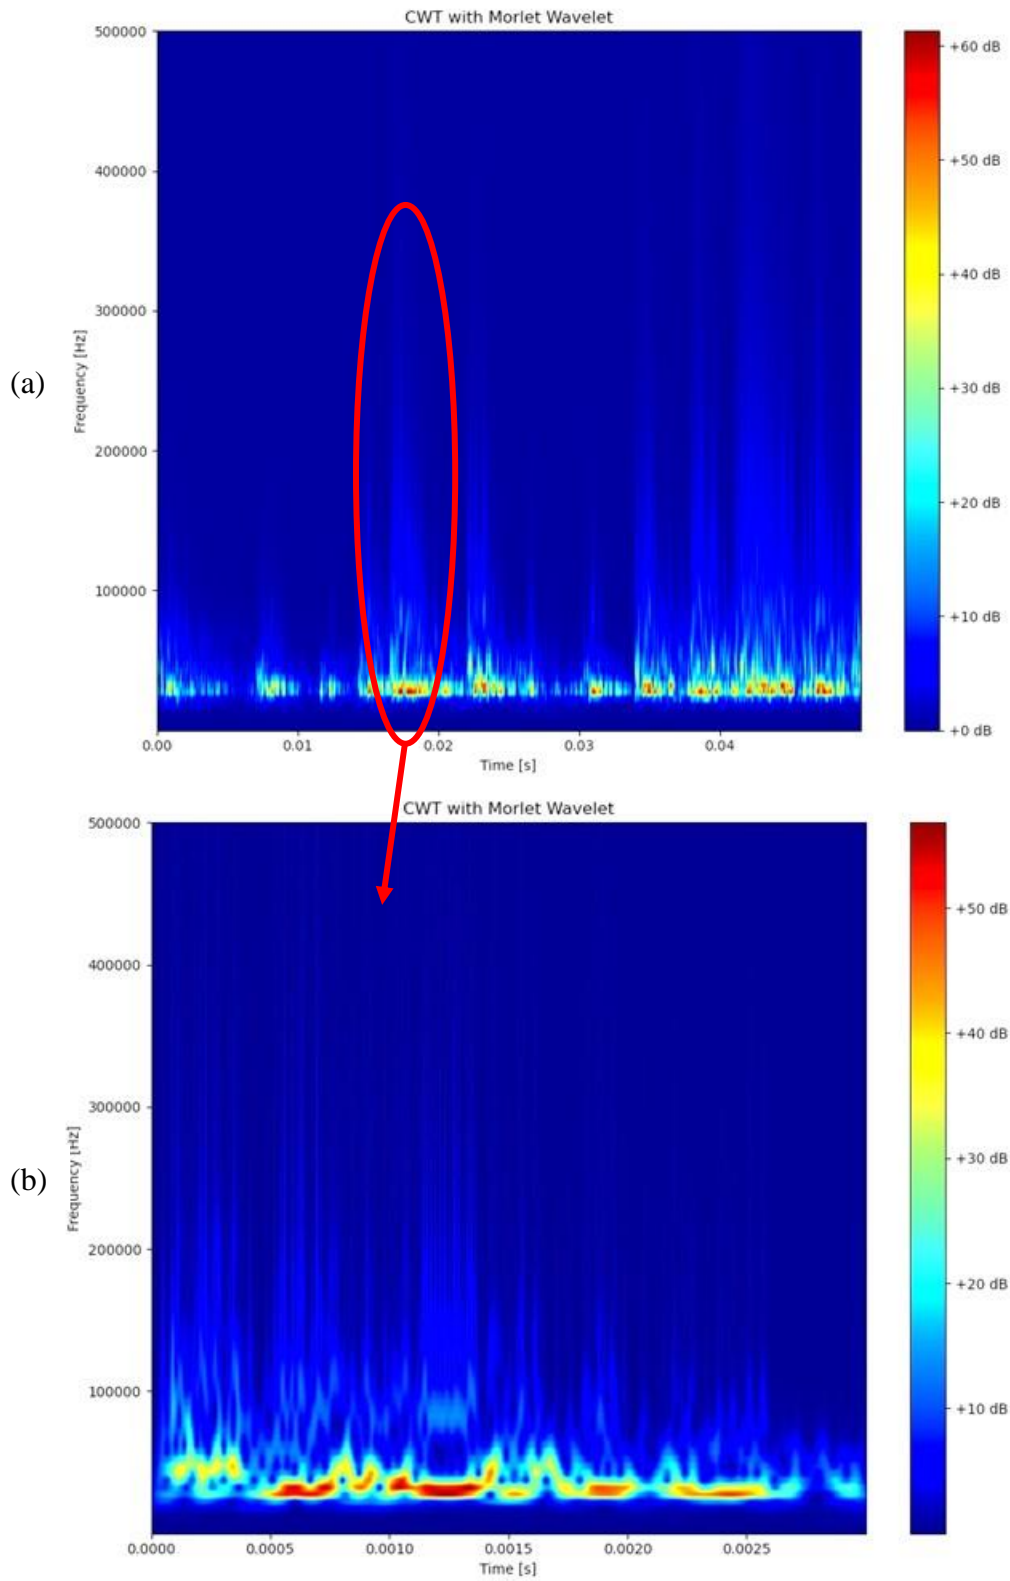
**Figure 32 Ambient noise affected signals in HTL loop**

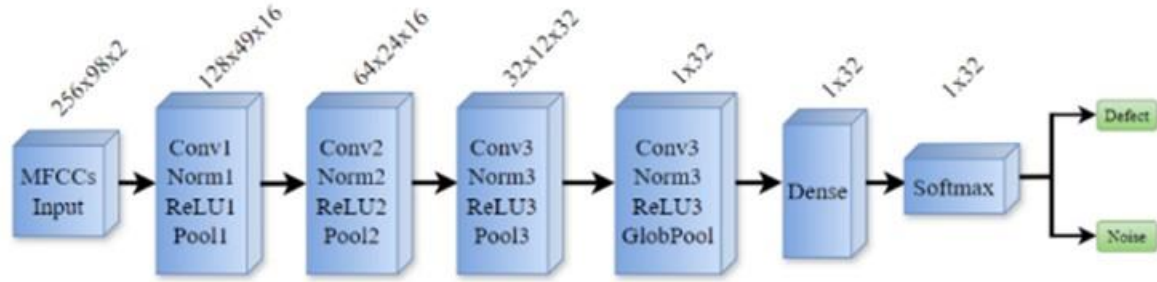
efficient learning, as shown in Figure 33. The convolutional layers progressively extract features from the input data, with the layers and the subsequent layers using various filter setups, with the consideration of optimizing the classification rate. The kernel size was set to  $3 \times 3$ . Max pooling layers with a pool size of  $2 \times 2$  followed each convolutional layer, reducing the spatial dimensions of the feature maps while retaining the most salient information. A global max pooling layer was incorporated to condense the feature maps further, followed by fully connected layers. The first dense layer had 16 units with ReLU activation, and the output layer consisted of 2 units with SoftMax activation, corresponding to the two classes in the classification task. The model was compiled with the Adam optimizer, using a learning rate  $1e-4$ , and trained with the sparse categorical cross-entropy loss function, with accuracy as the primary evaluation metric. To ensure robust performance, the model undergoes K-fold cross-validation, allowing it to be trained and validated on different data splits, providing a comprehensive evaluation of its classification capabilities. However, the data structures were modified to optimize the training performance, including revising the layer numbers, input structure, and layer filter amount.

**Figure 33 General architecture for defect classification**

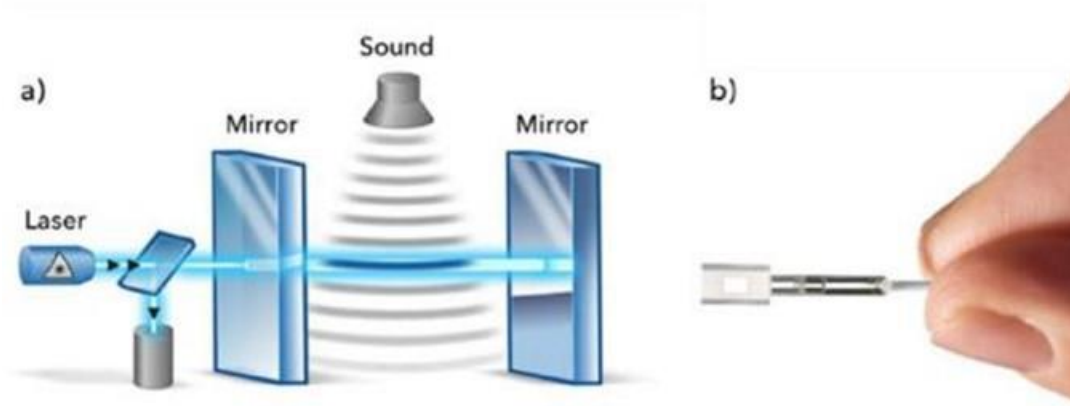
In addition to traditional piezoelectric sensors, optical microphones have gained attention for their innovative technology and superior performance in non-contact ultrasonic detection. The nature of air-coupled AE waves makes it feasible to develop non-contact sensors for detecting rail defects using this technology. As illustrated in Figure 36, when a monochromatic laser beam propagates through a medium in the presence of a sound field, it experiences slight modulation in its optical wavelength, which is proportional to the local density and, consequently, the sound pressure. The core component of the optical microphone is a miniaturized Fabry-Perot cavity, consisting of two semi-reflective mirrors. The intensity of the laser light reflected from this cavity is determined by the product of the input intensity and a transfer function. The round-trip phase shift depends on the laser wavelength and the distance between the mirrors. Therefore, any change in the laser wavelength induced by the sound field alters the light intensity, which is reflected by the cavity and can be detected by a photodiode.

**Figure 36 The optical microphone: a) mechanism. b) sensor head**

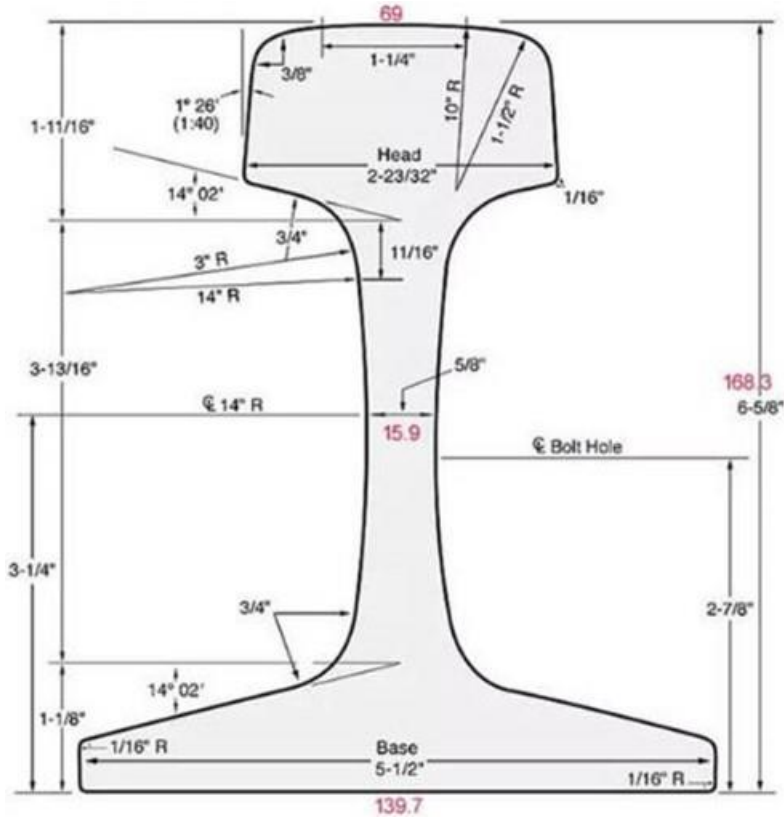
**Figure 37 Rail size of 115 Re Rail**

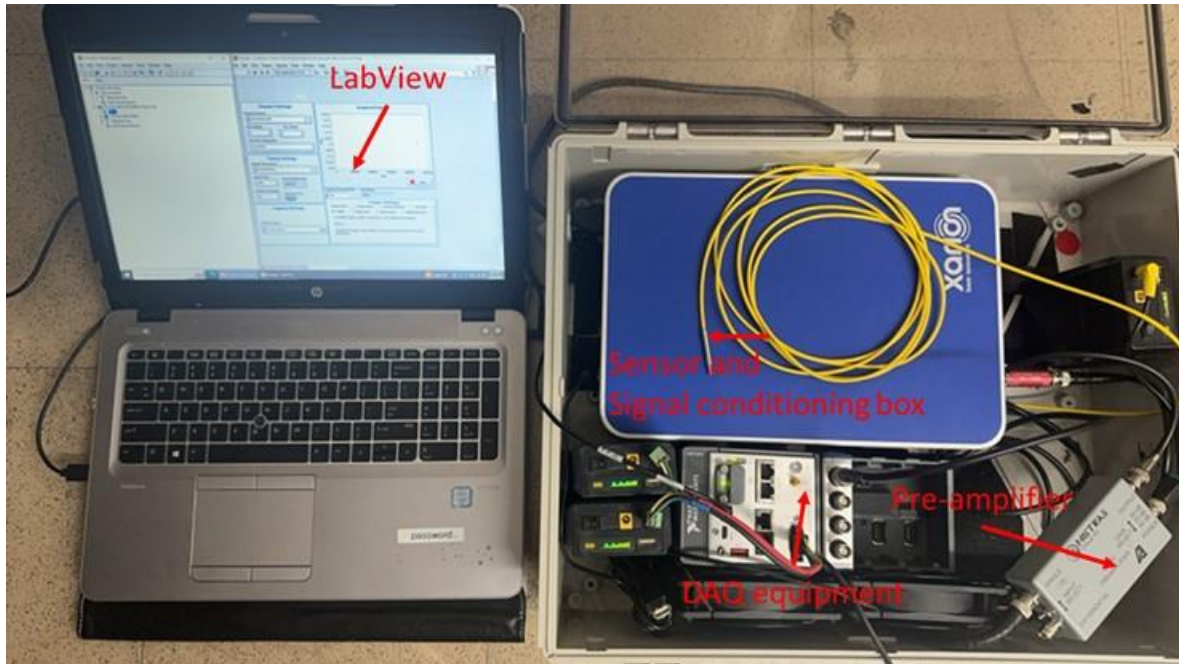
**Figure 39 DAQ system schematic**
