1. Report No. RailTEAM UNLV-3	2. Government Accession No.	3. Recipient's Catalog No.	
4. Title and Subtitle Non-Contact Acoustic Emission Approach for Rail Health Monitoring		5. Report Date July 2024

Final Report UNLV-3

## **NON-CONTACT ACOUSTIC EMISSION APPROACH FOR RAIL HEALTH MONITORING**

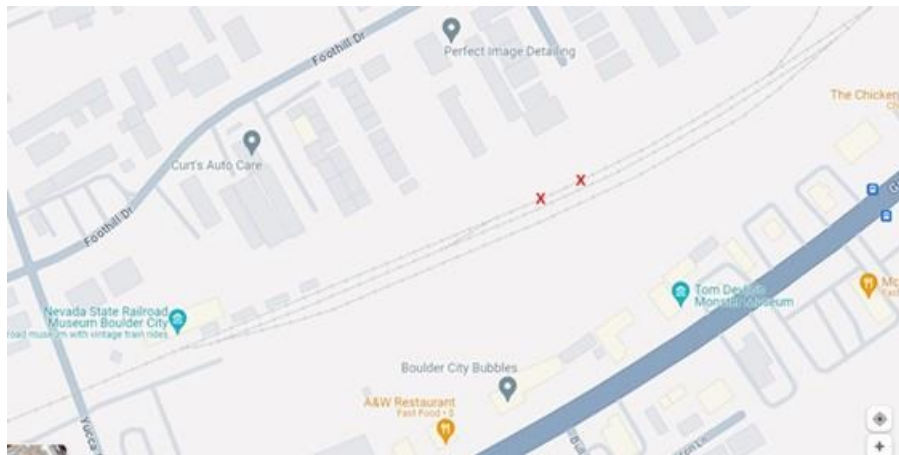
**Figure 40 Location of two Internal defects in the Nevada Railroad Museum**

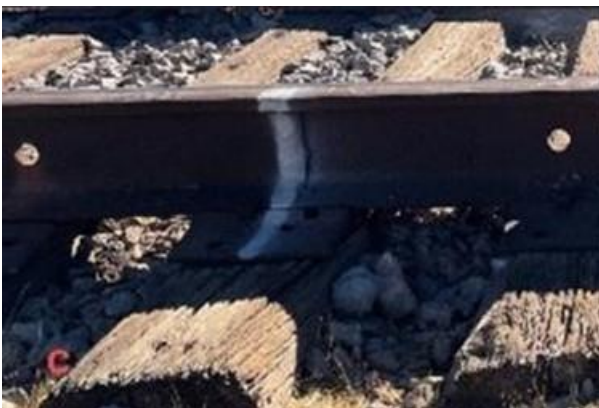
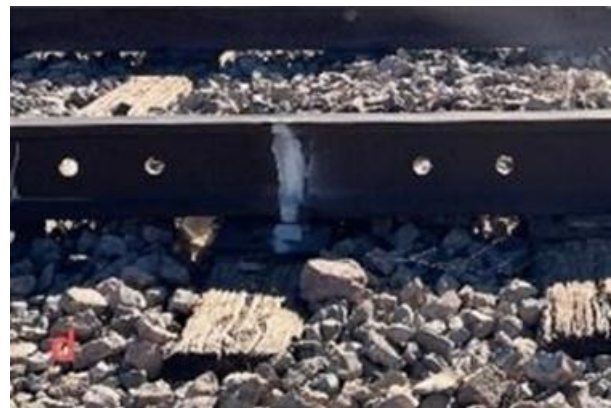
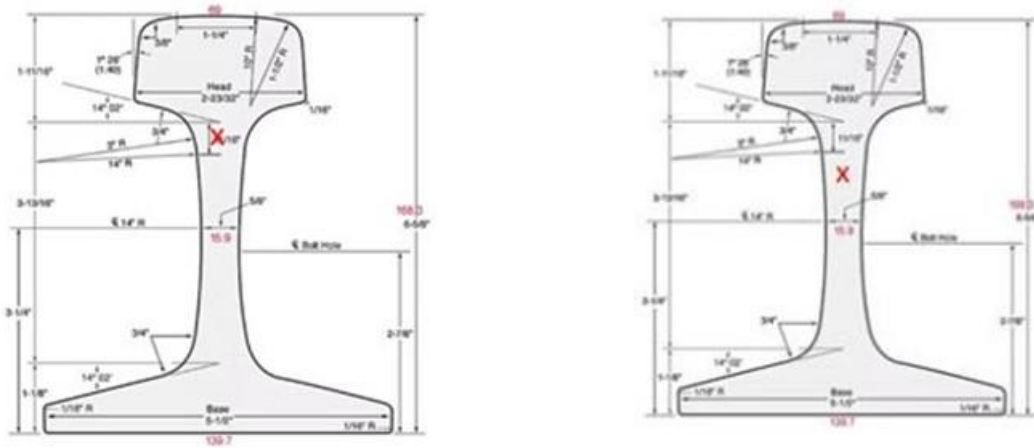
**Welding defect: 0.3 in \* 0.3 in. Location:  
1.9 inches below the surface**

**Welding defect: 0.2 in \* 0.3 in. Location:  
2.5 inches below the surface**

**Figure 41 Internal defect location and size**

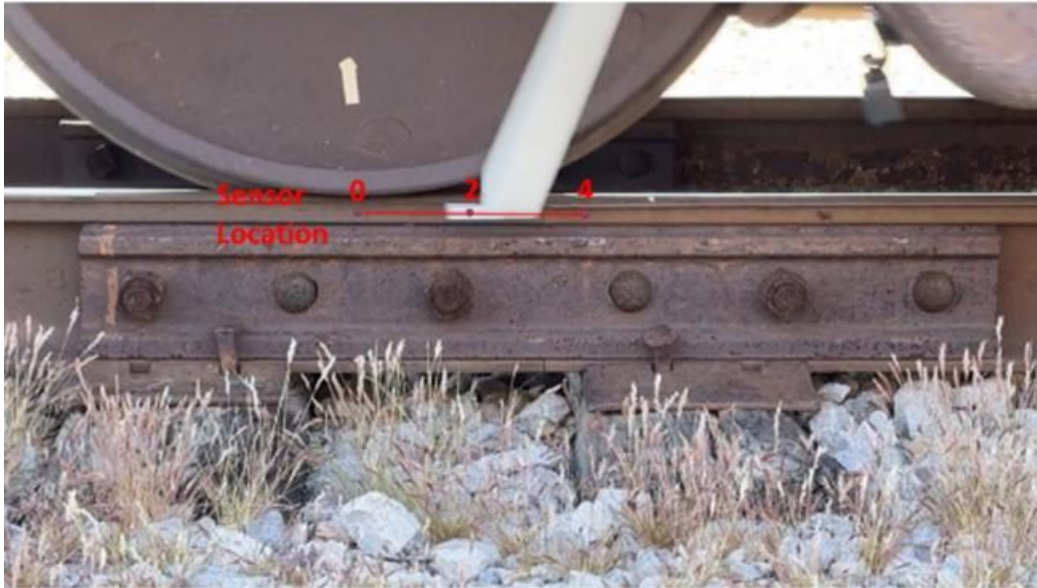
**Figure 45 Attenuation evaluation in the rail (longitudinally)**

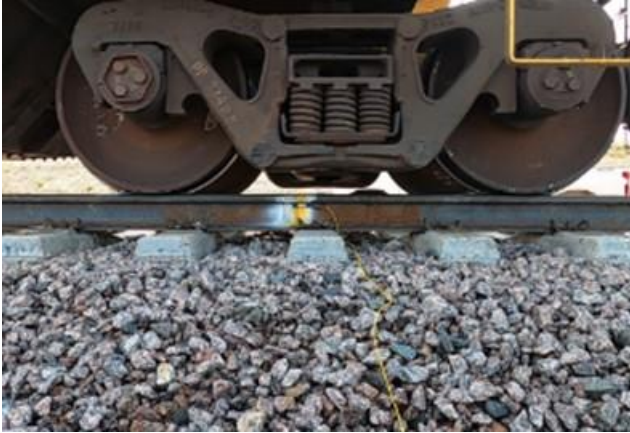
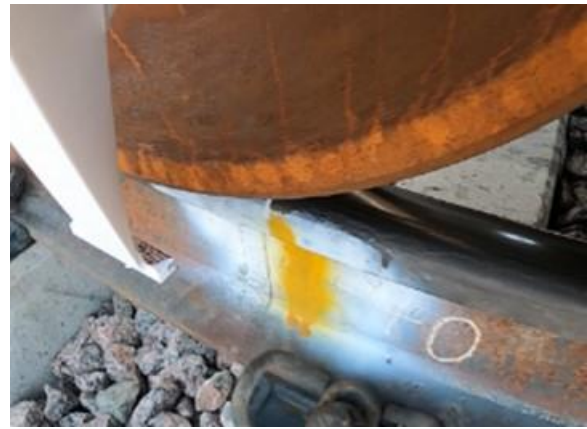
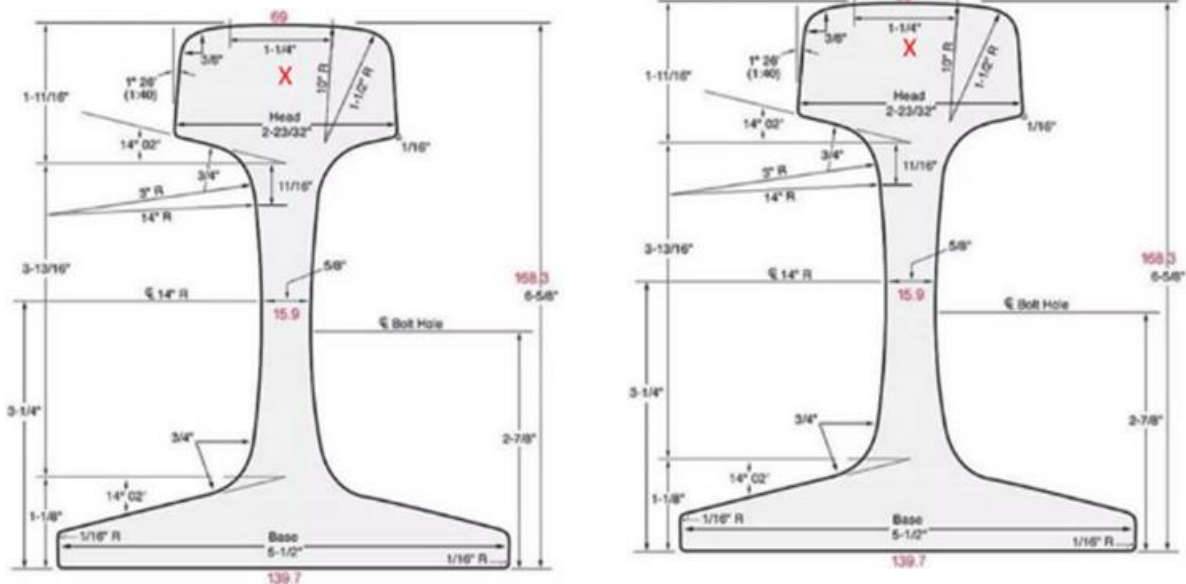
The rail-mounted field test used two naturally generated internal defects shown in Figure 46. Their detailed information as to the defect size and location were provided by MxVRail. The larger defect measured 0.8 inches by 0.6 inches and was situated 0.7 inches below the top surface, indicating that it was in the late stage of development. In contrast, the smaller defect, measuring 0.3 inches by 0.3 inches and located 0.6 inches below the top surface, was still in the early stage of development.

**Welding defect 1: 0.8 in x 0.6 in. Location:  
0.7 inches below the surface**

**Welding defect 2: 0.3 in x 0.3 in.**  
**Location: 0.6 inches below the surface**

### Figure 46 The internal defects

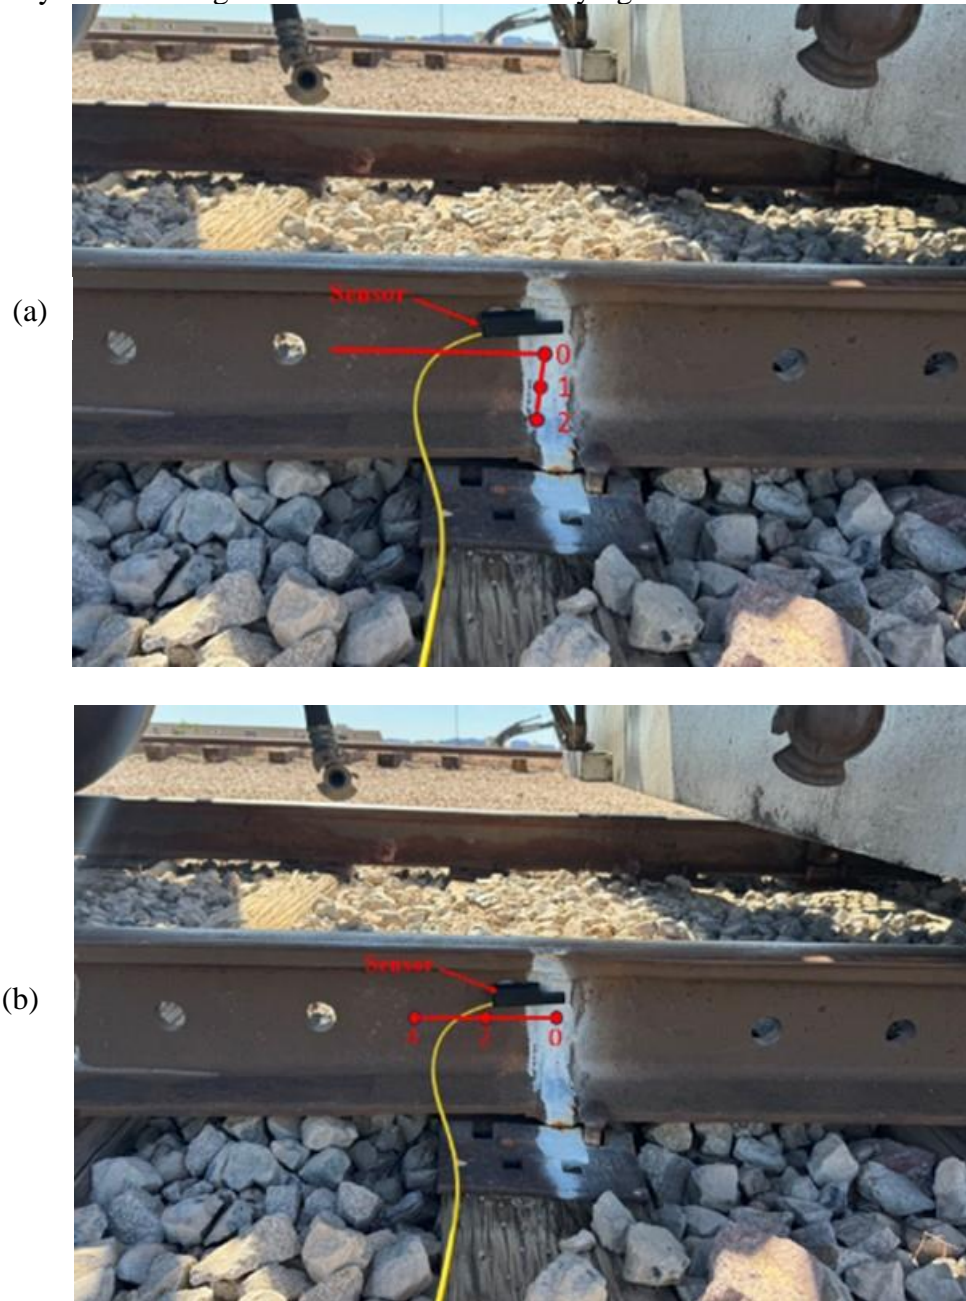
**Figure 47 Attenuation evaluation a) vertically in the air; b) longitudinally in the rail**

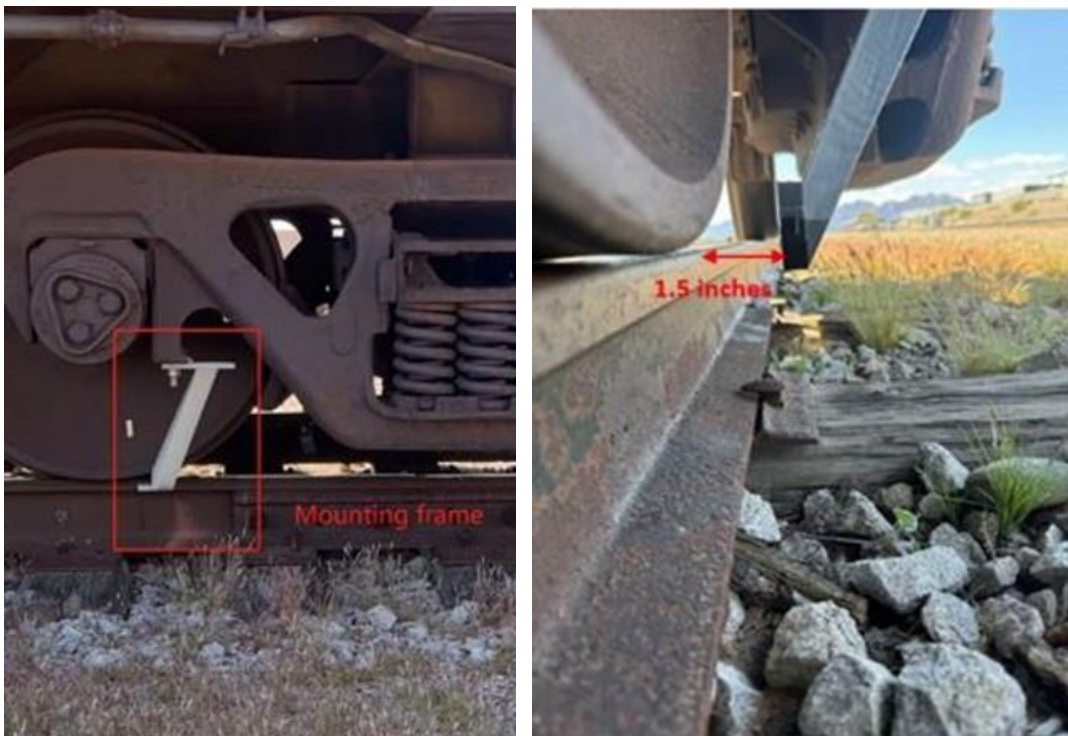
In this testing scenario, the sensor was installed the same way as in the museum test. It was installed on the train's mounting frame, and the acoustic signals were recorded when the train was running over defects (Figure 48). The sensor was designated to be safely placed 1.5 inches away from the rail head side. As in previous tests, the sensor was relocated from its original position to the far side of the defect by moving it from 0 to 4 inches at two inches increment (Figure 49).

Figure 48 Mounting frame (front and side views)

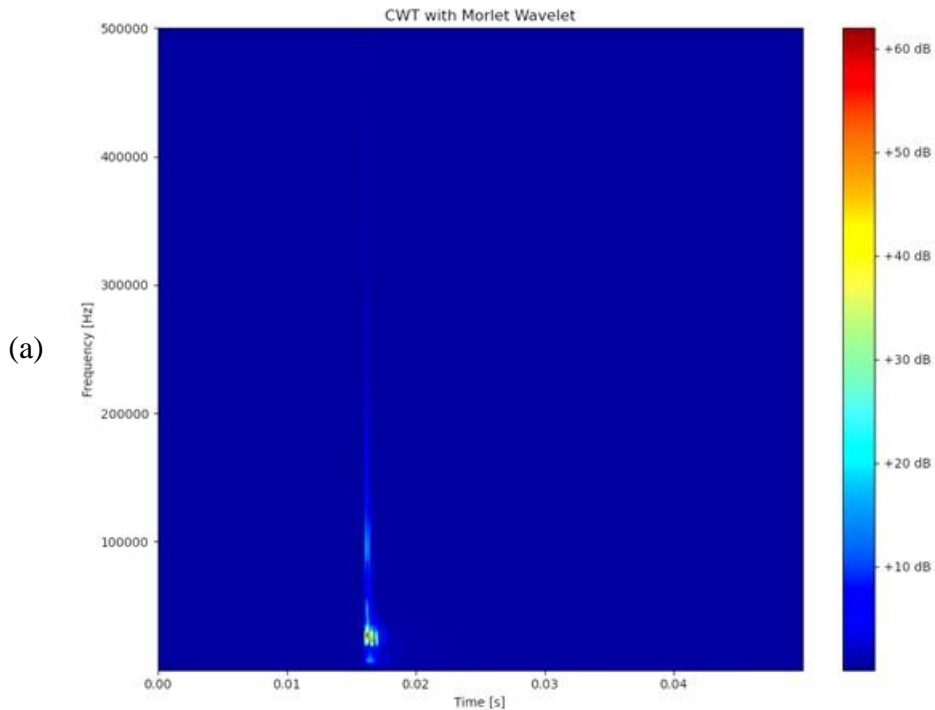
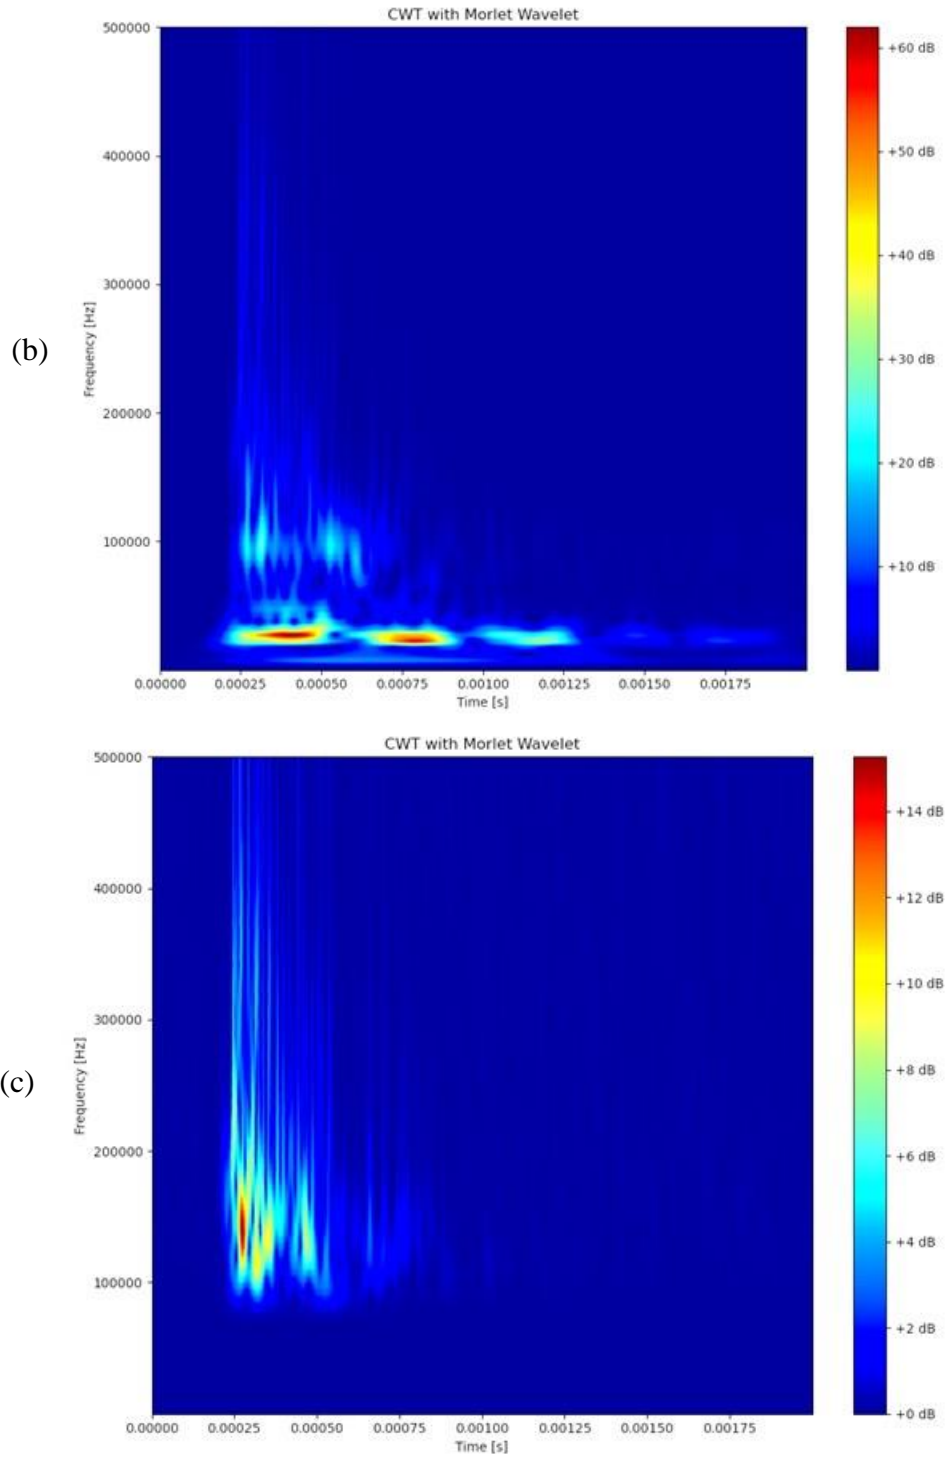
**Figure 50 CWT of PLB signal (a) overview (b) 20 kHz filter (c) 100 kHz filter**

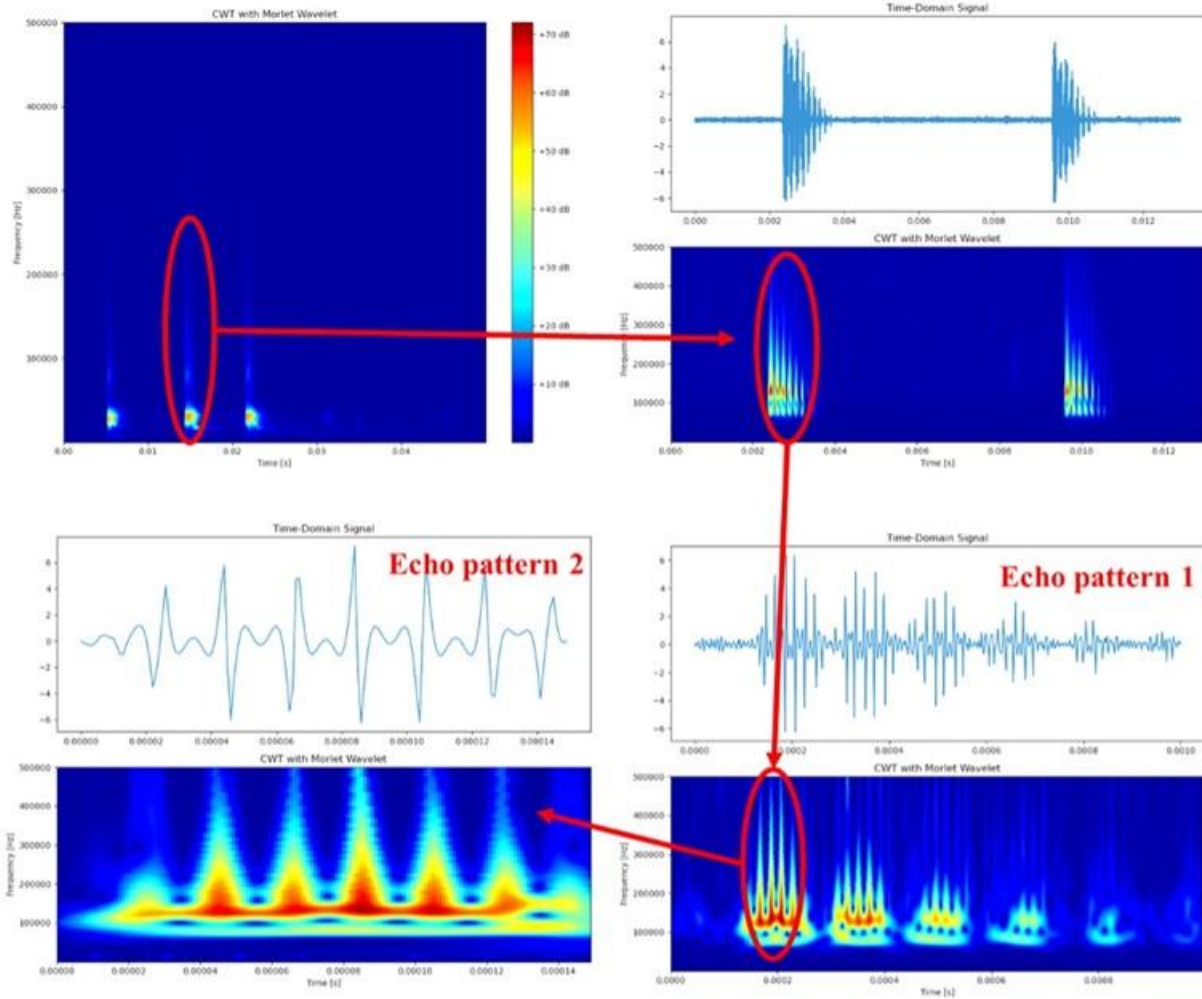
Moreover, distinctive pulse sequences were observed at two-time scales, particularly in Figure 52 (c), where the signal attenuation is gradual, and each pulse indicates a pattern of energy concentration in the center. Figure 53 provides a detailed view of these burst patterns across the two-time scales. It is important to note that these repetitive patterns were not observed across all AE sources; they were not observed in PLB signals and were significantly less frequent in AE signals from the small rail defect than the large defect observed in MxV Rail tests.

**Figure 53 Echo patterns in two time scales**

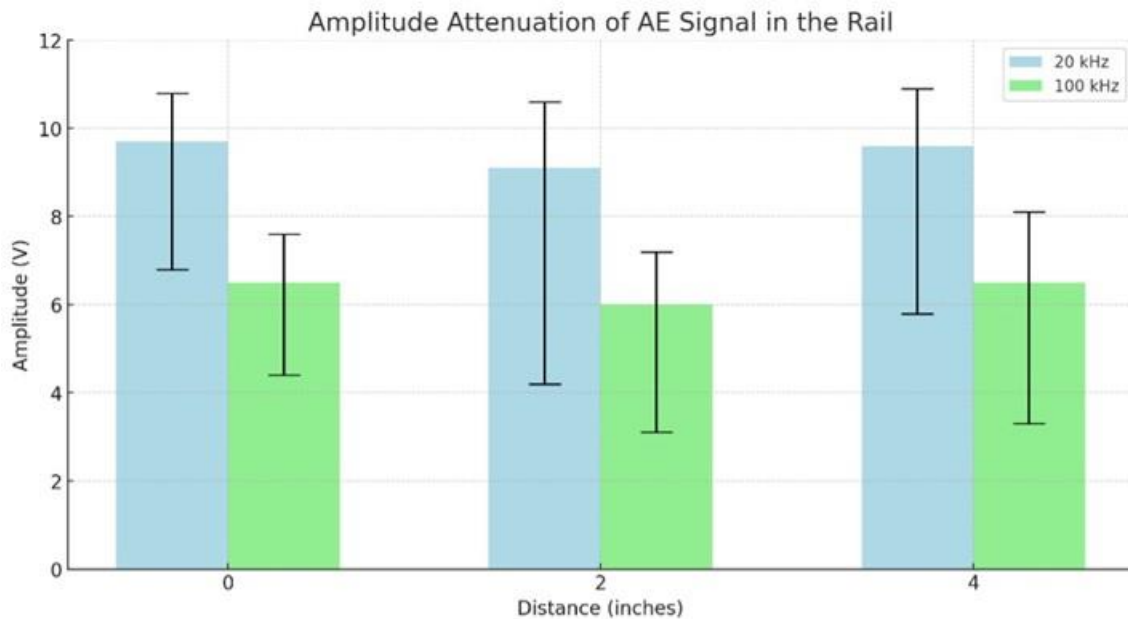
As to the real-world on-rail test, the amplitude attenuation of AE signals in both the air and the rail indicate the challenges of capturing only useful AE signal data in real-world scenarios compared to controlled laboratory PLB tests (Figure 56 and Figure 57). As stated above, the PLB tests typically demonstrate a clear attenuation of signal amplitude as the distance increases, reflecting a predictable decrease in energy due to propagation losses. However, in real-world field tests, this pattern is not as evident. In the attenuation plot in the rail scenario, it indicates that there is no obvious attenuation of the AE signals, with the amplitudes remaining relatively stable or even slightly increasing. This was caused by the complicated and noisy environment of real-world conditions, where numerous factors such as strong wheel-rail impact noise contribute to signal variability.

**Figure 56 Amplitude Attenuation of AE Signal in the Rail**

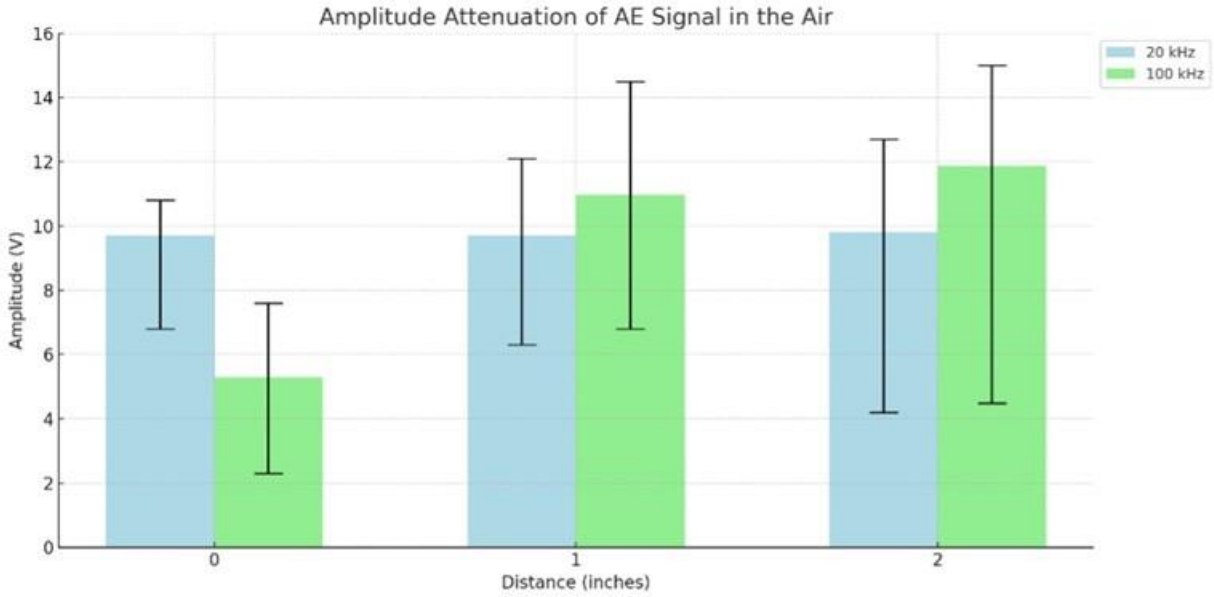
**Figure 57 Amplitude Attenuation of AE Signal in the Air**

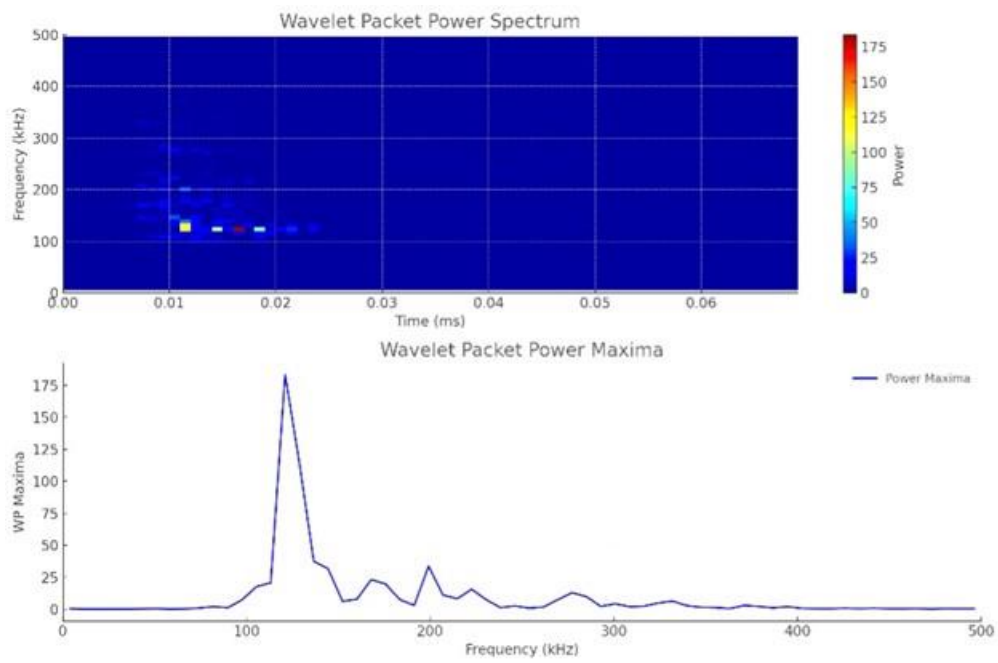
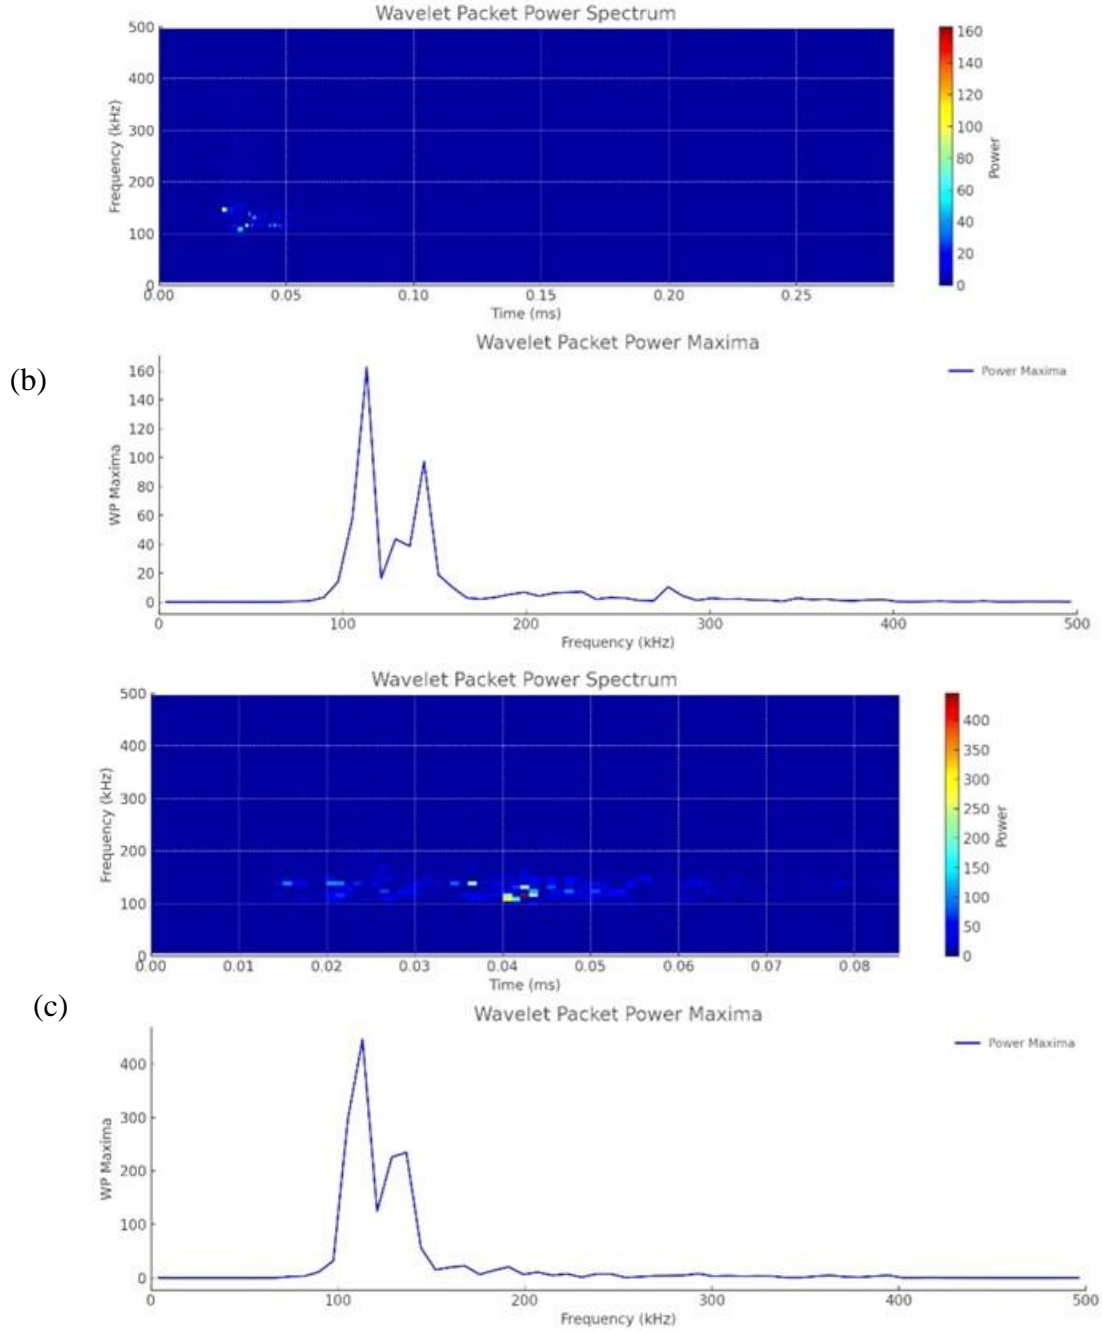
While both PLB and rail defect signals present a common presence of lower frequency components, the rail defect AE signals are characterized by more evident and localized peaks, suggesting more severe energy releases. This difference features the importance of detailed frequency analysis in the 50-150 kHz range for distinguishing between AE sources. The increased power levels and distinct peak patterns in rail defect signals emphasize the potential of using these AE characteristics for effective defect monitoring and diagnosis in rail systems.

**Figure 59 WPP spectrum and maxima of defect-induced AE signals**

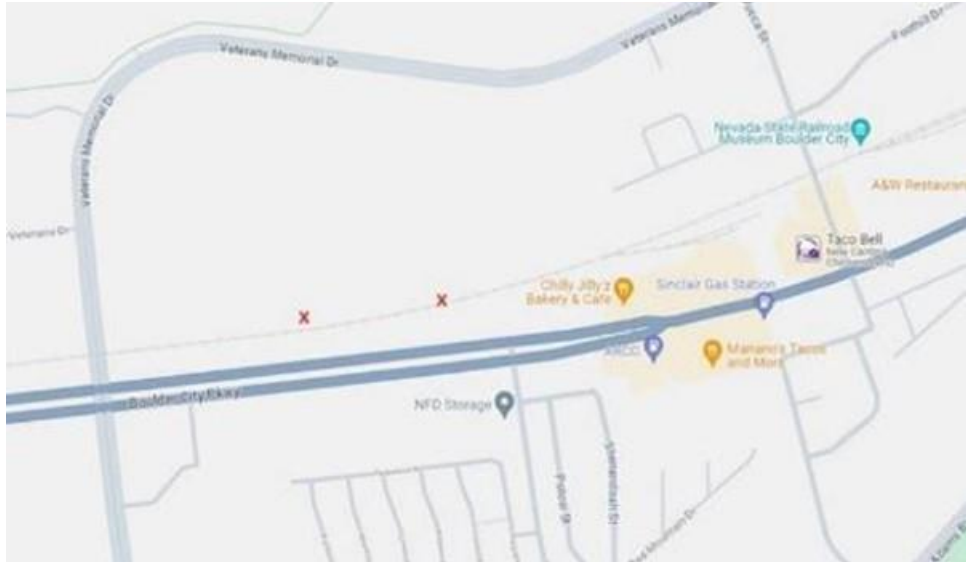
The field test configuration was the same as in Chapter 4.4.1; an unloaded hopper car with an axle load of approximately 70,000 lb. was employed. The tests were conducted at 5 mph. A GoPro camera was installed near these defect sites to record when the wheel passed over the defects. A hammer hit was used to synchronize the timeline between the video and the signals, allowing accurate synchronization of video and AE signal timestamps and ensuring a detailed analysis of AE events and associated noises.

**Figure 60 Location of two external defects in the Nevada Railroad Museum**

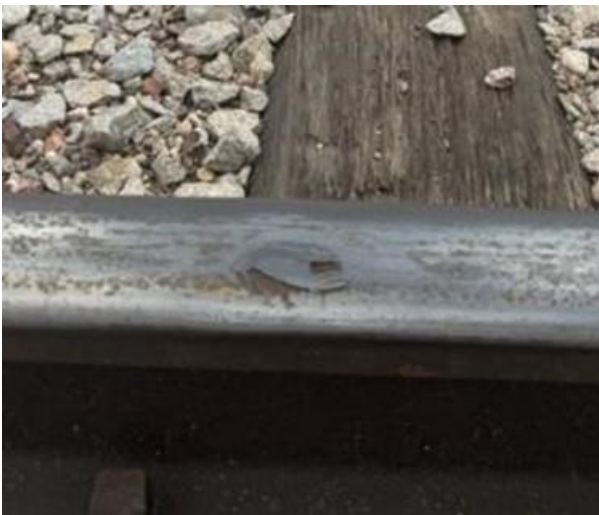
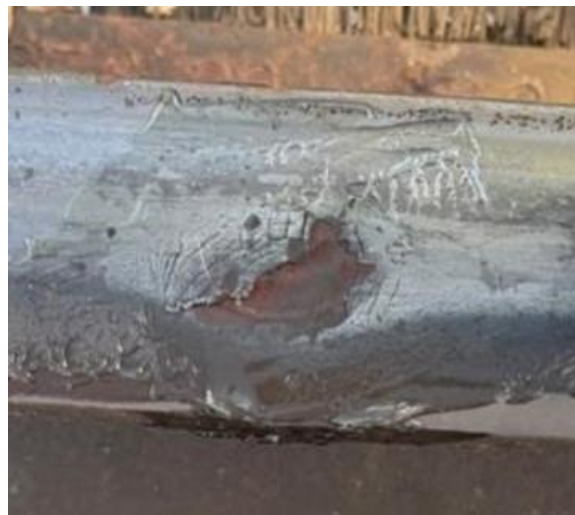
**Surface defect: 1.3 in \* 0.7 in**

**Surface defect: 1.2 in \* 0.5 in**

### Figure 61 External defect location and size

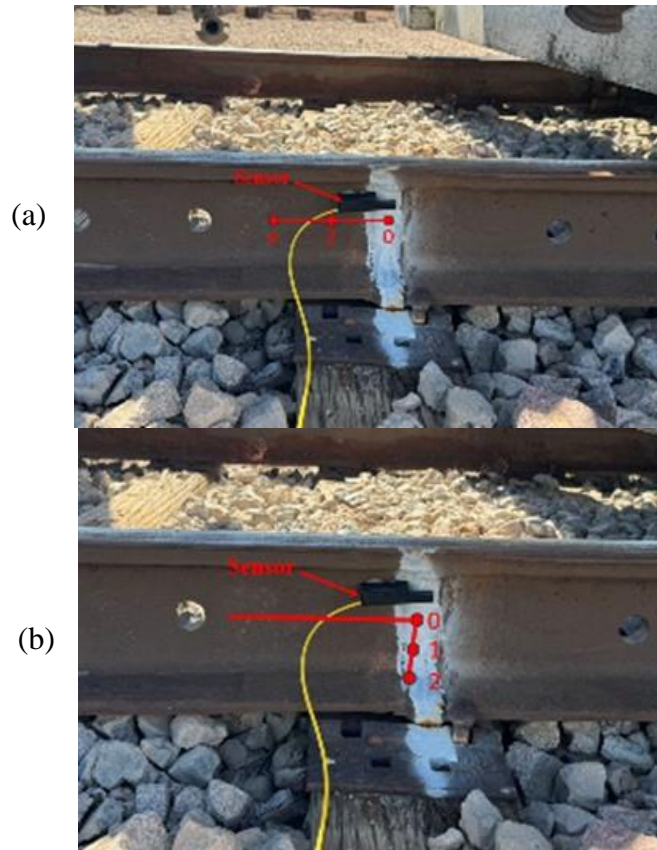
**Figure 62 Attenuation evaluation a) vertically in the air b) longitudinally in the rail**

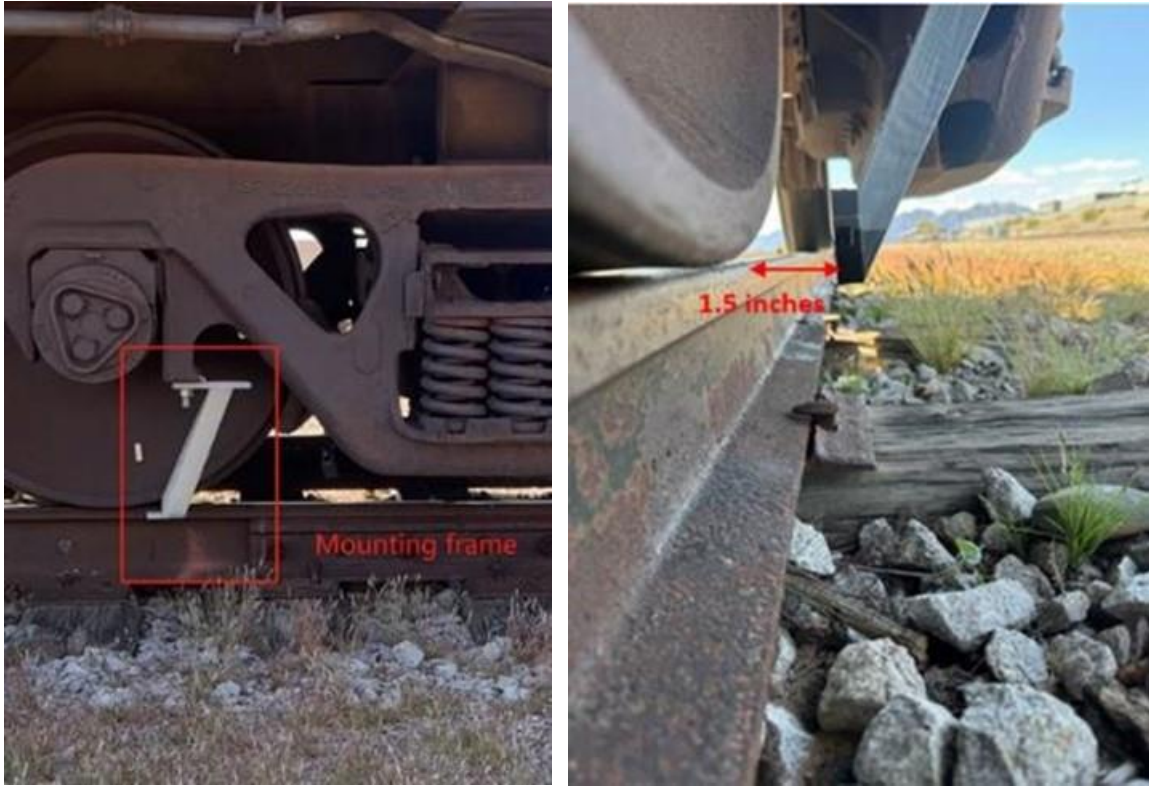
In this testing scenario, the sensor was installed the same way as previous on-vehicle tests. It was installed on the train's mounting frame, and the acoustic signals were recorded when the train was running over defects (Figure 63). The sensor was designated to be safely placed 1.5 inches away from the rail head side. As in previous tests, the sensor was relocated from its original position to the far side of the defect by moving it from 0 to 4 inches at two inches increment (Figure 64Figure 49).

**Figure 63 Mounting frame (front and side views)**

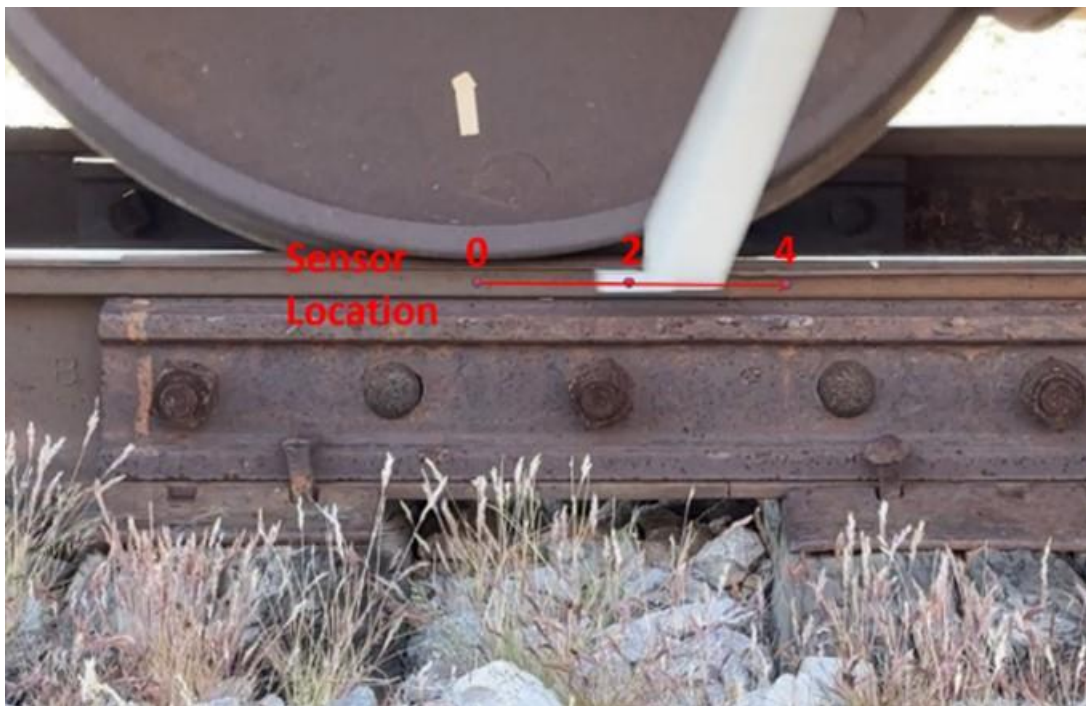
**Figure 64 Attenuation evaluation in the rail (longitudinally)**

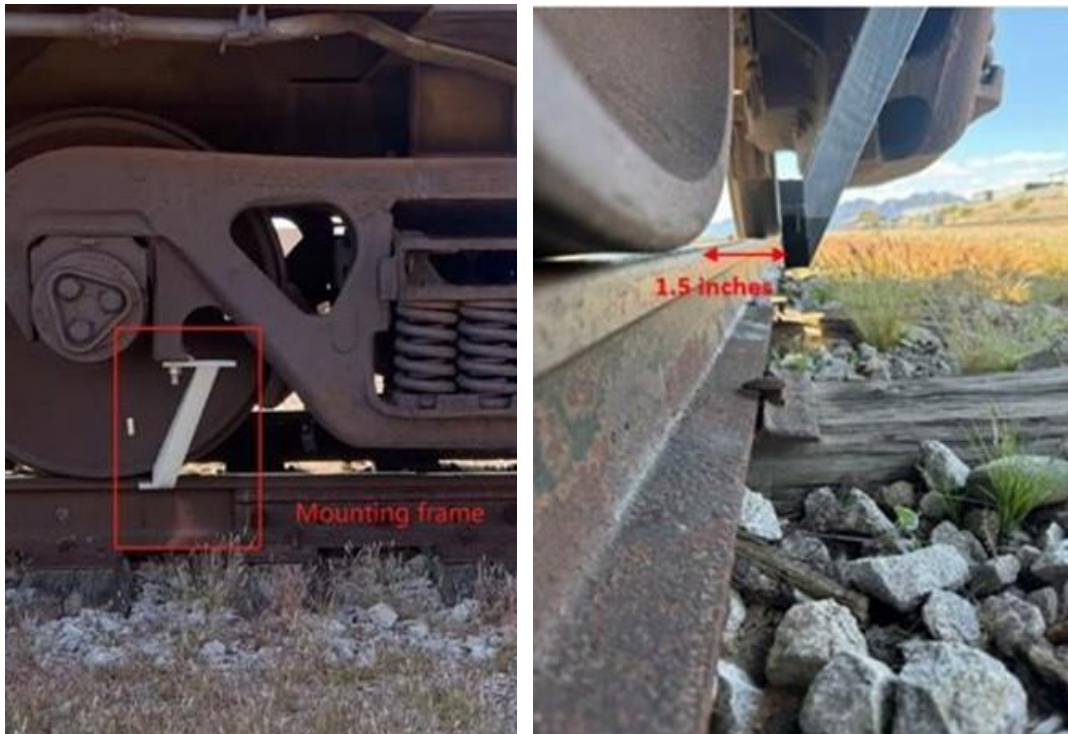
In this testing scenario, the sensor was installed the same way as the above museum test. It was installed on the train's mounting frame, and the acoustic signals were recorded when the train was running over defects (Figure 65). The sensor was designated to be safely placed 1.5 inches away from the rail head side. As in previous tests, the sensor was relocated from its original position to the far side of the defect by moving it from 0 to 4 inches at two inches increment (Figure 66).

**Figure 65 Mounting frame (front and side views)**

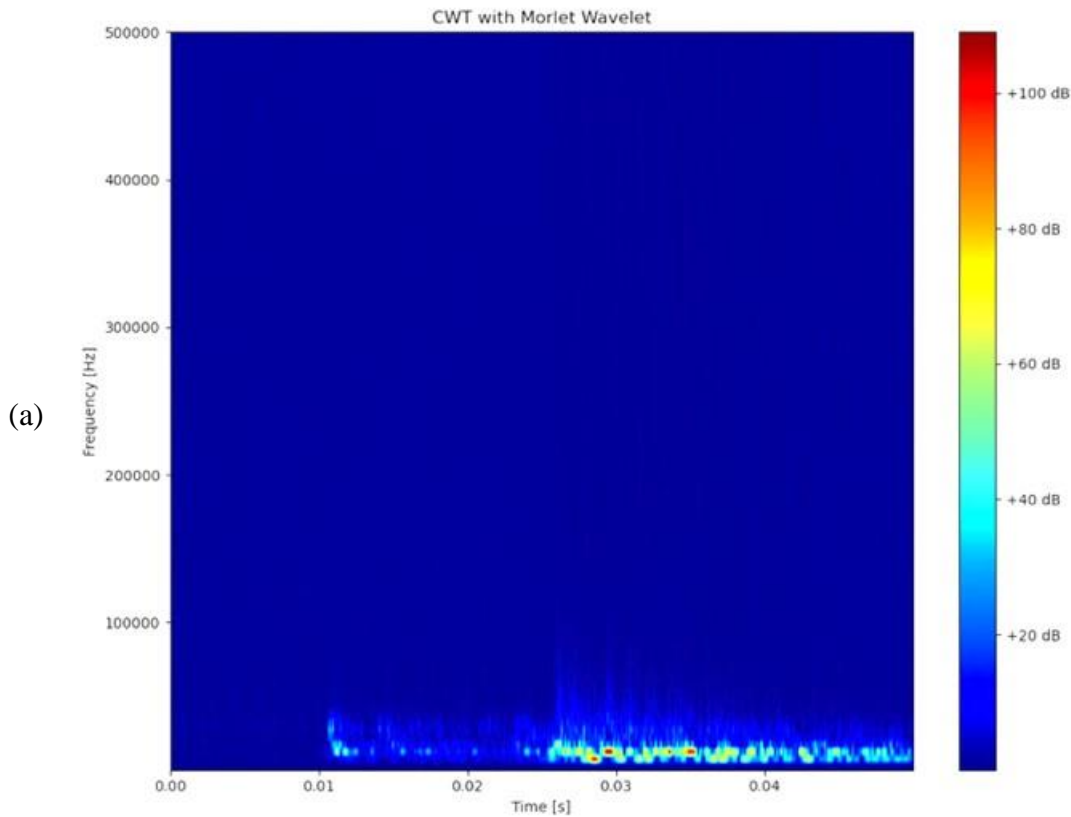
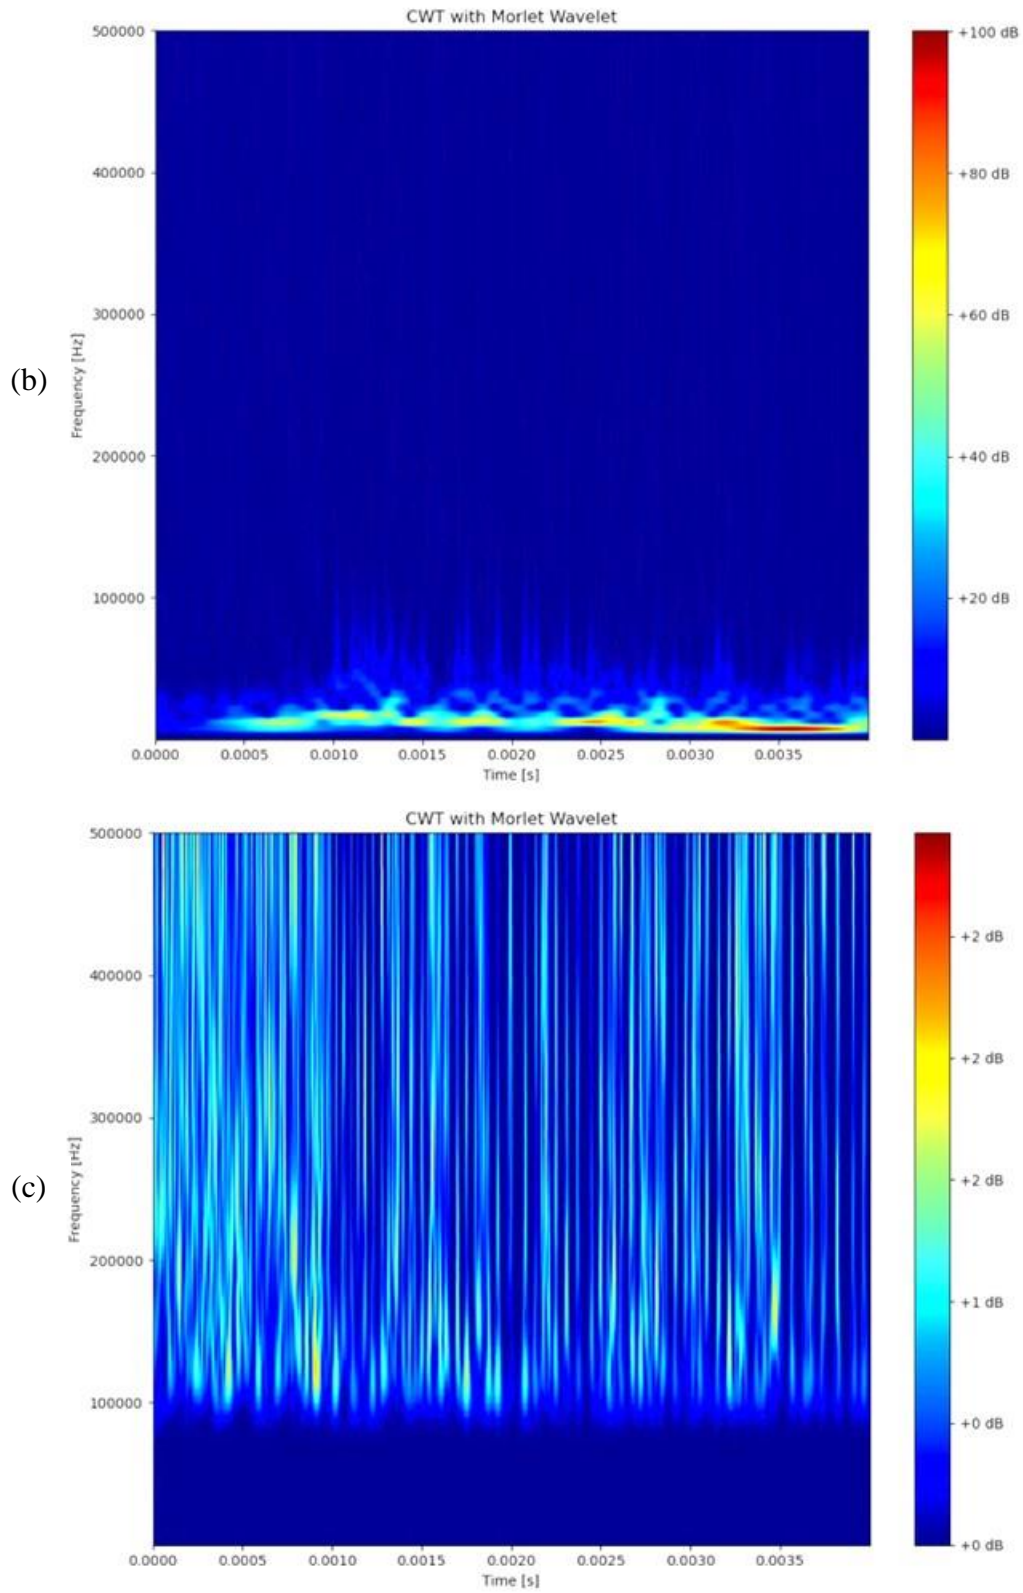
The AE signals collected from defect areas during real-world field tests were analyzed using CWT. Unfortunately, the CWT analysis of the Nevada field test data did not indicate the presence of AE signals. As shown in Figure 67, the tests predominantly captured low-frequency mechanical vibrations throughout the entire testing period. In the MxVRail field test, only two AE events were detected by the sensor during the examination of external defects, as illustrated in Figure 68 and Figure 69. The observed pattern was consistent with previous observations, with low-frequency components dominating the energy spectrum and a notable energy peak concentrated in the 120-150 kHz range. Several factors could account for these observations. One possibility is that the external defects in Nevada were in stable conditions, making it challenging to detect AE signals associated with active crack growth. Another possibility is that the defect in the MxVRail test was in its very early stages, which hardly producing AE signals. However, additional field tests are necessary to further assess the feasibility of detecting external defects under real-world conditions and to validate the effectiveness of AE signal analysis in these environments.

**Figure 67 CWT of AE in Nevada (a) overview (b) 20 kHz filter (c) 100 kHz filter**

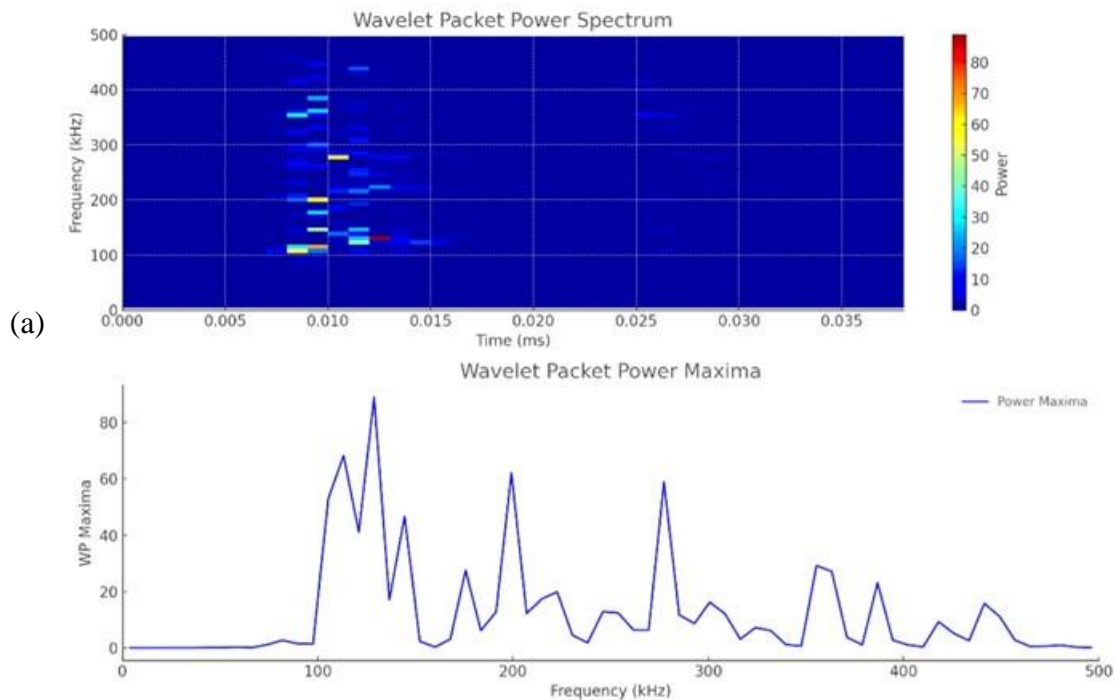
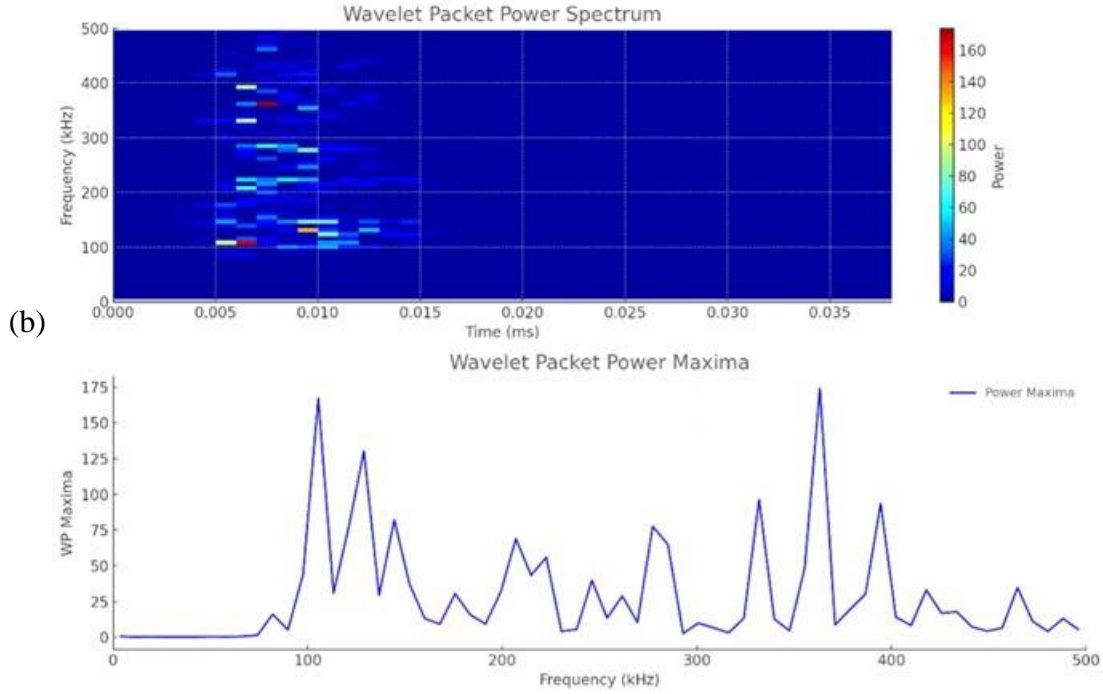
Although the field tests in this chapter did not detect significant amount of AE signals as previous chapter. It is still necessary to investigate the AE events captured in MxVRail. Based on the introduction of WPT-based power analysis from chapter 4.6.3, the WPP calculations used the two signals collected at 0 inch for the MxVRail surface defects. A high-pass filter with a cutoff frequency of 100 kHz was applied to all the data to better evaluate the AE characteristics in high-frequency range. As shown in Figure 70, the WPP spectrum and maxima present the typical energy distribution of signals collected from field tests. The power spectra indicate that the energy is concentrated within the 100 kHz to 400 kHz frequency range, typically three energy peaks around 100-140 kHz, 200 kHz, 280 kHz, and 360 kHz. These frequency peaks are observed in both plots, suggesting common features likely related to the AE characteristics of the external rail defects.

**Figure 70 WPP spectrum and maxima of defect-induced AE signals**
