1. Report No. RailTEAM VT-6	2. Government Accession No.	3. Recipient's Catalog No.	
4. Title and Subtitle Methods for Qualitative and Quantitative Measurement of Top of Rail Friction Modifiers (TORFM) in Revenue Service		5. Report Date September, 2022

Final Report VT-6

**METHODS FOR QUALITATIVE AND QUANTITATIVE MEASUREMENT OF TOP
OF RAIL FRICTION MODIFIERS (TORFM) IN REVENUE SERVICE**

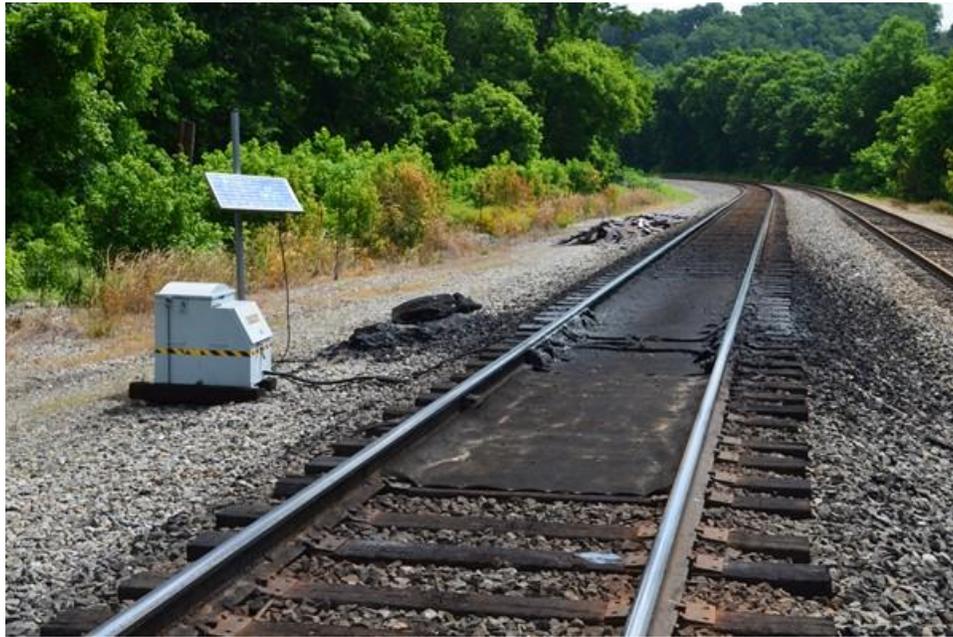
Figure 1-1: A gage face wayside applicator applies flange grease to the gage corner of the rail and the wheel flanges of passing wheels.

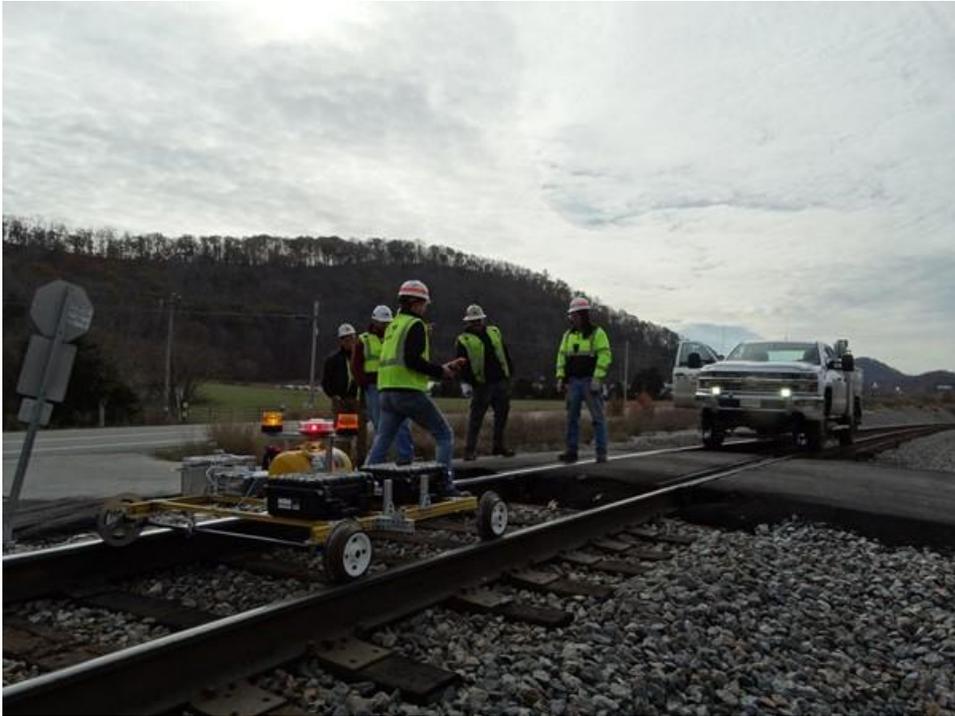
Figure 1-4: Remote Control (RC) Rail Cart and Third Generation Rail Lubricity Sensor setup on track and ready to begin field testing on revenue service track

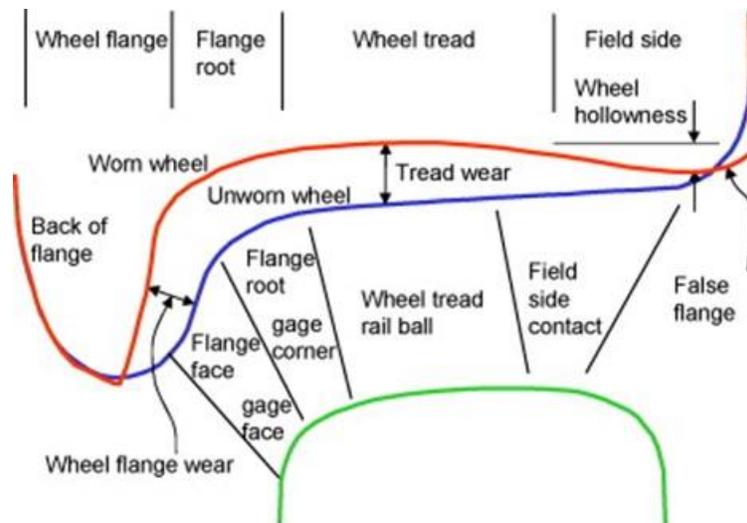
The wheel rides along the top of the rail as shown in the figure below. A wheel flange is inside the track gage to keep the wheelset on the rails. The primary load is supported by the wheel tread on the running surface of the rail. Over time this wears as shown by the red line compared to the new, unworn wheel profile in blue.

Figure 2-3: Worn and unworn wheel profiles [17]

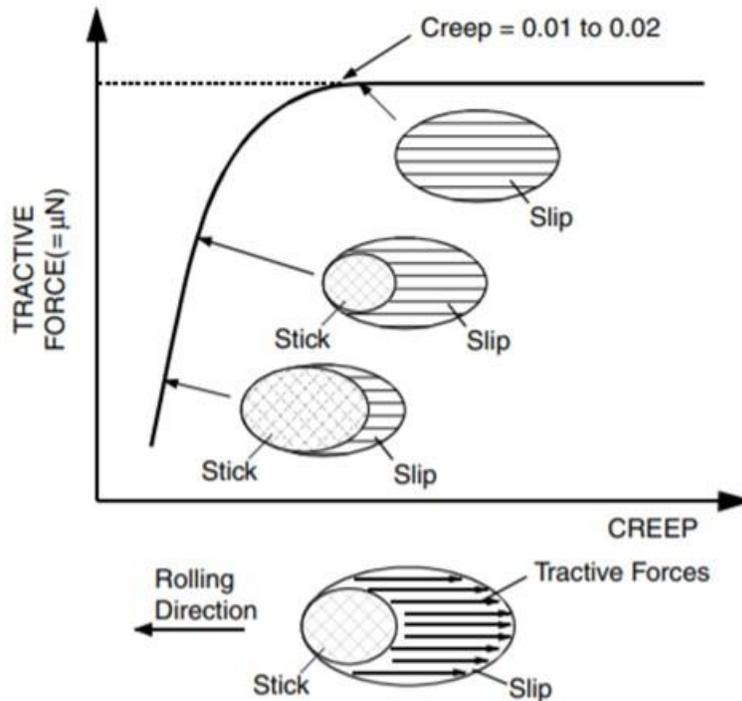
lost would be the result of incremental slippage at the contact patch. The ratio of stick to slip decreases until pure slipping takes over. At this point the behavior is driven by pure Coulomb friction of two bodies sliding past each other. Any point between pure rolling and full slip contact is an amalgam of those two contact behaviors and affects the shape of the contact patch [5].

Figure 2-7: Plot of Tractive Forces vs Creep and Stick/Slip regions of rolling contact [19]

The figure and example above is in terms of longitudinal creep forces but lateral creep forces and spin creep forces also occur during the lateral shift of wheelsets into curves. For the context of this study, it is important to understand that increasing amounts of creep result in higher amounts of wheel and rail wear at the top-of-rail surface.

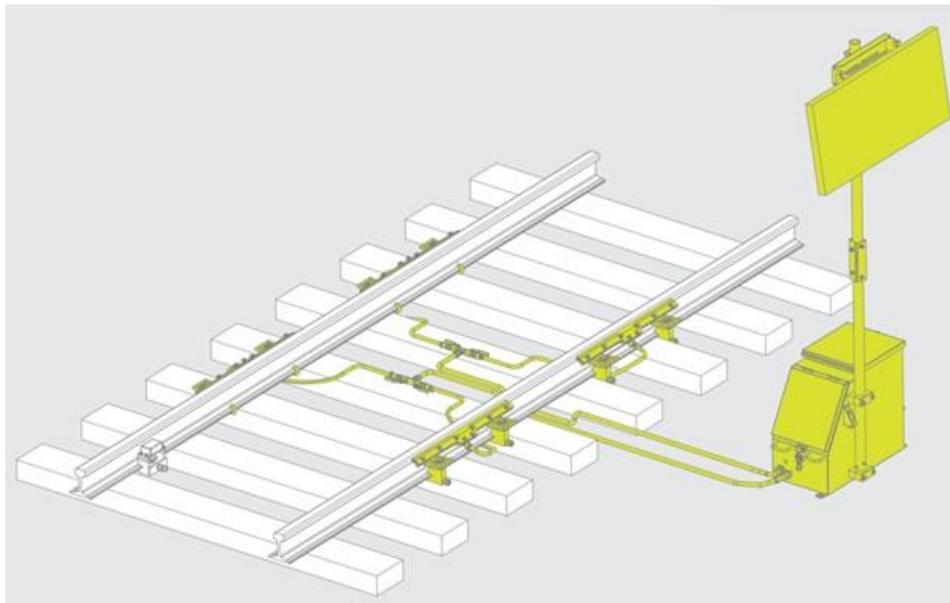
reduce friction in curves. Flange greases are designed to have frictional coefficients of less than 0.2 [5]. Top-of-rail friction modifiers (TORFM) are applied to the top-of-rail surface and act as a friction modifier rather than a traditional lubricant. A friction modifier is an engineering substance that is designed to alter the coefficient of friction to an optimal amount. TORFM is applied to the rail head to act as a third body layer and modulate the coefficient of friction to an ideal amount, usually between 0.25 and 0.4, for traction and adhesion while also reducing contact forces and wear that unnecessarily deplete the service life of the wheel and rail [5]. The TORFM creates a third body layer between the wheel and the rail and transmits longitudinal tractive forces while acting as a protective interface against wear forces from sliding. TORFM is applied at a TOR (top-of-rail) wayside applicator and the wiper bars for such an applicator are located on the field side of the rail rather than the gage side as with a flange greaser or gage face applicator.

Figure 2-8: TOR Wayside Applicator diagram [24]

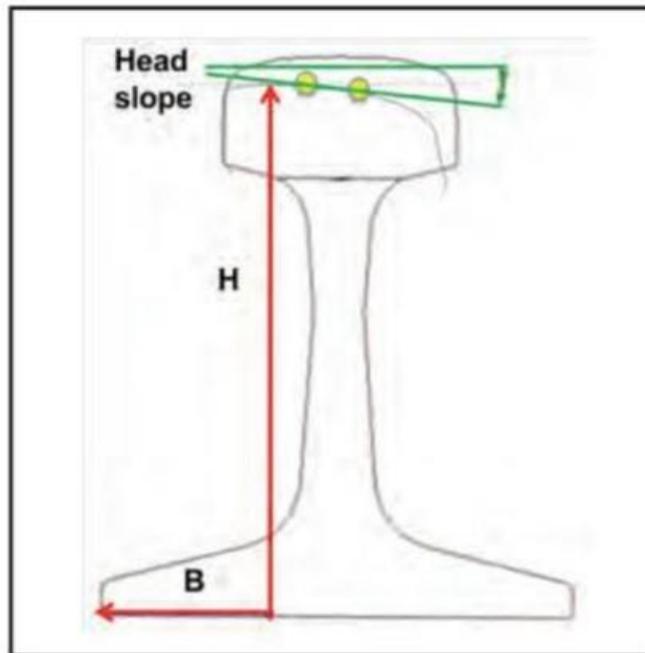
All of the optical properties presented so far presume a level, flat incident surface. This is not the case for optical methods conducted on a rail surface. The figure below taken from an article written by Brad Kerchof on rail profiles shows that the surface normal on the top-of-rail surface is not level or flat [49]. In fact, the rail head is not necessarily flat and is often crowned or sloped from rail wear. This head slope introduces another stochastic variable the needs to be accounted for while making optical measurements of track structures.

Figure 2-16: Worn Rail cross section with head slope annotation [49]

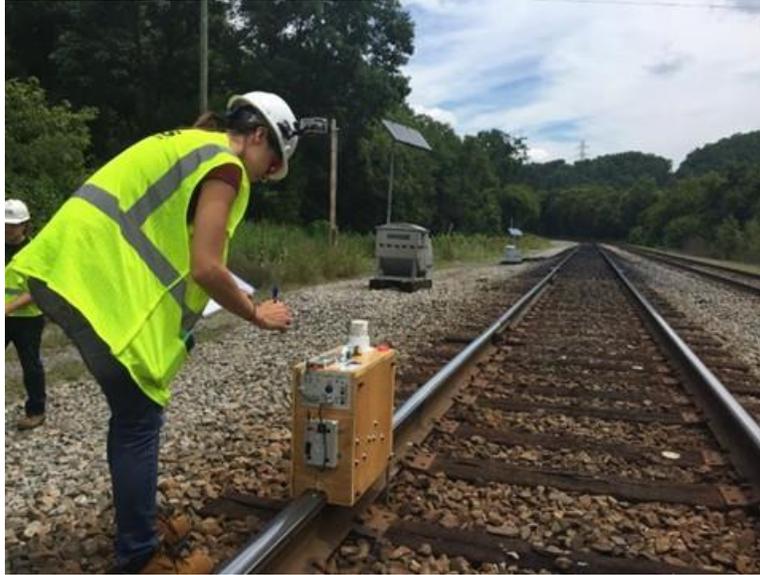
Figure 3-2: Second Generation Rail Lubricity Sensor in operation during field testing [31]

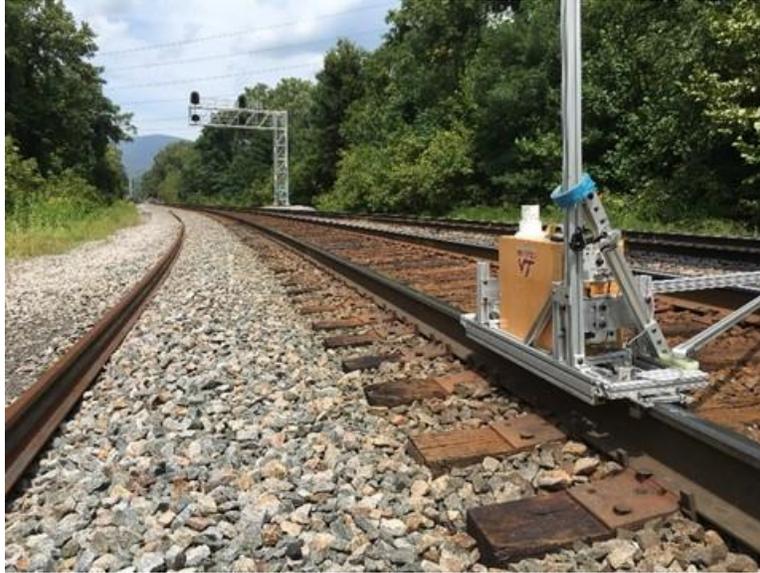
Figure 3-3: Second Generation Lubricity Assessment System in operation during moving field testing [4]

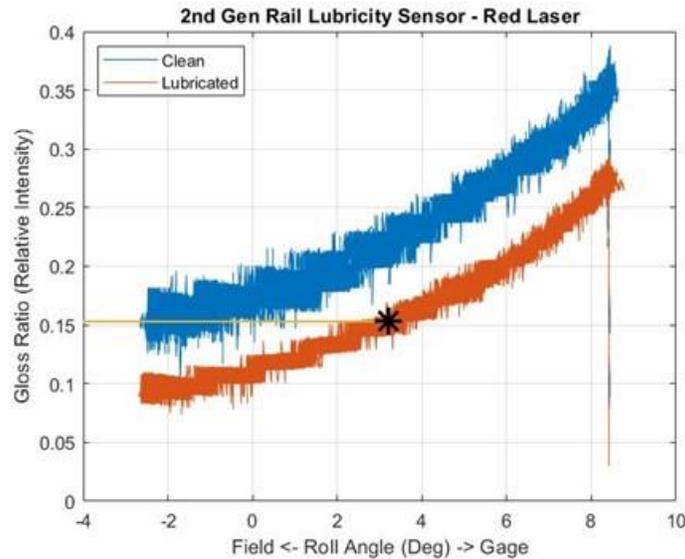
This first round of field testing revealed several key issues with the current Lubricity Assessment System. The rigid fixturing of the second generation Rail Lubricity Sensor to the push cart proved to be a challenge when it came to the changing rail surface normal. As the track would shift from tangent track to spiral and curved track, the local wear angle, also called head slope [49], would change and the optical scattering would vary as a result to a greater magnitude than the presence of absence of lubricants. For the second summer 2018 field test, a new set of sensor mounts was designed and fabricated to allow for quick adjustment of the box angle. These mounts featured two concentric arcs to allow the box to be rotated while staying equidistant and concentric to the same point on the rail head. Even so, the time constraints of the track authority window coupled with the slow rate of traversal while walking strongly limited the ability to make frequent enough adjustments [4]. It is understood that this field test data has inconsistencies in different sections due to the change in head slope. A laboratory test below shows the strong signal variance as the roll angle of the device changes. The yellow line shows the point where the two signals overlap and become ambiguous for the tested laboratory condition [51].

Figure 3-4: Gloss Ratio vs Roll Angle for different rail lubricity conditions demonstrating ambiguity due to roll angle [51]

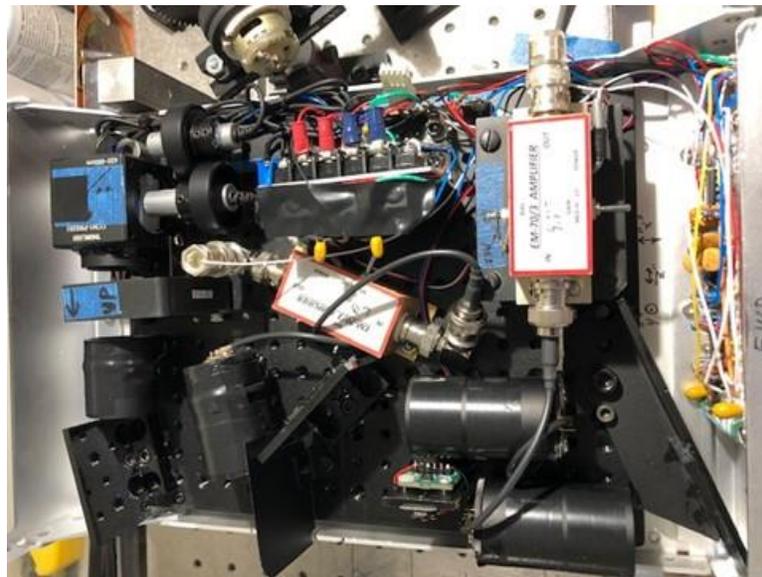
The peak power of the incident laser is 5.941 mW as it exits the sensor head. The peak power of the combined lasers inside of the sensor head is 9.5 mW which constitutes a Class 3B laser as defined by IEC 60825. Class 3B is an eye damage hazard if directly viewed but diffuse reflections are generally not harmful. When the beam exists the sensor head it has been expanded to a spot size of 1.5 cm x 1.0 cm. The 2.673 mW average power would lower the classification to a Class 3R laser although the peak power of 5.941 mW exceeds the 5 mW cap on the Class 3R definition. When reflected off the rail, the laser should not constitute an immediate eye damage hazard, however, eye exposure to both the direct and reflected light should be avoided. The instrument is marked with appropriate warning labels [52].

Figure 3-9: Inside view of optical sensor head [52]

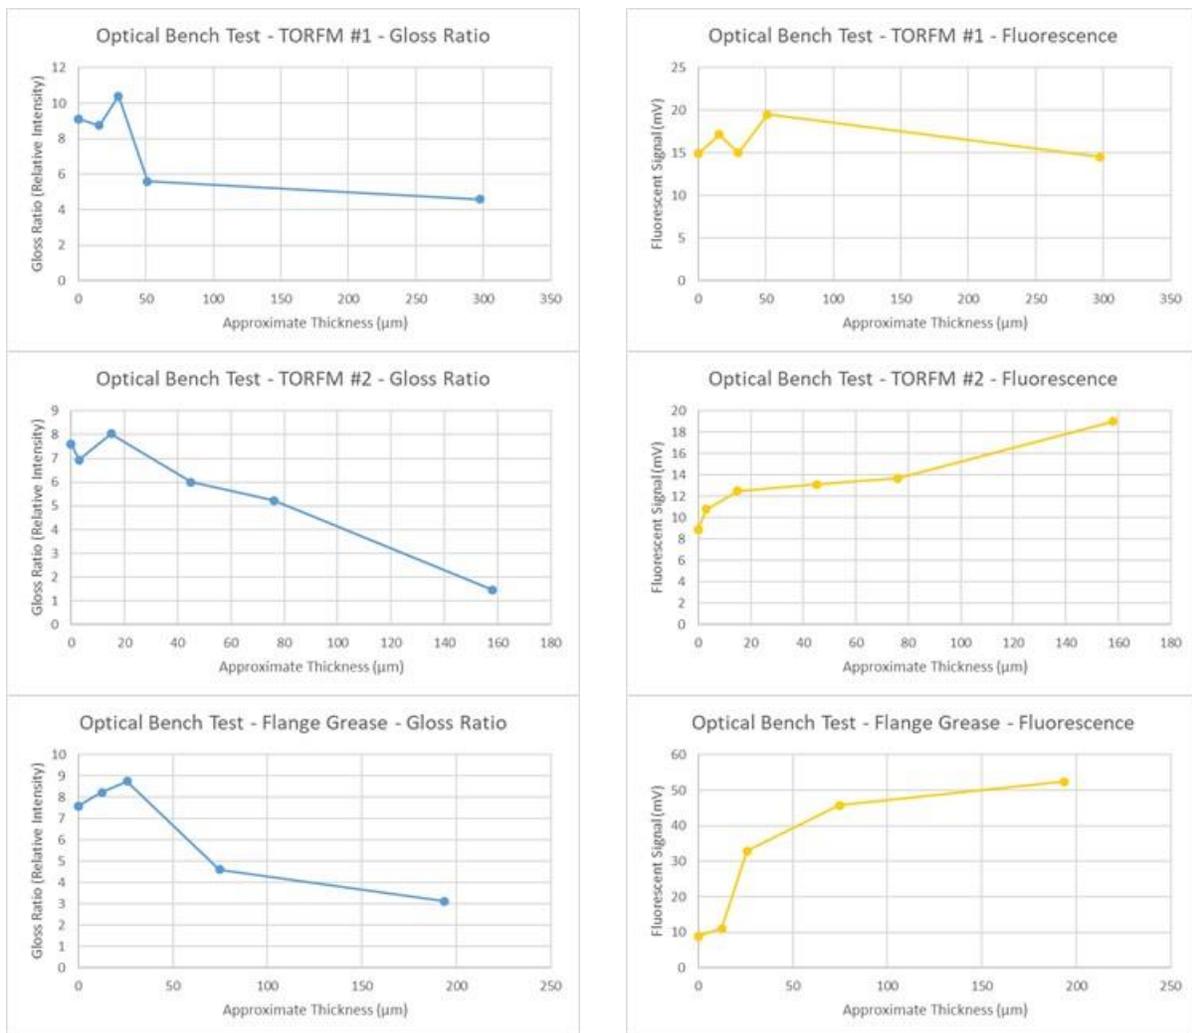
These tests were all static tests and the results were compiled into an internal CVeSS report, the results of which are also recorded here. Using an optical probe, a measurement of a cleaned rail condition was measured and compared with the measurements from different lubricated conditions. This allows for the estimation of an approximate material thickness with the understanding that the surface roughness variation is significant with respect to the material thickness making an absolute thickness measurement impossible. Instead, an approximate estimated thickness is imposed on the x axis allowing for a rough quantification of the general material thickness compared to optical response [53]. The optical bench tests demonstrate that there is a response in the gloss ratio between a clean rail condition and one where an opaque lubricant has been added to the surface. The different fluorescent plots demonstrate the fluorescent behavior of the 3 tested lubricants. The flange grease and TORFM #2 fluoresce more than TORFM #1 does but the fluorescent behavior of any of these lubricants can aid in the detectivity of the sensor.

Figure 3-13: Optical bench tests for 3 different rail lubricants

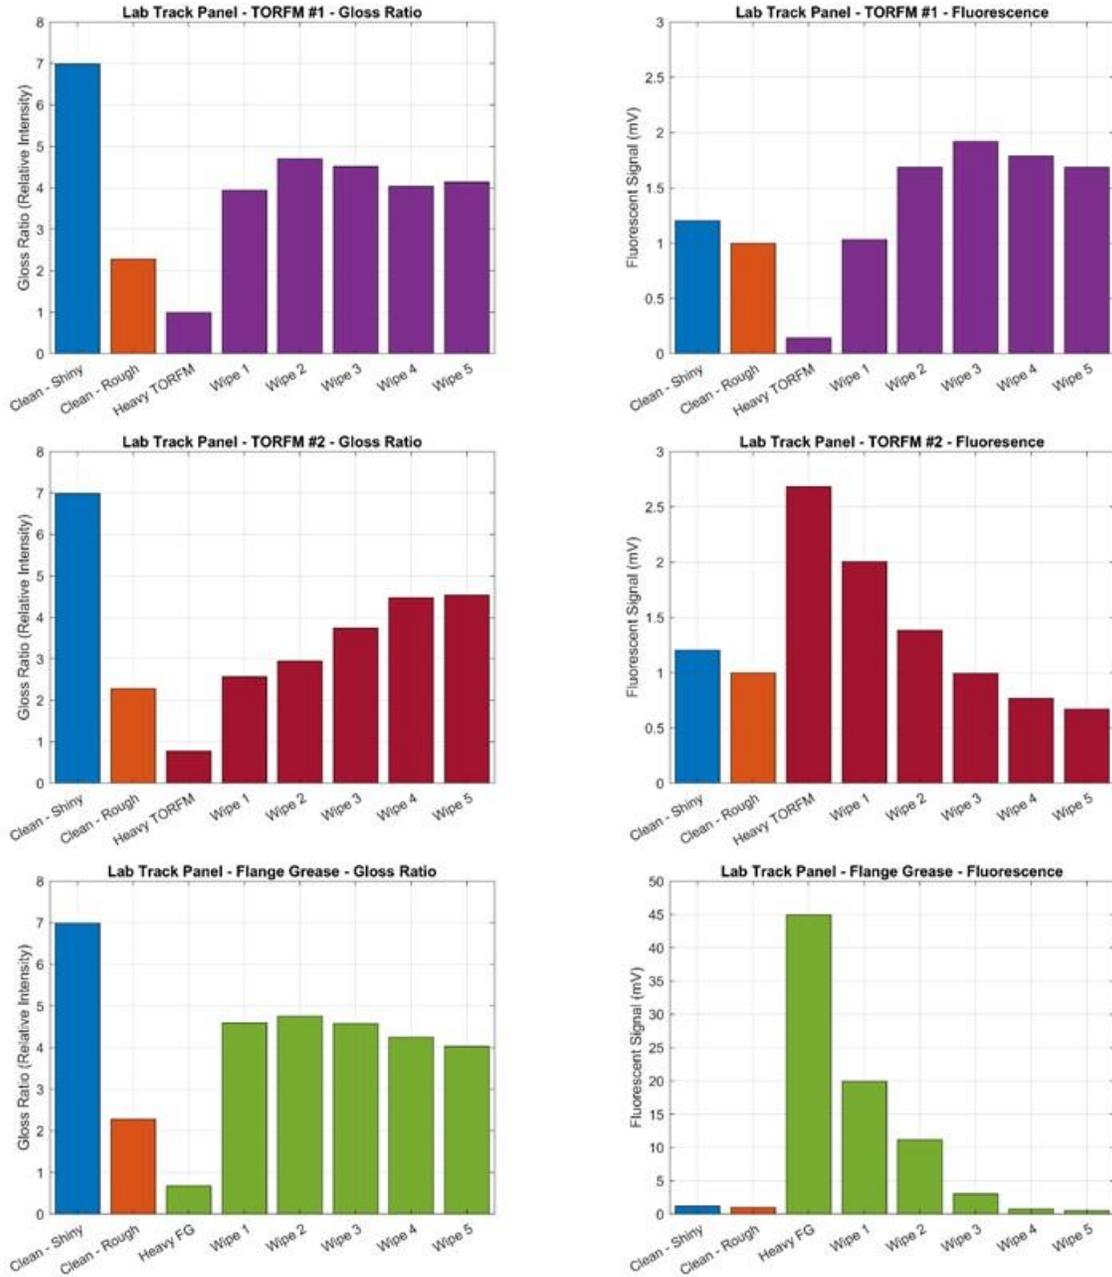
The following tests show a section of track that was first cleaned, and then had heavy amount of lubricant applied to it. Every successive test, a fresh Kim-Wipe was used to incrementally clean the surface and reduce the lubricity condition. Finally, the section was once again cleaned and the next lubricant was tested on the same section of track. Clean rail measurements were observed in-between tests to verify that the underlying rail conditions were identical. This was done for two different brands of TORFM and for the sample of flange grease supplied to the lab.

Figure 3-14: Laboratory Track Panel tests for 3 different rail lubricants

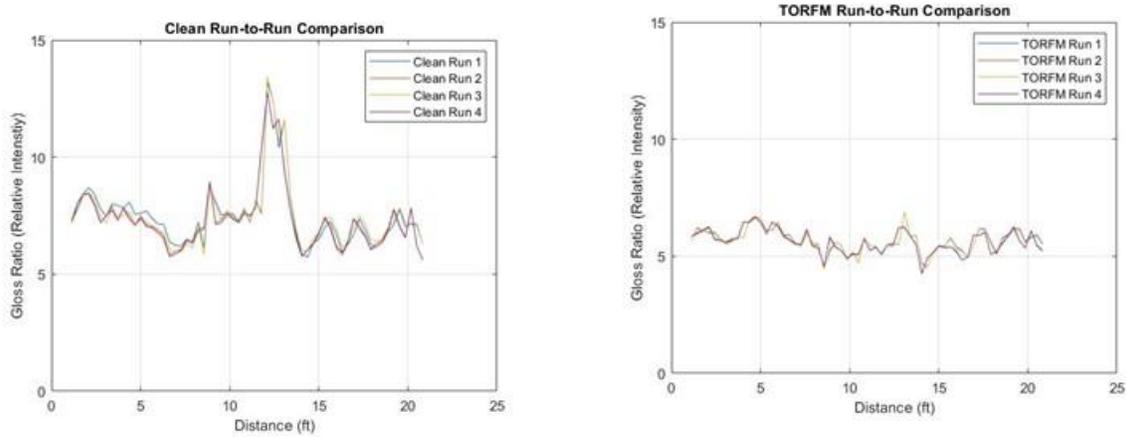
from one clean condition to the next. This shows that the cleaning process is consistent and repeatable and the sensor is likewise repeatable.

Figure 3-15: Run-to-run repeatability evaluation for clean and lubricated condition

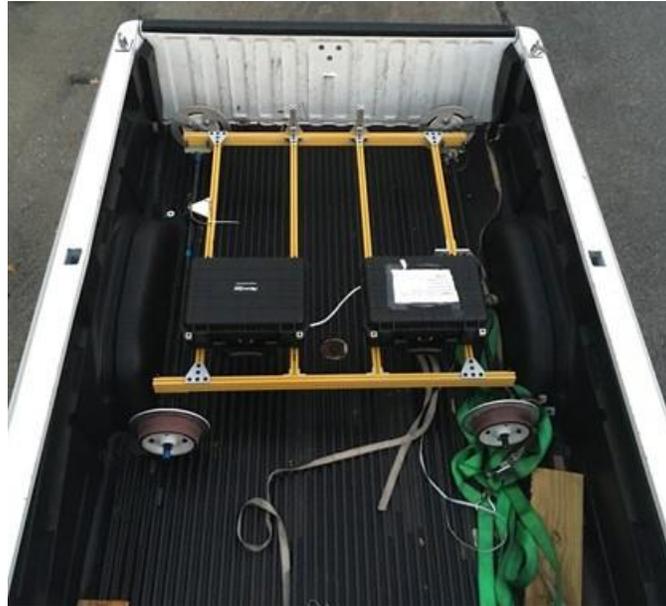
rough service roads to get to the testing site and removes the need to do any onsite assembly prior to the test. Upon arriving at the test site, the cart can be removed from the bed of the truck and set on the track immediately ready for testing.

Figure 4-2: Test fit of remote control rail cart in the bed of the lab pickup truck

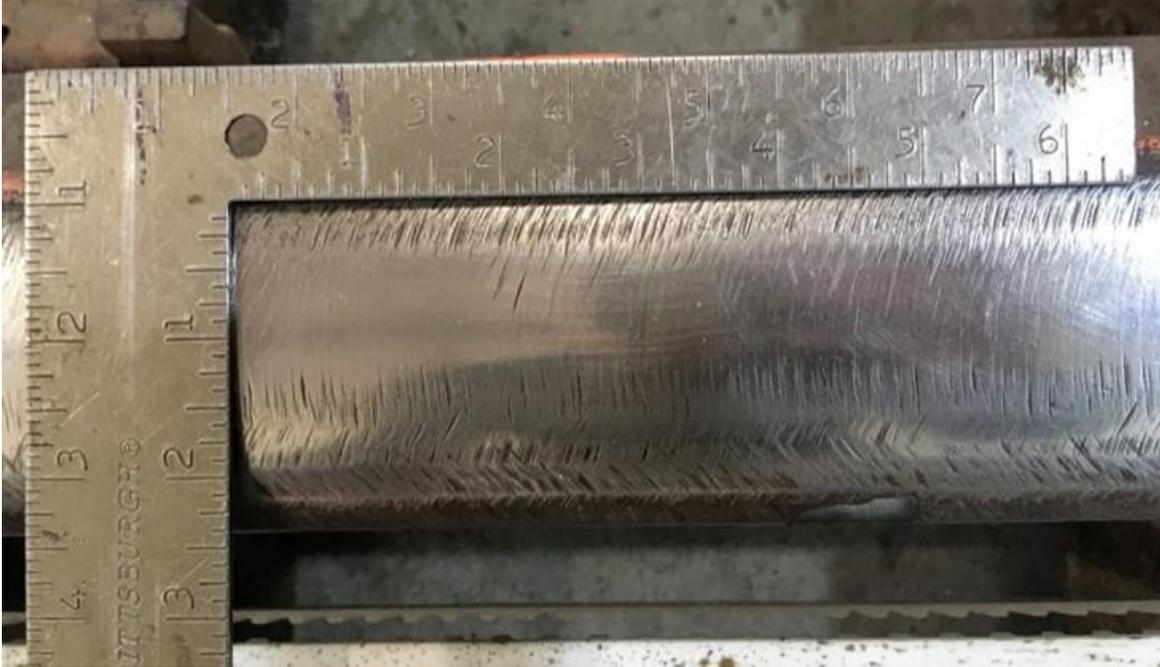
Small localized spikes in the optical channels are prevalent as the rail surface is not a uniform, smooth surface. The rail surface is very stochastic with a high amount of surface imperfections. Different angled cracks in the rail surface can sharply change the scattered power for a single sample and surface glints are common during measurements on rail surfaces. Some of these surface features can be easily visible by the human eye and some of the cracks and facets will require a microscopic view of the specimen. Because all of these features are far below the -20 dB cutoff period of 3.73 feet, the majority of the effects of these high frequency, low period effects should be strongly attenuated by the moving average filter.

Figure 5-2: Top-of-Rail Surface roughness of RTL track panel

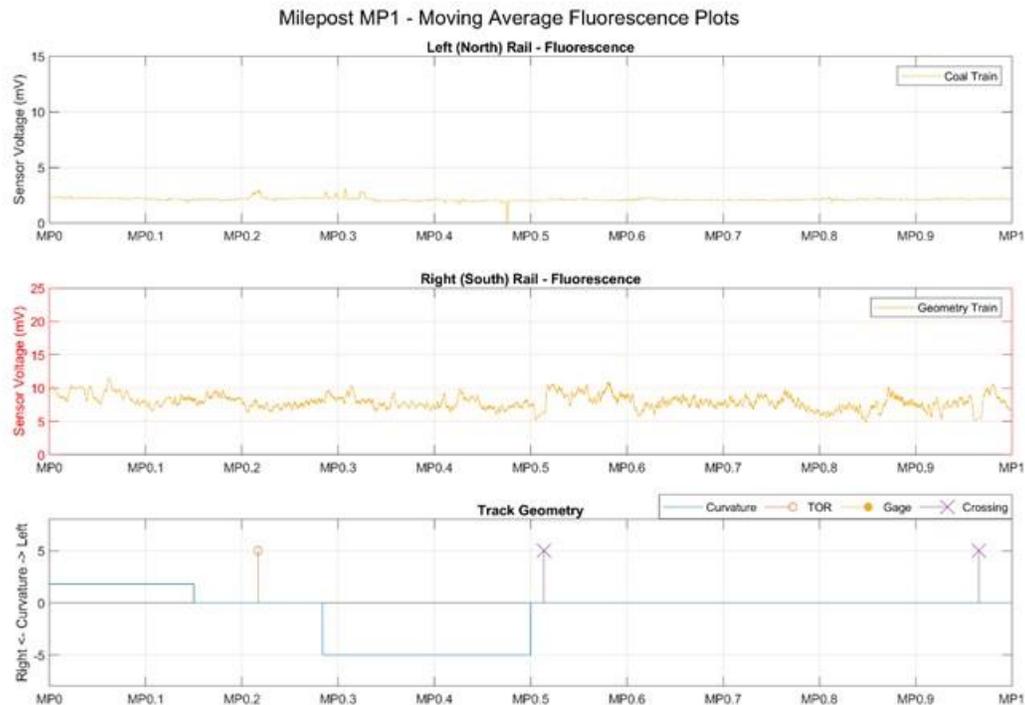
The fluorescence signal is already elevated for the right hand rail prior to the TOR applicator. Flange grease has been demonstrated to be highly fluorescent and as a result, the flange greaser is imparting a significant lubricity signal for the geometry train even before it arrives at the TOR applicator. For the left hand rail, it appears as though much less flange grease is migrating to the top-of-rail surface. At the TOR applicator, there is a small bump in fluorescent signal indicating that the sensor has correctly identified the presence of the TOR applicator. There are a few other small jumps directly at the entrance of the curve.

Figure 5-6: Moving Average Filtered Fluorescence Data from Milepost 1

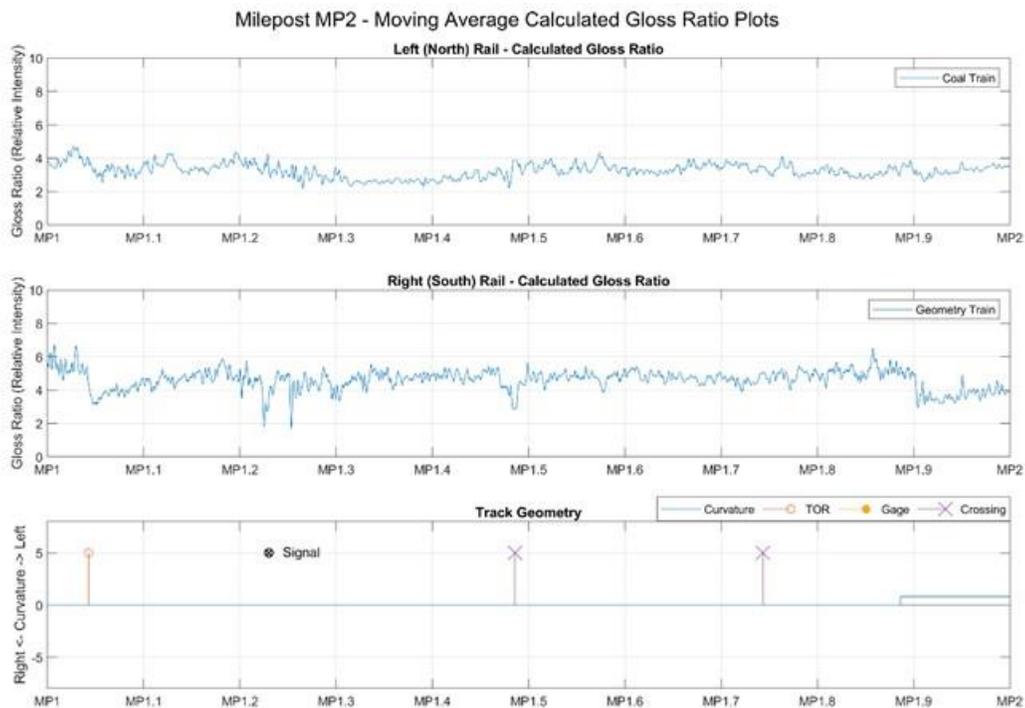
The next TOR applicator is very close to MP 1. This time the dip in CGR is prominent on both the left and right handrails as heavy TORFM is present at the wayside applicator. The CGR quickly rebounds from a heavy TORFM condition to a gloss ratio of around 4-5 which is more typical of lubricated rail. Again, the right hand rail shows a higher lubricated condition than the left hand rail from the preceding traffic. This section of rail is straight for almost a mile and after passing over the second applicator, the conditioned wheels tend to maintain their lubricity longer.

Figure 5-7: Moving Average Filtered Calculated Gloss Ratio Data from Milepost 2

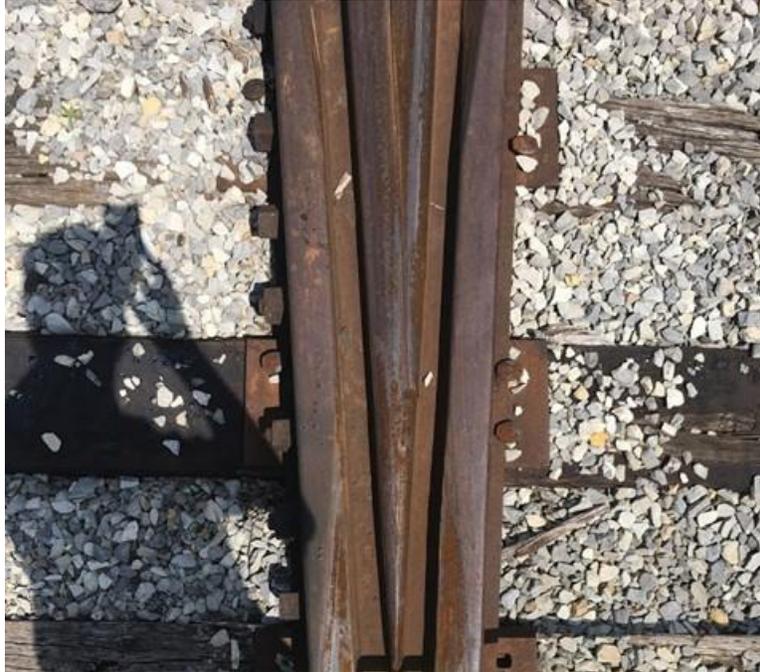
Near MP 1.2, there are a few dips in the gloss ratio on the right hand rail. At this spot there is a signal and a switch to the passing siding at Riverside. The right hand rail passes through a switch frog which allows for the diverging rails to cross and the trains to navigate from one track to the other. When the sensor goes over the switch frog, it is exposed to the rough oxidized steel surface of the frog and the gloss ratio drops for a short distance. With access to track data, it is easy to identify these anomalies and disregard the local effects caused by them.

Figure 5-8: Example of a switch frog

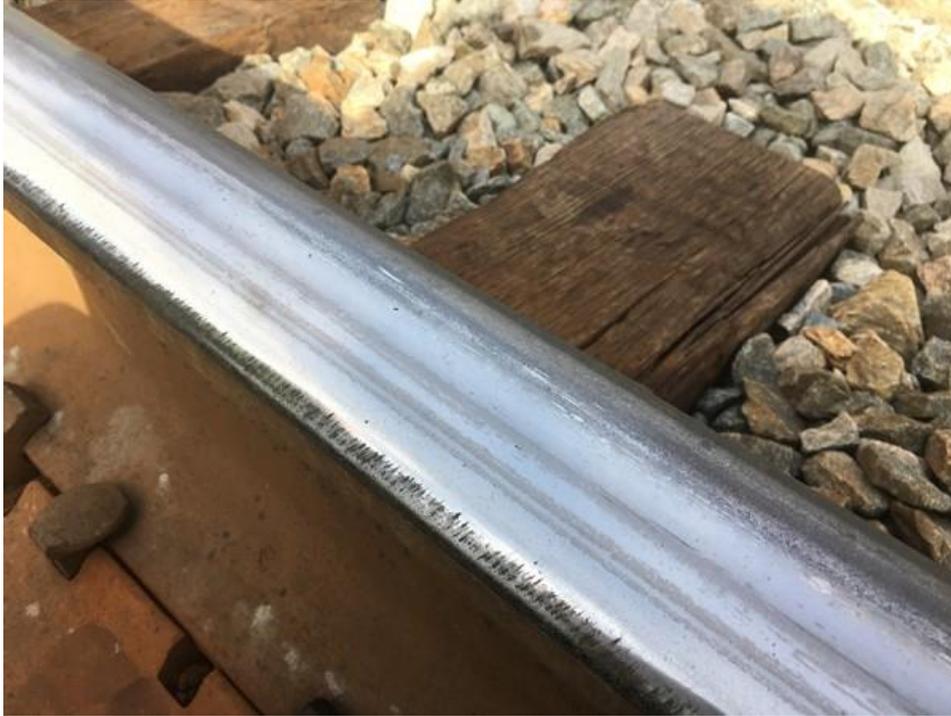
Figure 5-11: A field survey of the mainline track shows evidence of TORFM on the outside of the rail.

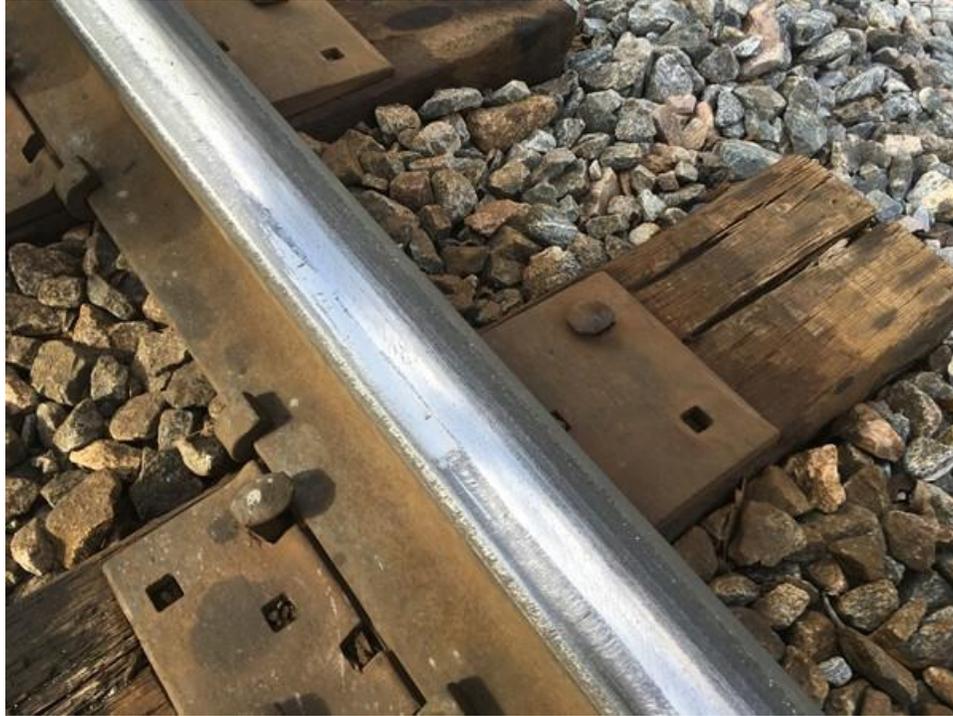
Figure 5-12: Patchy TORFM condition in a sharp left hand curve

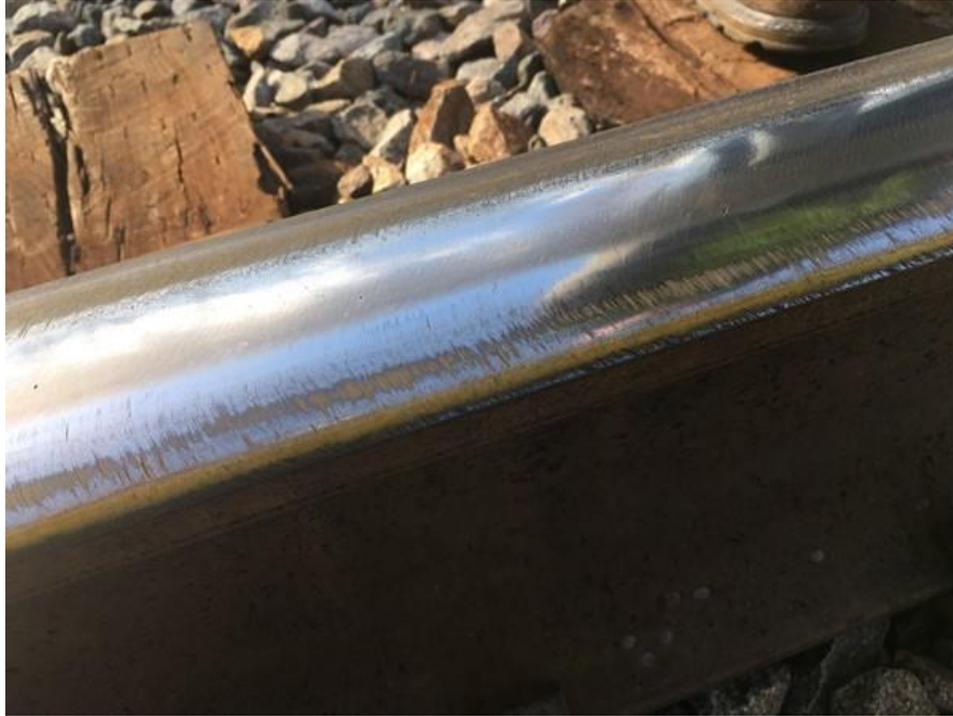
Figure 5-16: A field survey of the track near MP 3.7 shows limited signs of TORFM

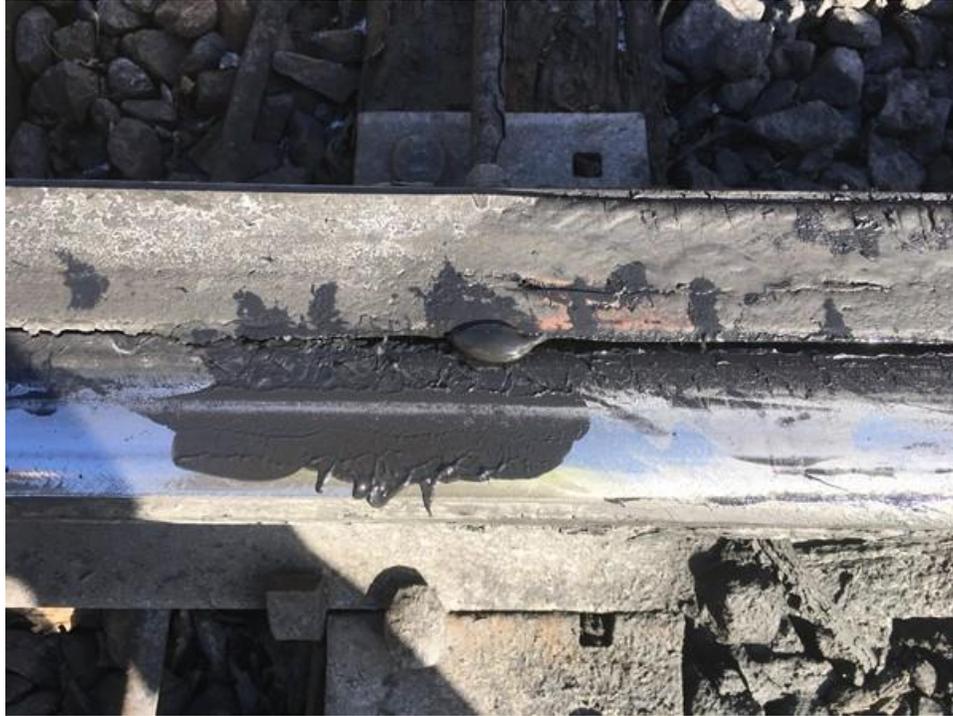
Figure 5-21: TOR wayside applicator functioning correctly in the field with TORFM applied to the rail surface.

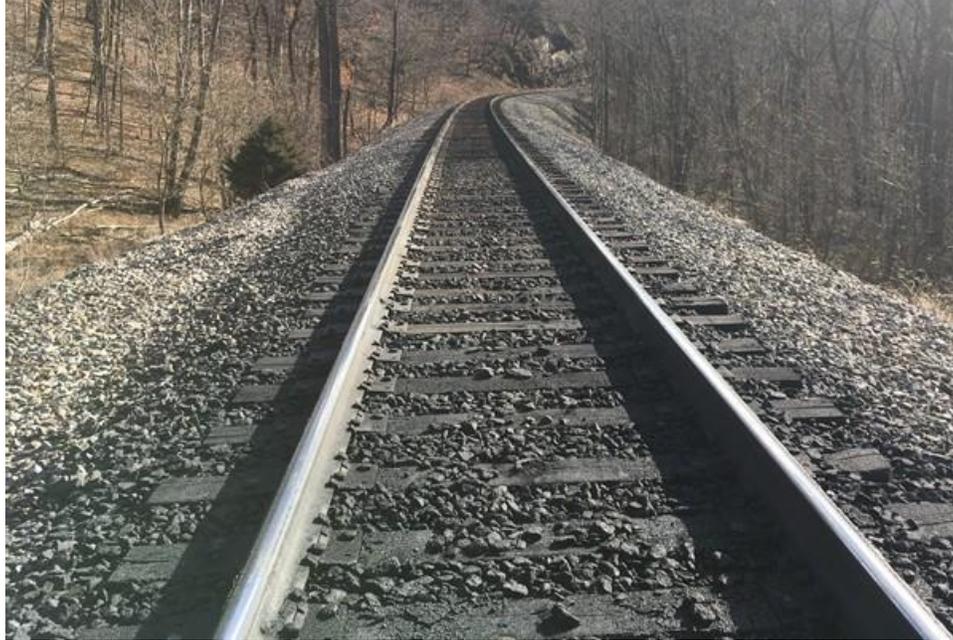
Figure 5-44: TORFM patches moving down track from a TOR applicator caused by the coherent phase of the train wheels

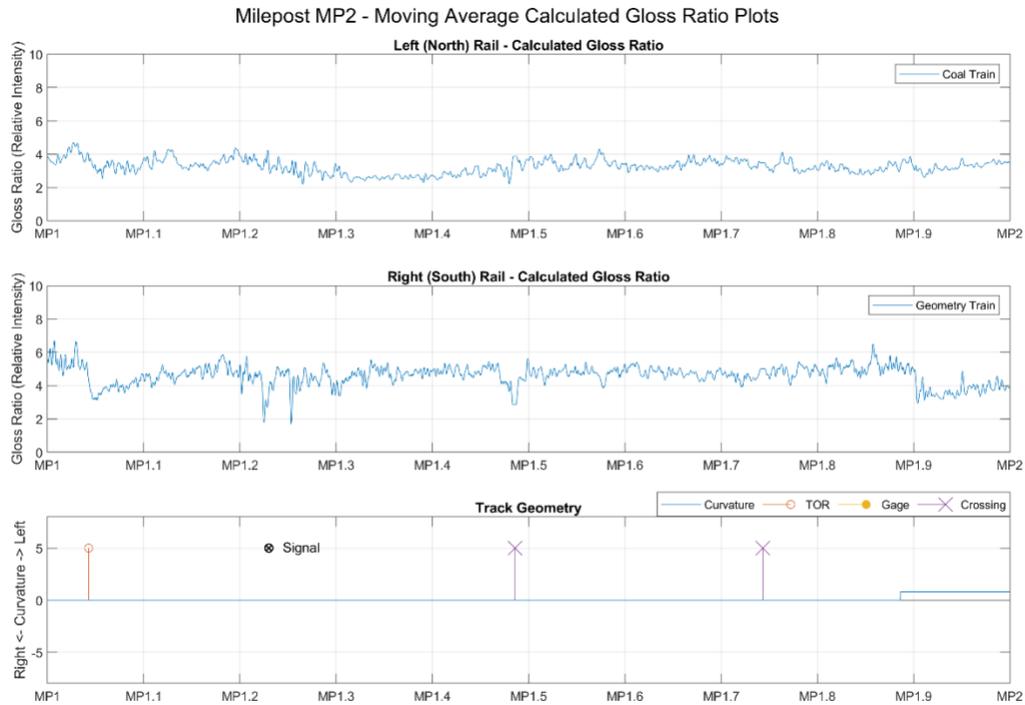
Figure 6-4: Physical wayside applicator effect at MP1.05 and Phantom applicator effect at MP1.9 in Calculated Gloss Ratio Moving Average Filtered Plots

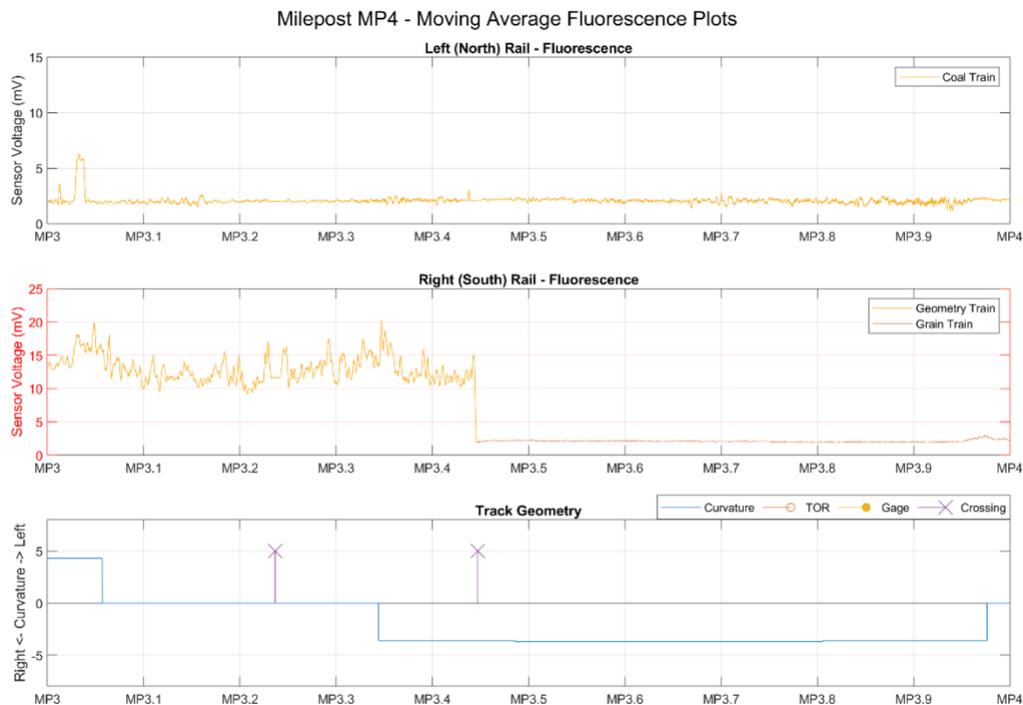
Figure 6-5: Demonstration of variation in lubricity signal magnitudes between three different preceding traffic conditions

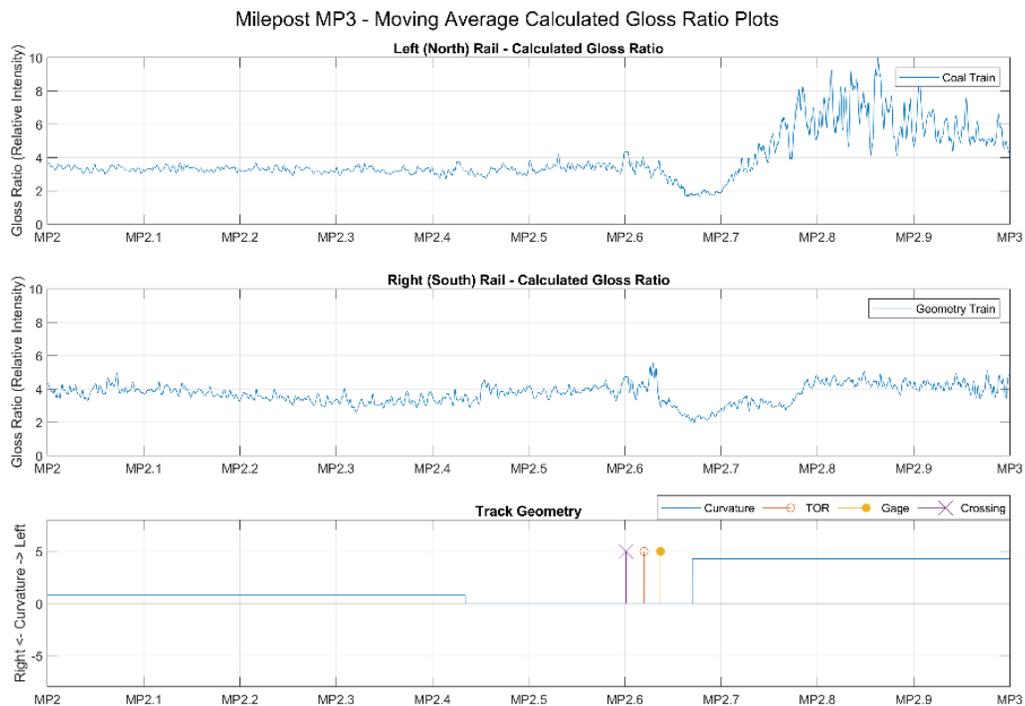
Figure 6-6: High variation in top-of-rail lubricity condition on left hand rail in a tight curve

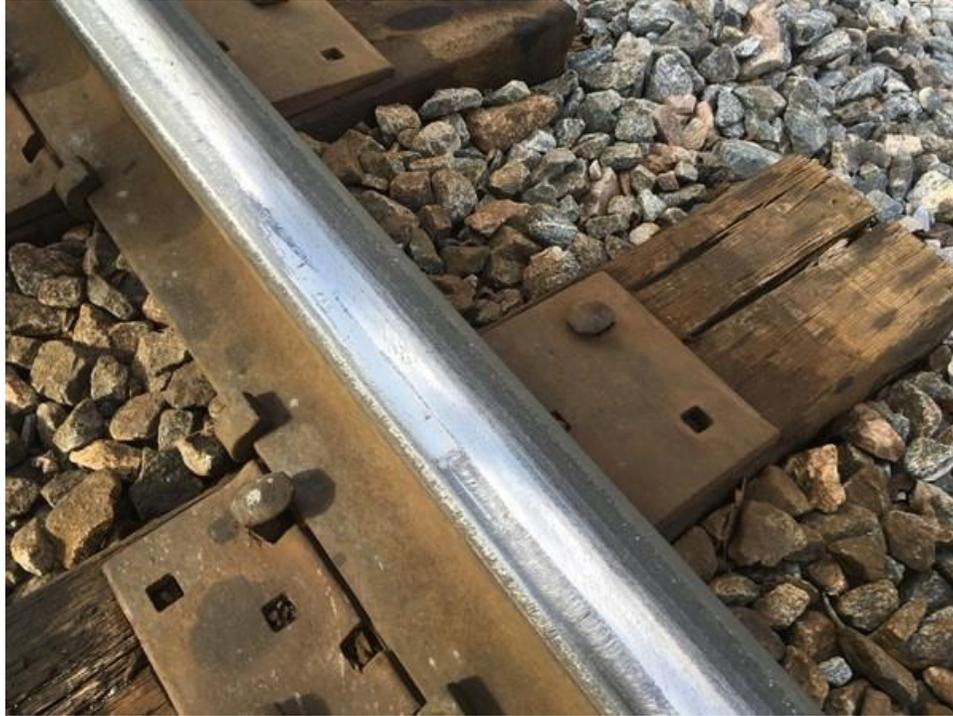
Figure 6-7: Non-uniform, "patchy" distribution of TORFM on the top-of-rail surface in a sharp curve

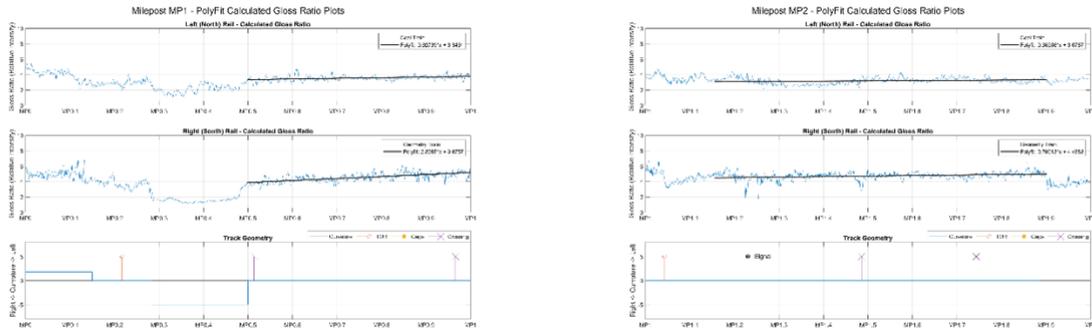
Figure 6-8: Comparison in trend line slope trailing the first TOR applicator (Left) and the second TOR applicator (Right)

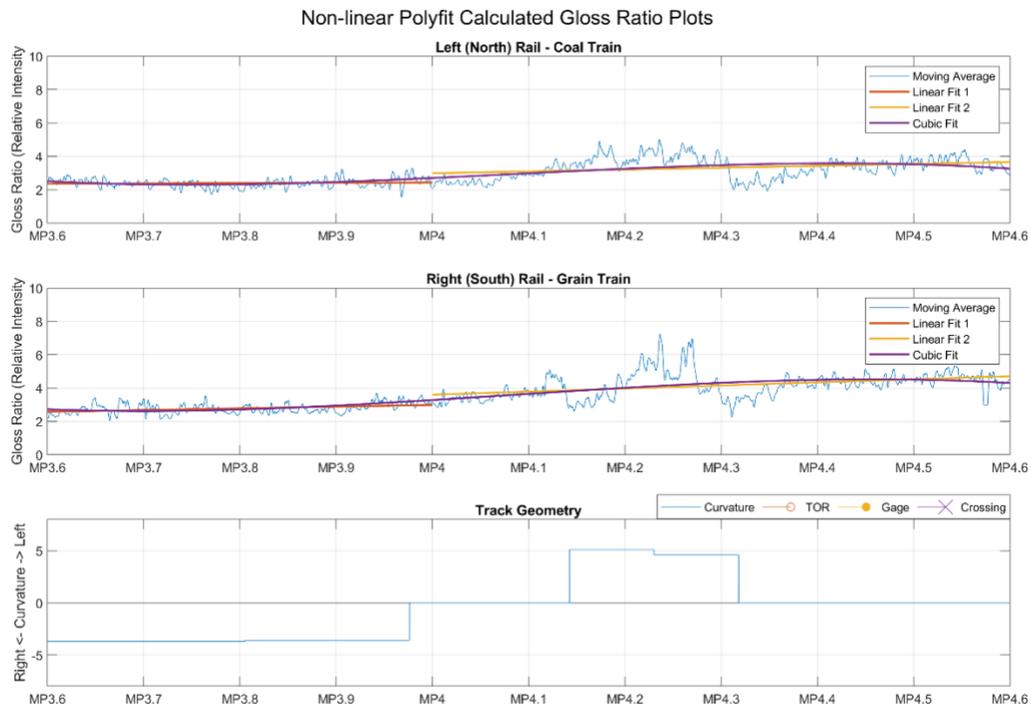
Figure 6-9: Various curve fits applied to Moving Average Filtered Calculated Gloss Ratio data

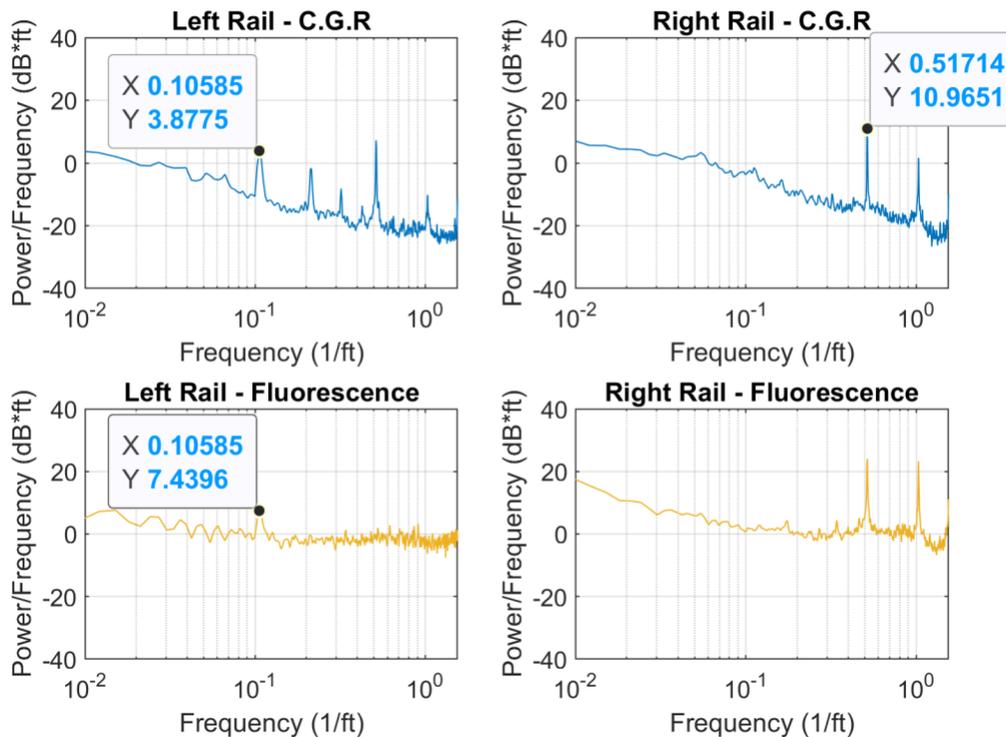
Figure 6-10: Power Spectral Density Plot of Lubricity Signals for Milepost 2 with Data Tips applied to Freight Car Wheel Frequency
