1. Report No. RailTEAM VT-6	2. Government Accession No.	3. Recipient's Catalog No.	
4. Title and Subtitle Methods for Qualitative and Quantitative Measurement of Top of Rail Friction Modifiers (TORFM) in Revenue Service		5. Report Date September, 2022

Final Report VT-6

**METHODS FOR QUALITATIVE AND QUANTITATIVE MEASUREMENT OF TOP
OF RAIL FRICTION MODIFIERS (TORFM) IN REVENUE SERVICE**

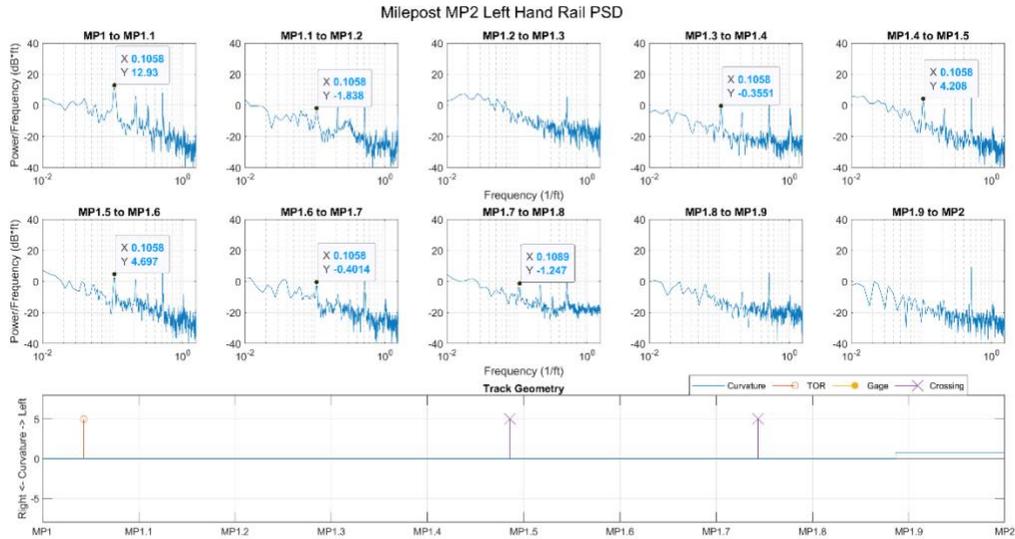
Figure 6-11: 1/10th milepost block Calculated Gloss Ratio Power Spectral Density Plots for Milepost 2 with Data Tips applied to Freight Car Wheel Frequencies
